1105 CARLTON STREET  
BUILDING ASSESSMENT

1105 CARLTON STREET  
CLEARWATER, FL 33755

CITY OF CLEARWATER

FINAL

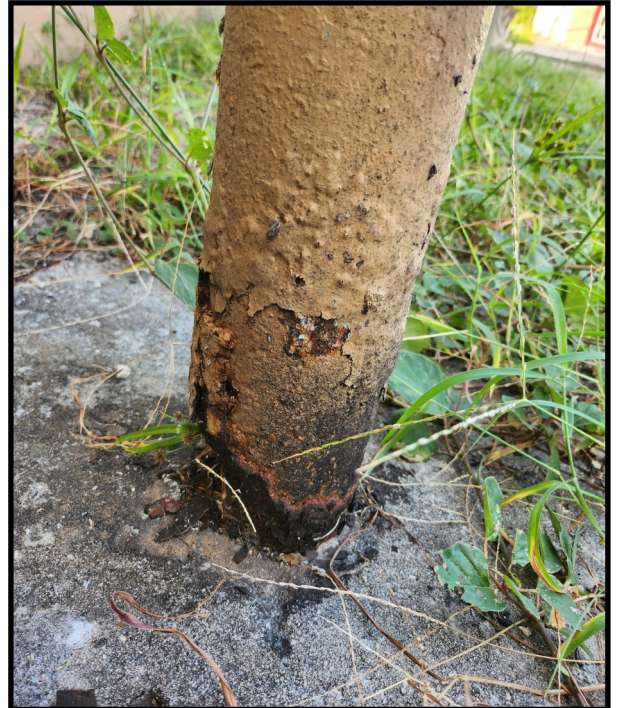
Photo 10 -

The second floor is accessed by cast in place concrete stairs on the north and south side of the building. The handrail posts are embedded in a concrete block that is post installed on the stairs. The north side posts, top and bottom rails are square tube without intermediate pickets between the posts (Photo 8). On the south side the posts and top rail (no bottom rail or pickets) appear to be conduit (Photo 9). Both sets of handrails are structurally deficient. The landings at the second floor are partially supported by steel pipe columns which show signs of significant corrosion at the bases and cap plates (Photos 10 & 11).

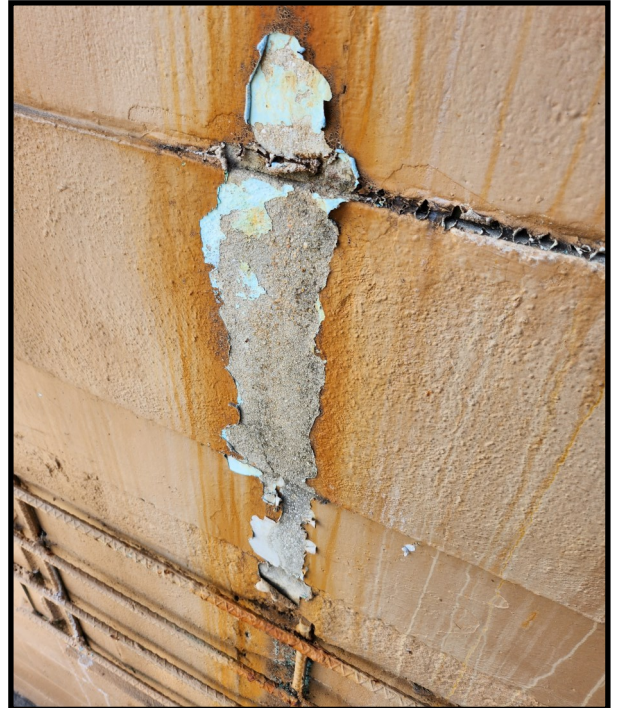
Photo 14 -

The exterior CMU walls appear to be in good overall condition and show minimal signs of active cracks, however, there are signs of an old crack that has been repaired on the south side near the southeast corner of the building. Several existing penetrations that are not needed for utilities will need to be patched/grouted (Photos 12 & 13). The CMU walls are unreinforced and assumed face shell mortar bed, and along with their age drastically reduce the ability of the walls to resist wind pressures. The existing wall capacity is about 60% less of today's current required wind pressure. If necessary for future use, there are options to strengthen the walls, such as adding reinforcement in the walls or using steel tubes to brace the walls on the interior face. Both options are invasive and have a high cost associated with them. There are several locations of staining and paint erosion on the CMU walls caused by water damage from the AC units (Photo 14).

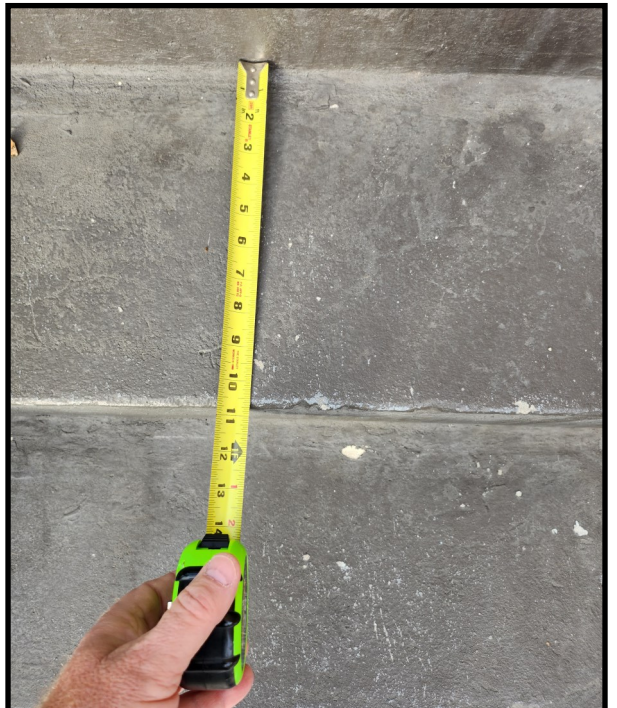
Photo 16 -

Per Florida Building Code, FBC, stair treads shall have a maximum rise of 7" and a minimum depth of 11", the existing concrete stairs do not meet this requirement (Photos 15 & 16). The handrail on both stairs exceed the pass through spacing requirement, which requires a maximum clearance of 4". The south side handrail is a non-structural member and will not meet current loading criteria. The attachment of the handrails to the stairs on both sides does not meet current requirements. Both handrails shall be replaced to meet current code requirements. The existing storage enclosures shown in (Photos 6 & 8), and the metal awning (Photo 17) should be removed or replaced with exterior grade code compliant material with proper attachment. The concrete slab at the base of the south stair is broken and shall be replaced (Photo 18), the north side stair slab has settled and will not meet accessibility requirements and shall be replaced (Photo 19). The second floor landing at the south side has minor chipping and shall be patched/grouted (Photo 10). The pipe columns supporting each second floor landing shall be repaired or replaced.

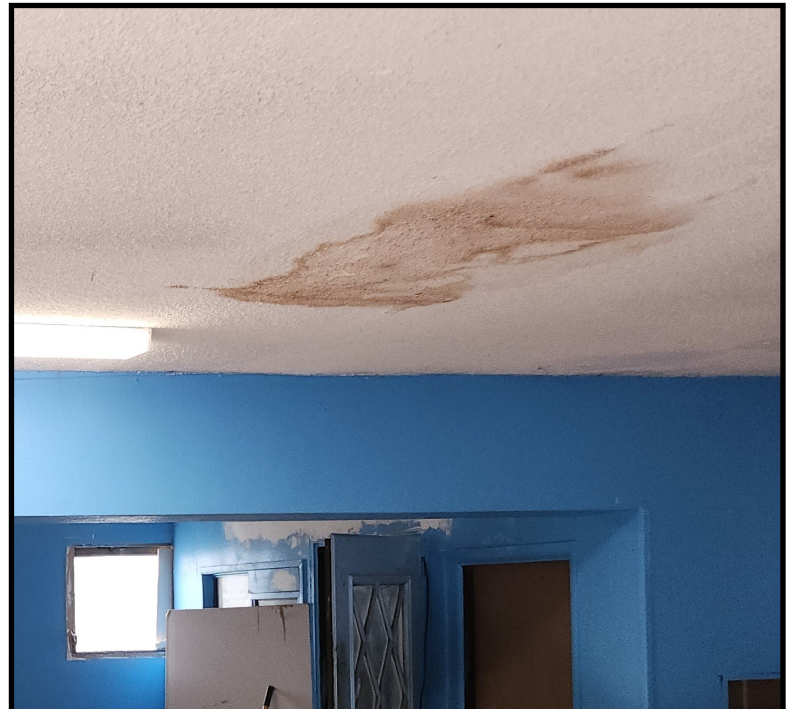
Photo 24 -

The ceiling on the first floor shows signs of water damage (Photo 24). This damage is consistent with what is seen on the visible portions of the second floor joists and decking, there also appears that some repair have been made by sistering and new wood member to the existing joist (Photos 25 & 26). It is crucial that the first floor ceiling be removed to see the extent of the damage and see which members shall be replaced or repaired. The visible portion of the wide flange beam supporting the second floor joists appears to be acceptable. The pipe column supporting the wide flange beam on the east side appears to be in satisfactory condition, the support on the west end is encased with in wall but assumed to a pipe column but the condition is known.

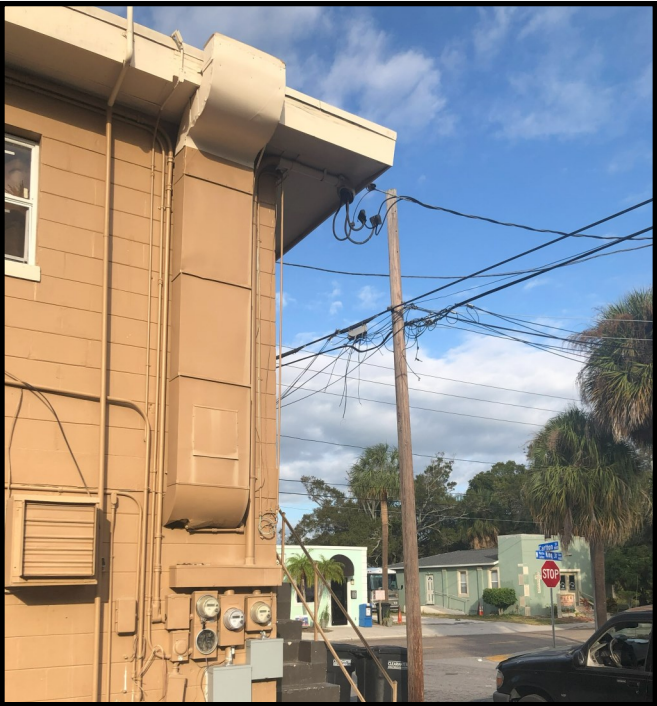
Photo 07 -

The first floor had been used as a restaurant and the kitchen hood has been removed. The remaining exhaust duct and makeup air fan are inadequate and would need to be replaced if a new commercial kitchen hood with fire suppression was to be installed (Photos 5,6 & 7).

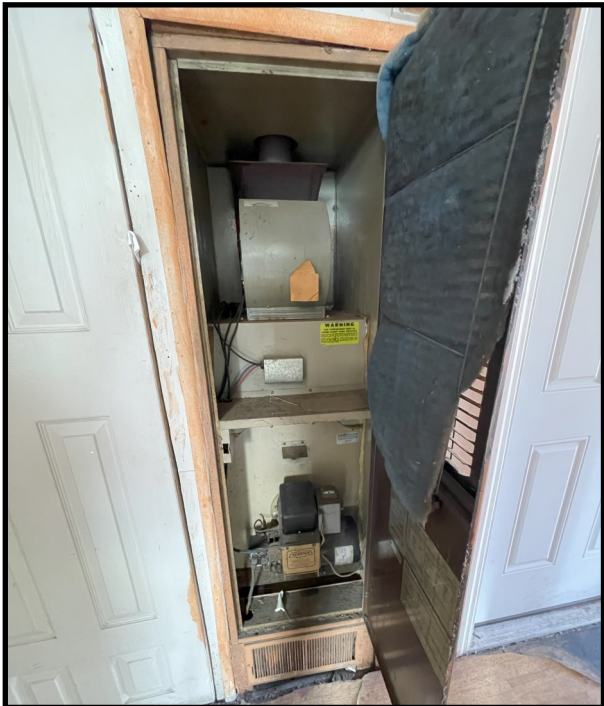
Photo 10 -

2ND floor heat is provided by a fuel fired furnace located in a closet. We were unable to determine if the unit was in working condition. During the site evaluation we were unable to locate the fuel tank (Photo 10).

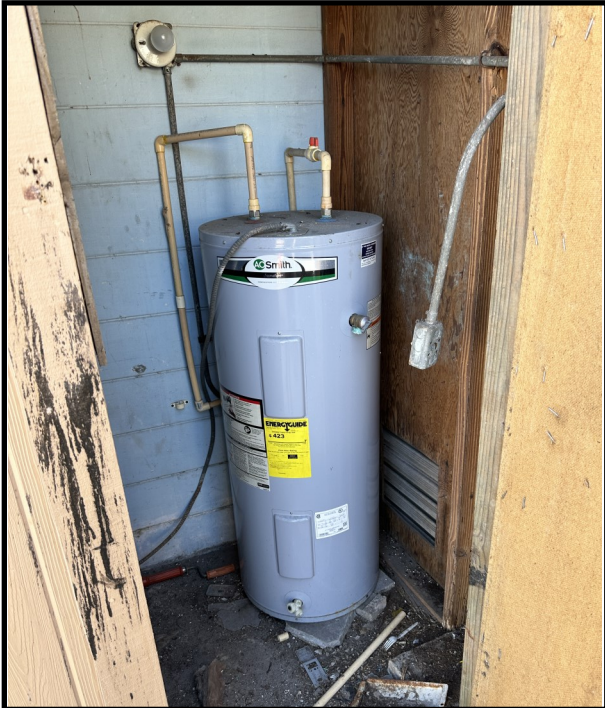
Photo 15 -

The existing 40-gallon electric water heater is in a closet located under the north stair case. It was manufactured on November 2, 2018 and has a warranty that is good thru November 1, 2024. We would recommend adding a small expansion tank to prevent the leaking at the pressure relief valve as indicated by deposits on the valve. This water heater serves both the 1st and 2nd floors (Photo 15).

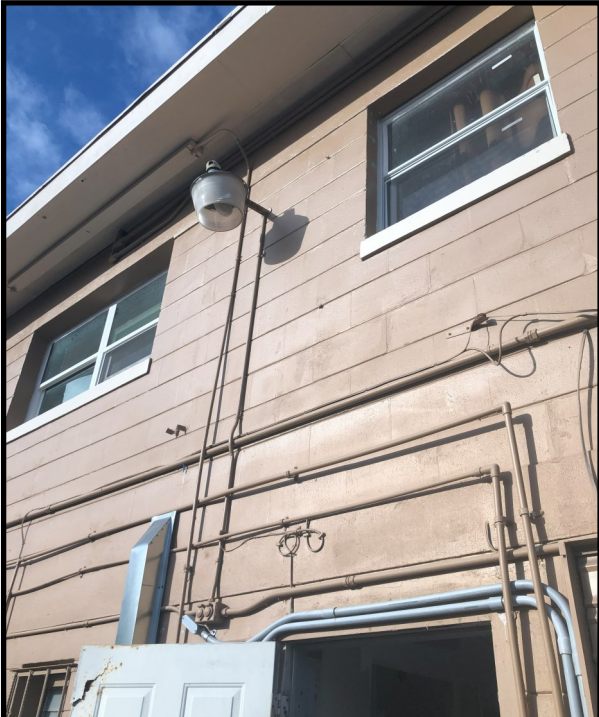
Photo 09 -

Building exterior lighting was limited and operation could not be verified (Photo 9). The exterior wall lights were incandescent type and it recommend to replace all fixtures with LED type fixtures. The emergency lights shall be provided above the building egress front and back doors in accordance with 2017 NFPA 101 Life Safety Code. Florida Energy Efficiency Code (FEEC) requires exterior lighting controls include astronomic features allowing the system to adjust for changes in seasonal daylight patterns.

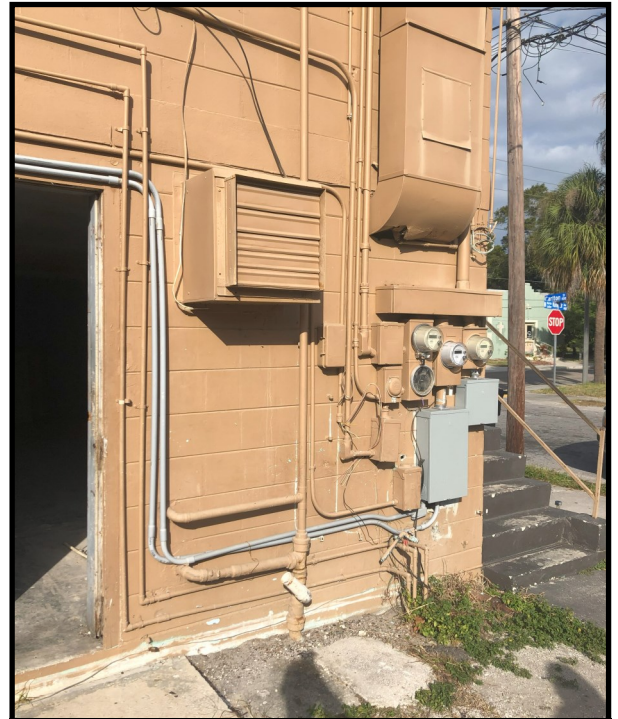
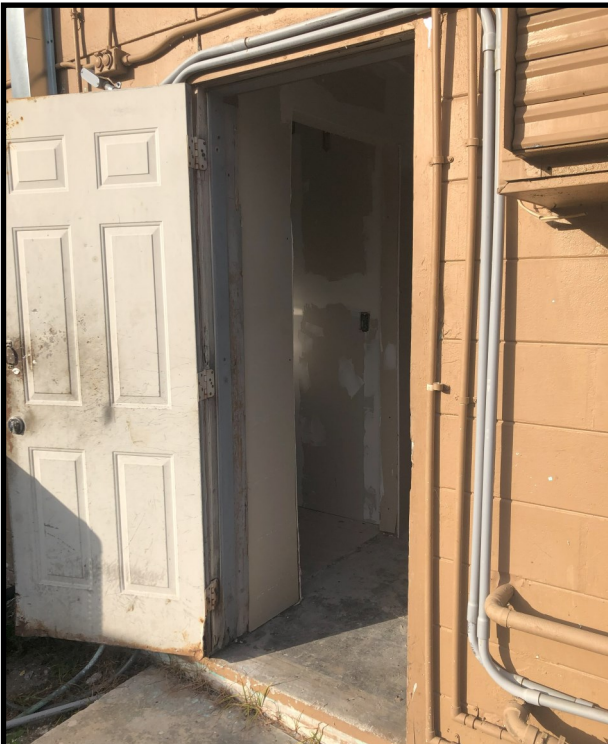
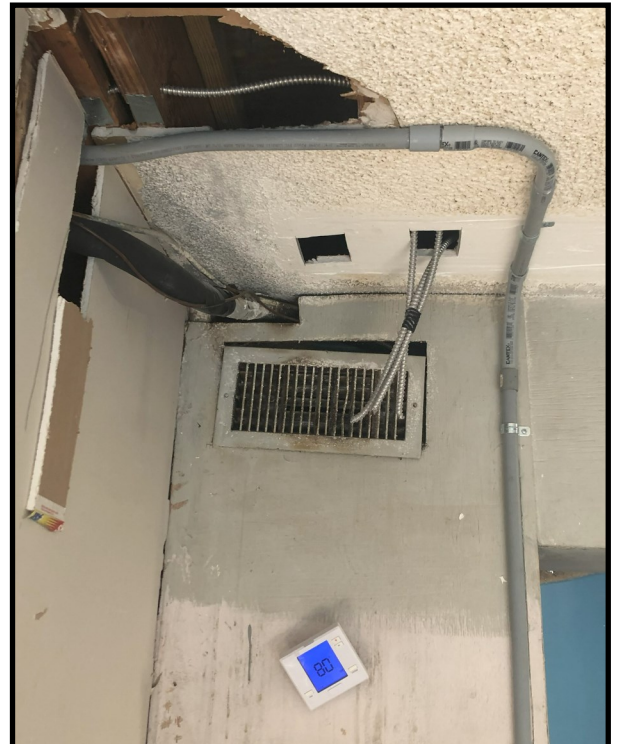
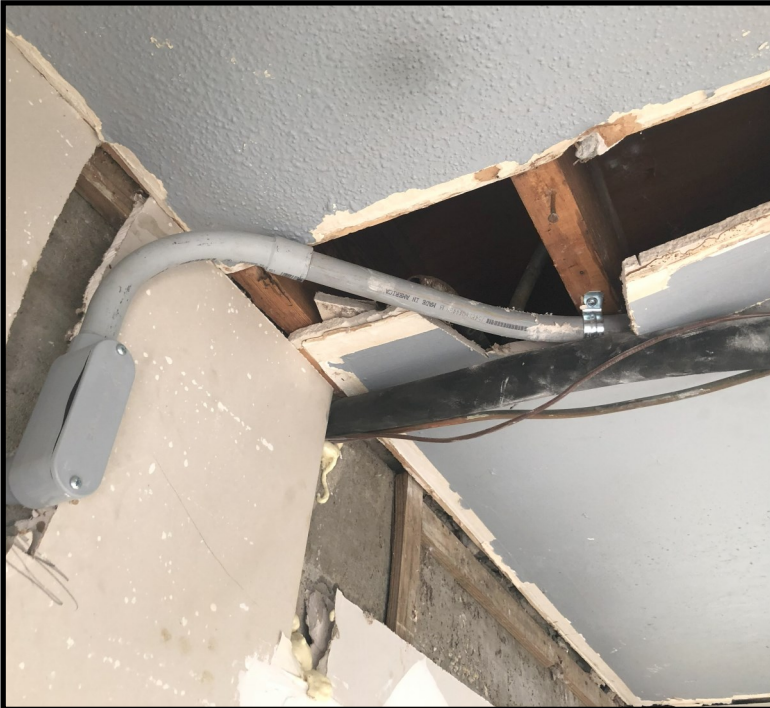
It appears that PVC conduits were used in both building exterior locations (Photo 10 & 11) and interior locations (Photo 12 & 13). It is not recommended to use PVC conduits in these locations due to the potential of toxic fumes being released from PVC conduit during a fire. Recommend to replace exterior PVC conduits with rigid aluminum conduits and replace PVC in interior locations with EMT conduits.

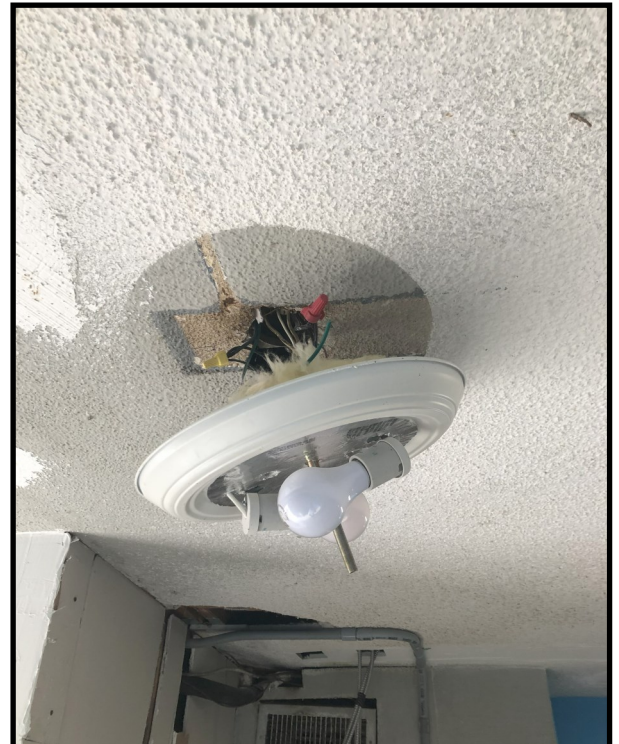
Photo 16 -

Light fixtures were not secure to the ceiling and missing outlet boxes (Photo 16). Some light fixtures were not working (Photo 17). Some light switches were missing cover plates and outlet boxes were not secured in walls in accordance with the 2017 NEC (Photo 18). Some light switches were disconnected and abandoned in the outlet box (Photo 19). The 2017 Florida Energy Efficiency Code requires automatic lighting controls for a restaurant space. New lighting control system with occupancy/vacancy sensors and dimmer switches shall be installed per FBC.

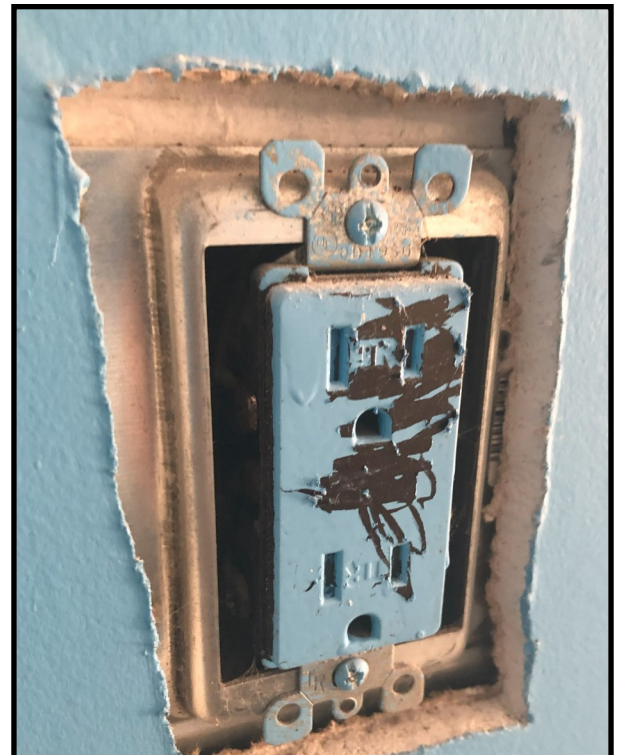
Photo 20 -

Some receptacles were missing cover plates (Photo 20) several receptacles were not secured in the outlet boxes (Photo 21).

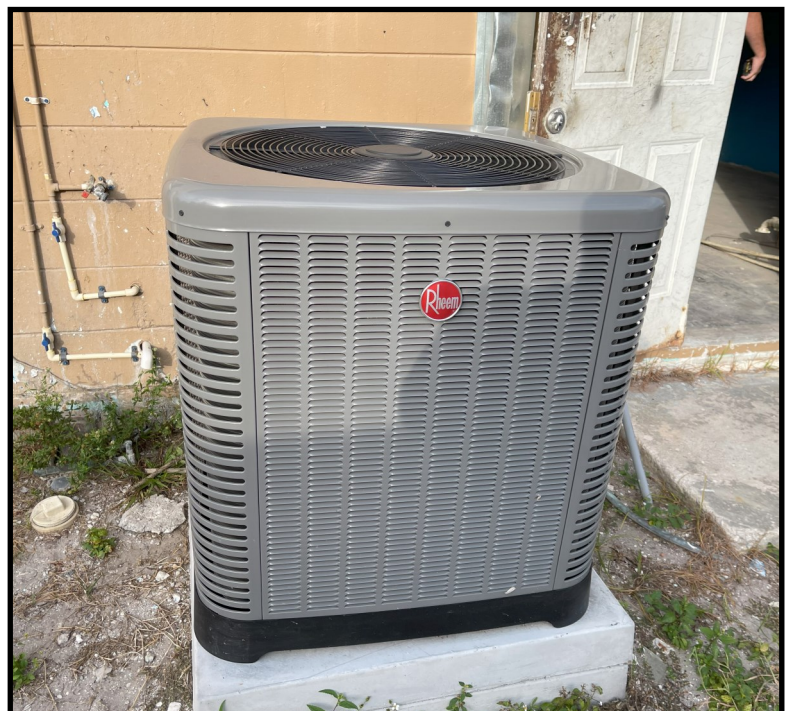
Photo 24 -

A new condenser unit was installed at the east side of the building (Photo 24). The electrical branch circuit wires are exposed and are required by code to be conceal in a UL approved raceway system (Photo 25). There was no service receptacle found within 25 feet of the AC unit. This is required by NEC. A new service receptacle shall be installed within 25 feet of the AC unit.

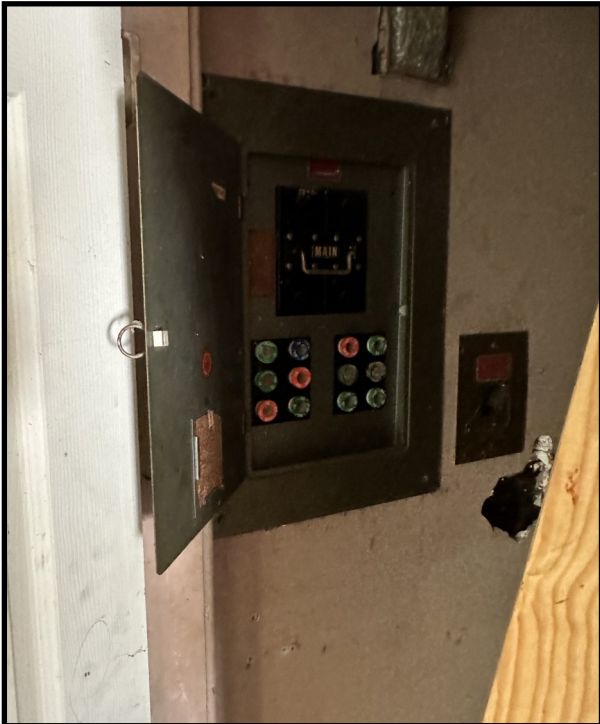
Photo 29 -

There was an obsolete fuse type panel located in the 2nd floor closet (Photo 29). This panel serves the 2nd floor 3 bedrooms, 1 bathroom and 1 breakroom. Most insurance companies will not insure a building with fuse panels. This panel is not in compliance with the current NEC and shall be replaced with a new compliant panel.

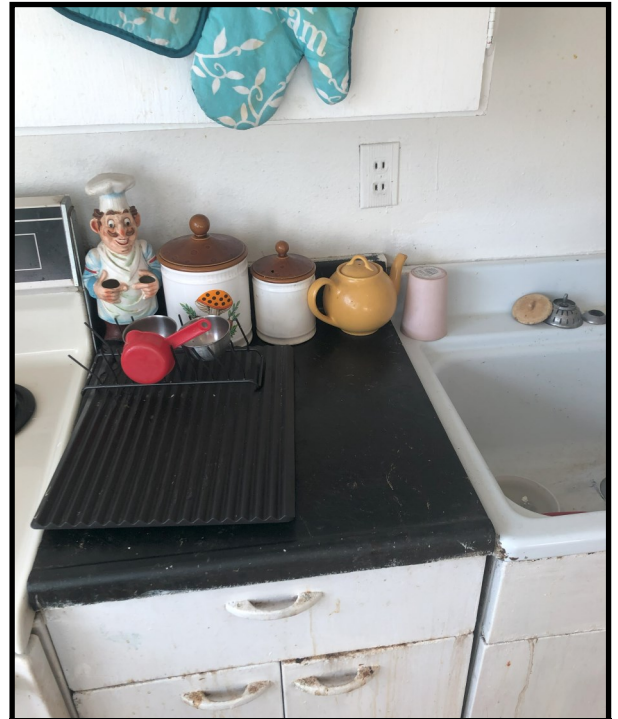
Photo 30 -

The 2nd floor kitchen above counter receptacle (Photo 30) shall be GF type receptacles per NEC. The receptacle shall be replaced with GF type receptacle. A minimum of 2 dedicated 15 or 20 amp branch circuits are required to serve dwelling unit kitchen countertop receptacles. Dedicated circuits are required to serve refrigerators and microwaves.

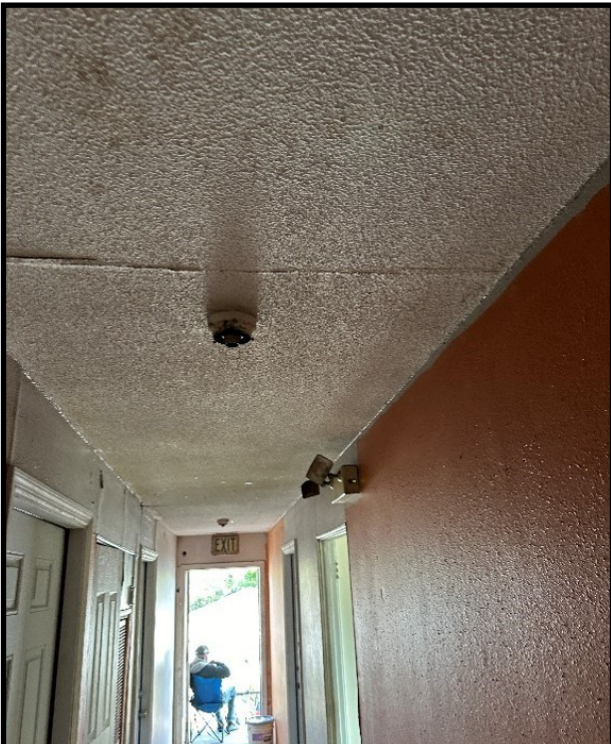
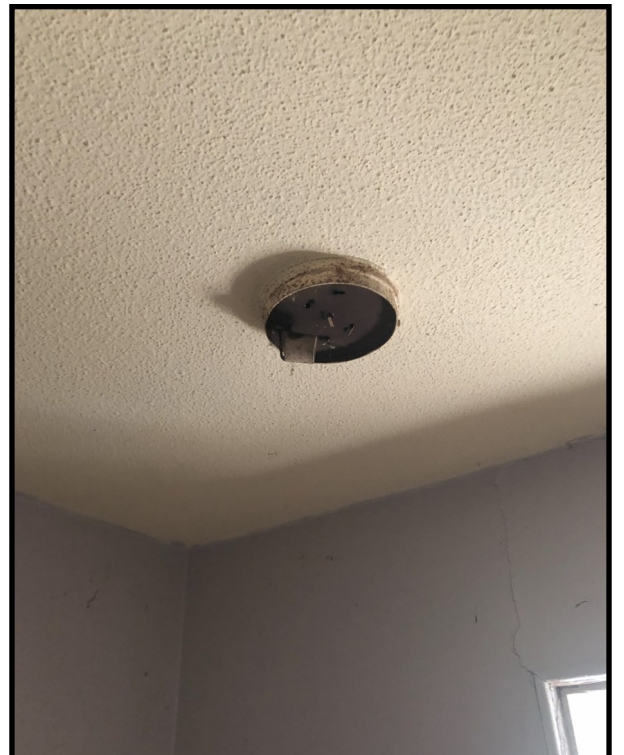
The 2nd floor corridor lights were missing lamps (Photo 31 & 32). The exit lights were not operational (Photo 33 & 34). It is recommended that all lighting and lighting controls in building to be upgraded to LED lighting for compliance with the FEEC and 2016 ASHRAE 90.1.

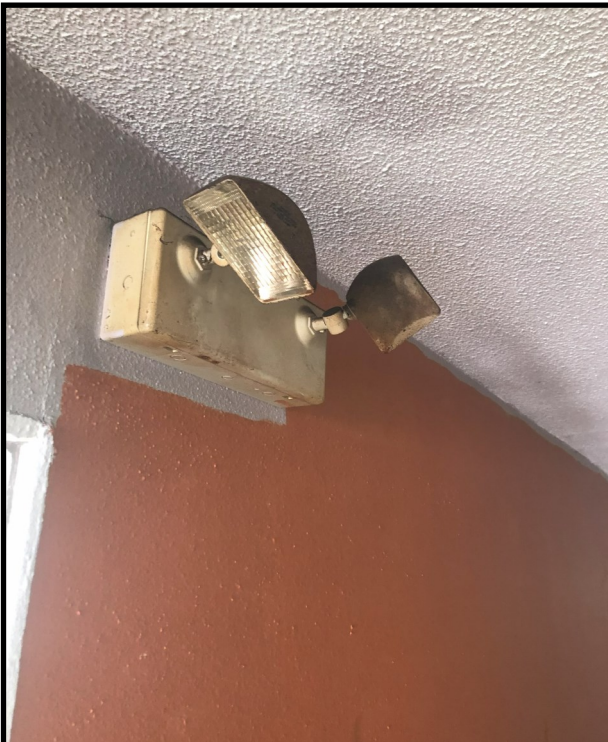
Photo 35 -

Operation of corridor emergency lights could not be verified (Photo 35). The NFPA 101 Life Safety Code requires that the emergency lights or lighted exit signs be inspected and tested at least once a month. New emergency lights shall be installed to replace the non-operable lights.
