1105 CARLTON STREET  
BUILDING ASSESSMENT

1105 CARLTON STREET  
CLEARWATER, FL 33755

CITY OF CLEARWATER

FINAL

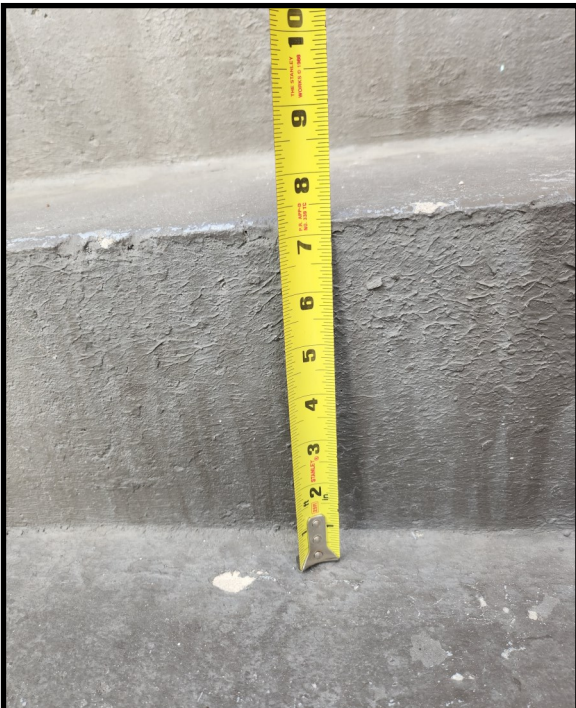
Photo 15 -

Per Florida Building Code, FBC, stair treads shall have a maximum rise of 7" and a minimum depth of 11", the existing concrete stairs do not meet this requirement (Photos 15 & 16). The handrail on both stairs exceed the pass through spacing requirement, which requires a maximum clearance of 4". The south side handrail is a non-structural member and will not meet current loading criteria. The attachment of the handrails to the stairs on both sides does not meet current requirements. Both handrails shall be replaced to meet current code requirements. The existing storage enclosures shown in (Photos 6 & 8), and the metal awning (Photo 17) should be removed or replaced with exterior grade code compliant material with proper attachment. The concrete slab at the base of the south stair is broken and shall be replaced (Photo 18), the north side stair slab has settled and will not meet accessibility requirements and shall be replaced (Photo 19). The second floor landing at the south side has minor chipping and shall be patched/grouted (Photo 10). The pipe columns supporting each second floor landing shall be repaired or replaced.

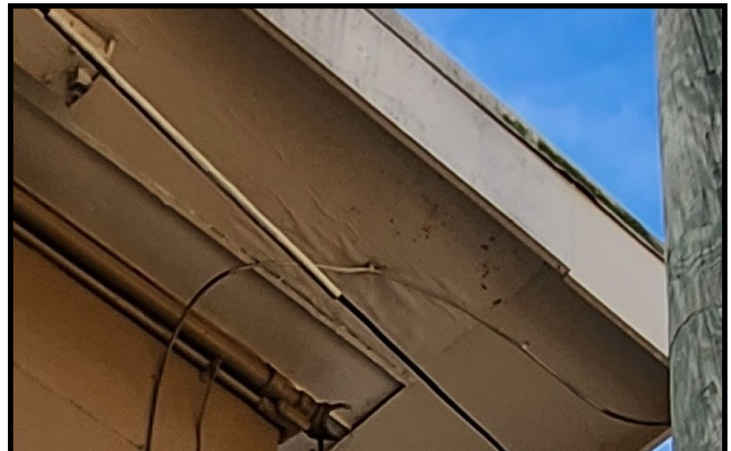
Photo 20 -

There are signs of water damage at various locations around the soffit (Photo 20). There is an existing wood canopy over the front entry which appears to be in satisfactory condition, there is also a metal awning over the front door directly under the canopy that is in disrepair (Photo 21). There are a variety of windows throughout the building ranging from jalousie to double hung, we were not provided any product or attachment information on any of the windows, therefore we cannot comment on their available wind load capacity or impact resistance. The exterior wood door frames show signs of water damage and rot (Photo 22). The exterior doors are in a similar state and the hinges are barely attached (Photo 23).

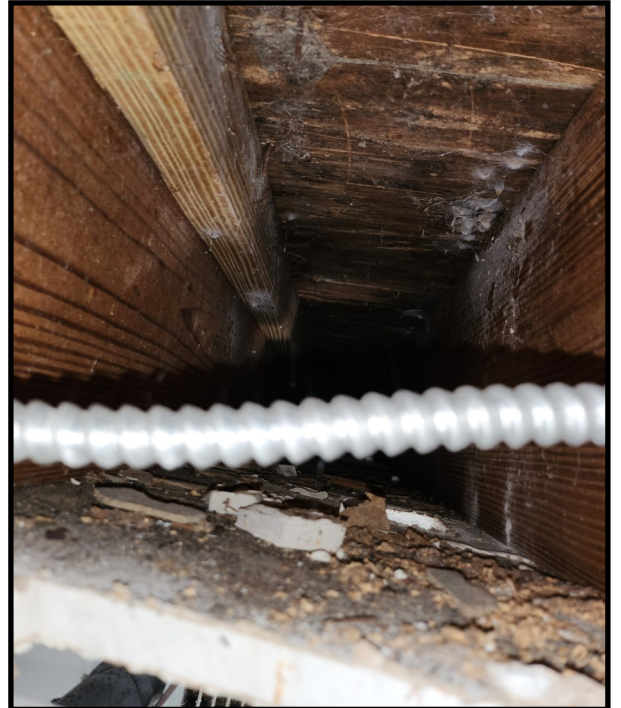
Photo 26 -

The ceiling on the first floor shows signs of water damage (Photo 24). This damage is consistent with what is seen on the visible portions of the second floor joists and decking, there also appears that some repair have been made by sistering and new wood member to the existing joist (Photos 25 & 26). It is crucial that the first floor ceiling be removed to see the extent of the damage and see which members shall be replaced or repaired. The visible portion of the wide flange beam supporting the second floor joists appears to be acceptable. The pipe column supporting the wide flange beam on the east side appears to be in satisfactory condition, the support on the west end is encased with in wall but assumed to a pipe column but the condition is known.

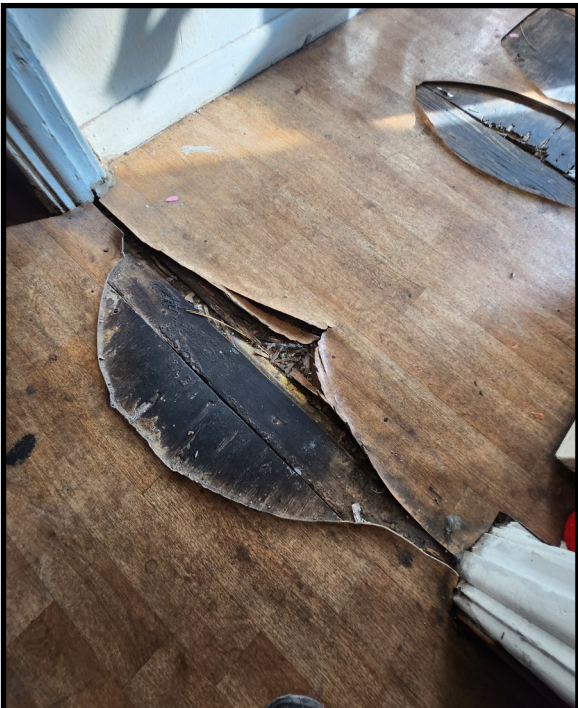
Photo 27 -

The sheathing on the second floor has lots of damage throughout and shall be removed and replaced (Photo 27). There is no access above the ceiling on the second floor, therefore the entirety of the roof structure is unknown. Removal of the ceiling on the second floor is critical to evaluate the roof structure and ability to withstand current wind pressures.

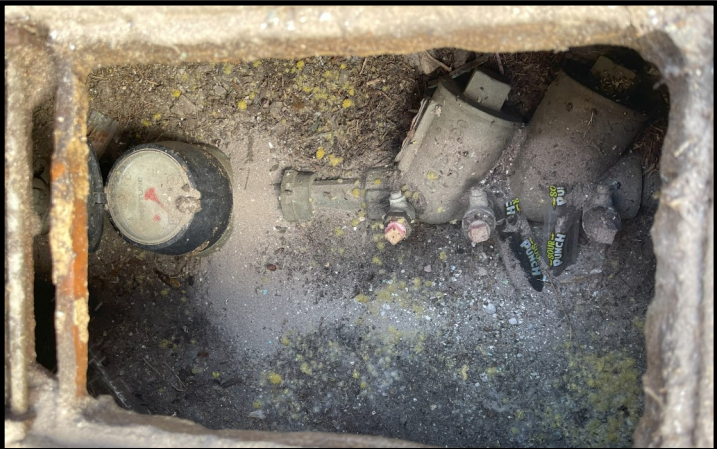
Photo 14 -

The existing domestic water plumbing system utilizes CPVC and copper pipes. There is an existing water meter and backflow preventor in a meter box outside of the building (Photo 14.)

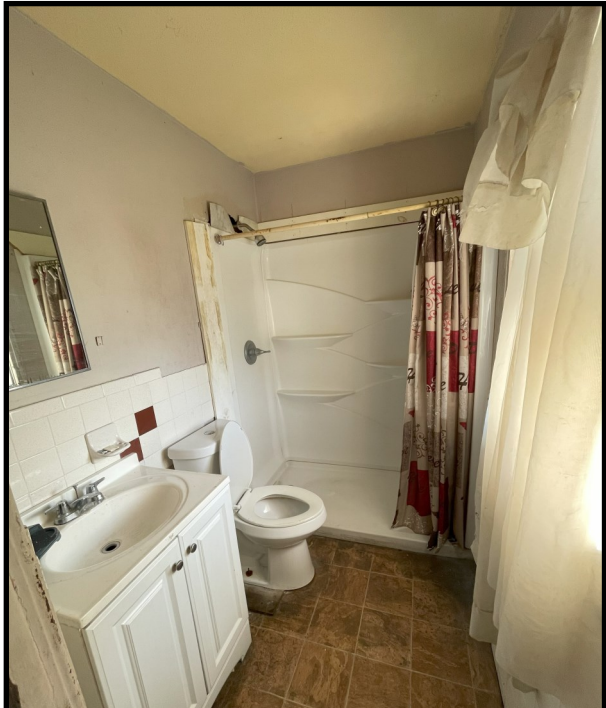
Photo 16 -

The toilet room appeared to have a functioning toilet, lavatory, and shower (Photo 16).

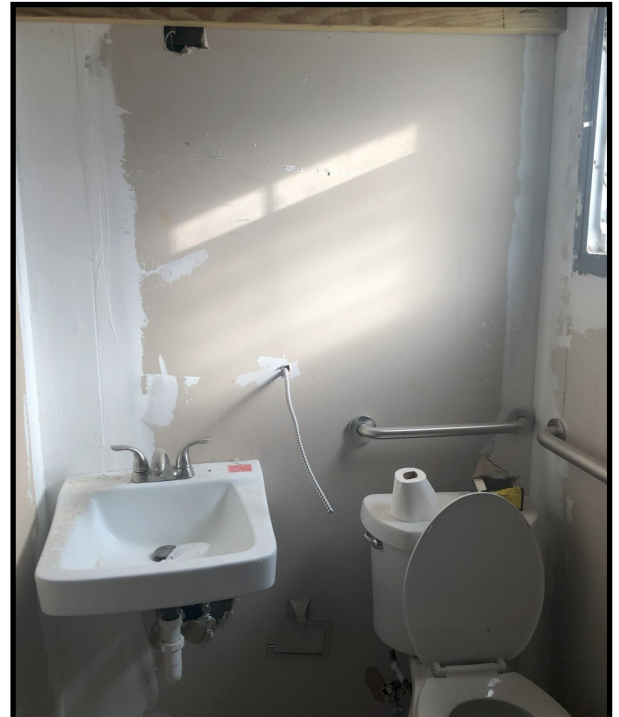
Photo 14 -

It appears that the 1st floor building electrical system was partially under renovation, however the construction work was not complete. MC cables were cut off and not connected to wiring device outlet boxes and equipment (Photo 14 & 15).

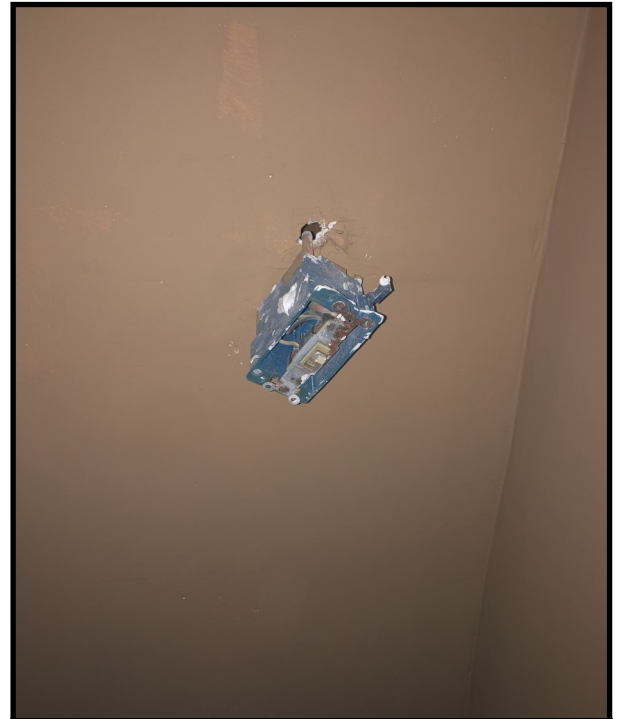
Photo 18 -

Light fixtures were not secure to the ceiling and missing outlet boxes (Photo 16). Some light fixtures were not working (Photo 17). Some light switches were missing cover plates and outlet boxes were not secured in walls in accordance with the 2017 NEC (Photo 18). Some light switches were disconnected and abandoned in the outlet box (Photo 19). The 2017 Florida Energy Efficiency Code requires automatic lighting controls for a restaurant space. New lighting control system with occupancy/vacancy sensors and dimmer switches shall be installed per FBC.

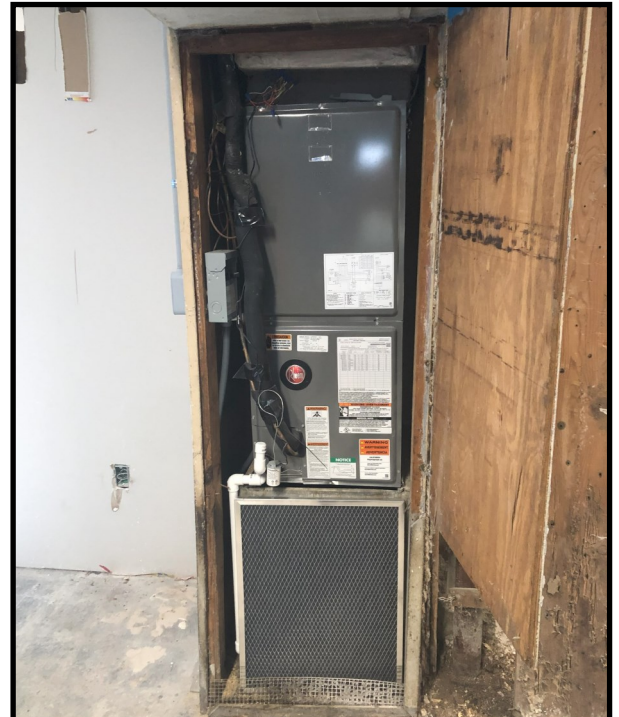
Photo 22 -

There was an Air Handler unit installed in the closet (Photo 22). The disconnect switch for the AHU does not have the required minimum clearance per NEC (Photo 23). This disconnect switch shall be relocated to maintain a minimum code clearance.

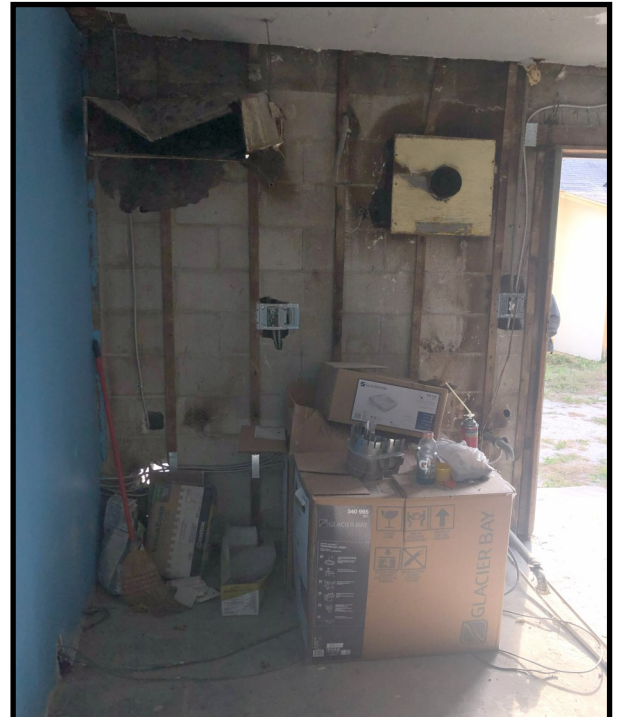
Photo 26 -

Kitchen equipment, kitchen hood, exhaust fan, etc. were not installed (Photo 26). If the first floor is to be renovated to a restaurant, additional electrical panels and circuits will be required to accommodating the new loads. The electrical distribution system will also need to be modified to meet the intended building occupancy classification.

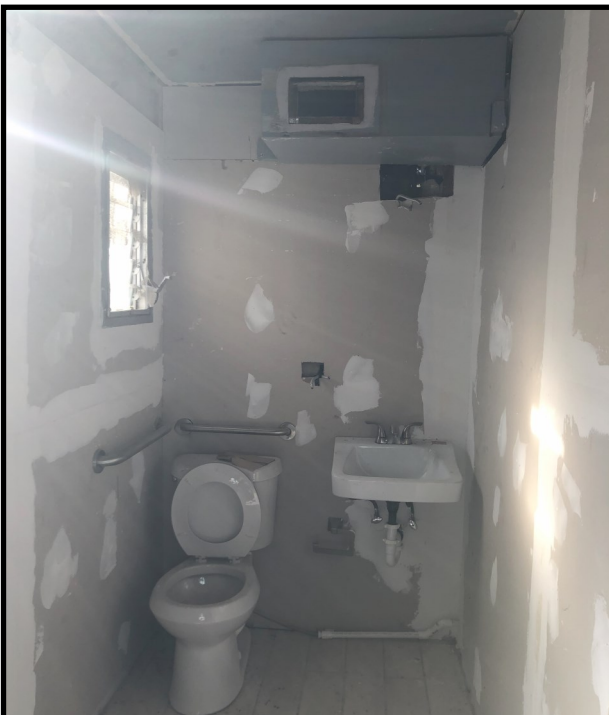
Photo 27 -

No light fixtures, switches and receptacles were installed in 1st floor restrooms (Photo 27 & 28). Receptacles within 6ft of a sink shall be GFCI protection receptable per NEC.
