STEVENSON CREEK WATERSHED MANAGEMENT PLAN

FINAL REPORT

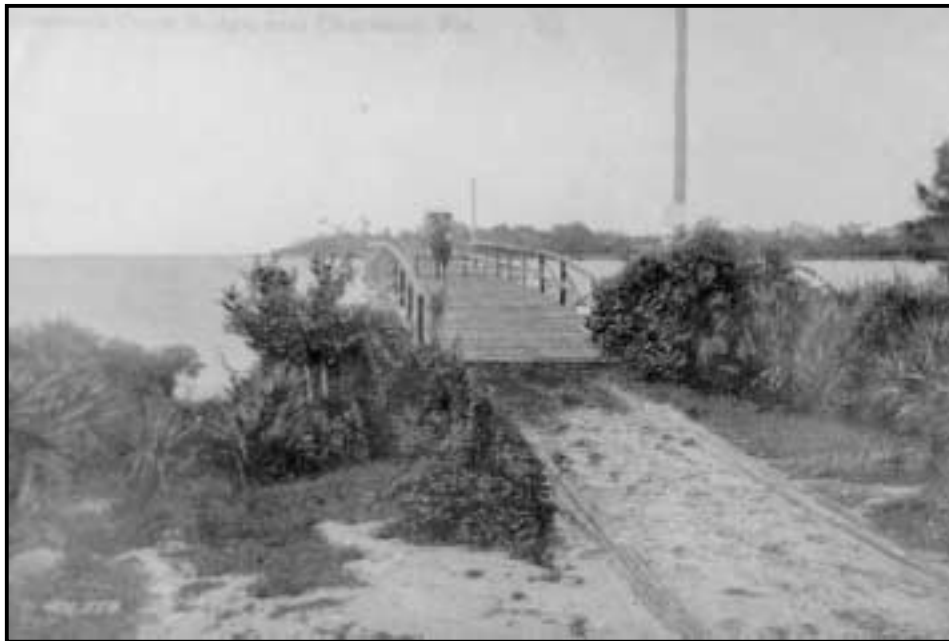
Figure 1.3-2 Stevenson Creek Bridge, near Clearwater, Fla., 1890.

(Photo courtesy of City of Clearwater Public Library)

1926 shows the Stevenson Creek Estuary to be much wider than it is now, approximately 1,000' wide at the mouth, compared to only 700' today. Prior to 1926, the original 19th Century wooden bridge connecting Clearwater to Dunedin, which spanned the entire estuary (Figure 1.3.2), was replaced with an earthen causway with a much narrower open span for Edgewater drive. The 1926 photography depicts a relatively intact floodplain and associated wetlands, with adjacent land uses predominantly agricultural, under development, or undeveloped. Some channelization had occurred within Spring Branch, and within Stevenson Creek between Drew Street and Druid Road. The east-west railroad that bisects the basin as well as the coastal railroad that borders the basin to the east had already been constructed. Most of the population at the time was concentrated within a ½-mile strip of land bordering Clearwater Harbor. Effects of the 1920's land boom are evidenced by the numerous subdivision streets with sidewalks constructed throughout the interior portions of the watershed. However, by 1942, only a few homes had been built within these interior subdivisions. During the post-war boom of the 1950's and 1960's, the majority of the watershed was built out within these medium density residential subdivisions and commercial developments. Also during this period, portions of the Stevenson Creek estuary were filled in along its southern banks.

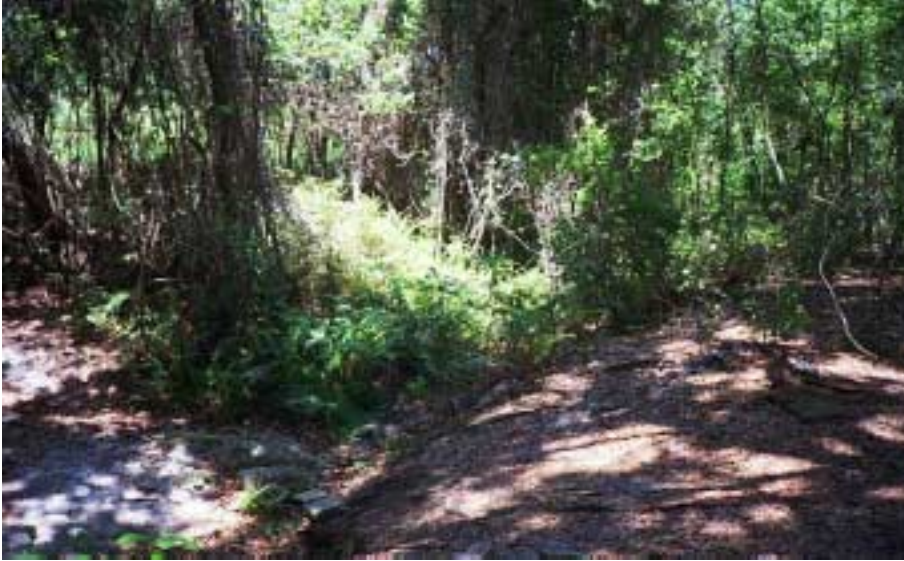
This photo was taken facing north from the ditch that drains the small excavated pond within the forested area at Betty Lane and Sunset Point Drive.

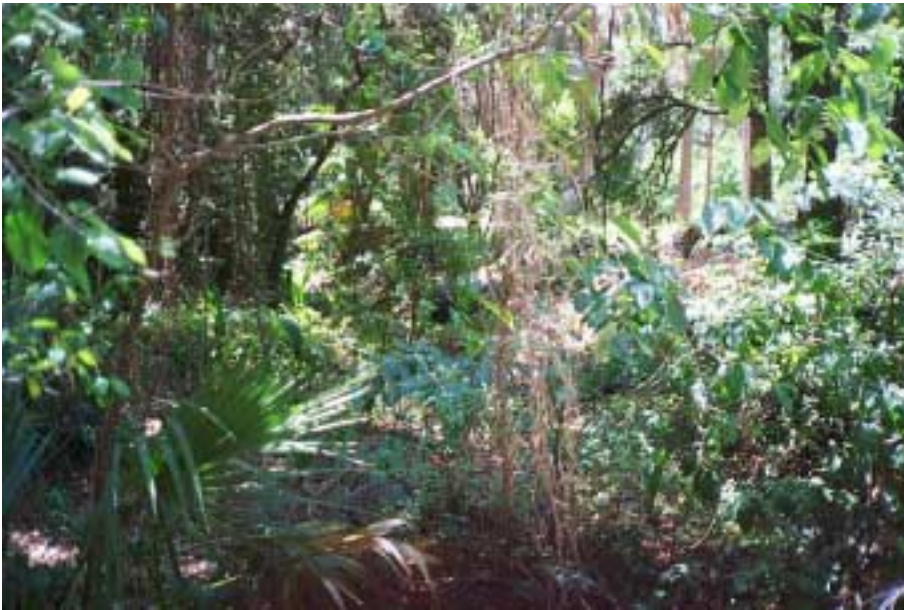
This photo was taken in the mesic forested area, in the southern part near State Street. The vegetation in this area includes slash pine, laurel oak, saw palmetto, and cabbage palm.

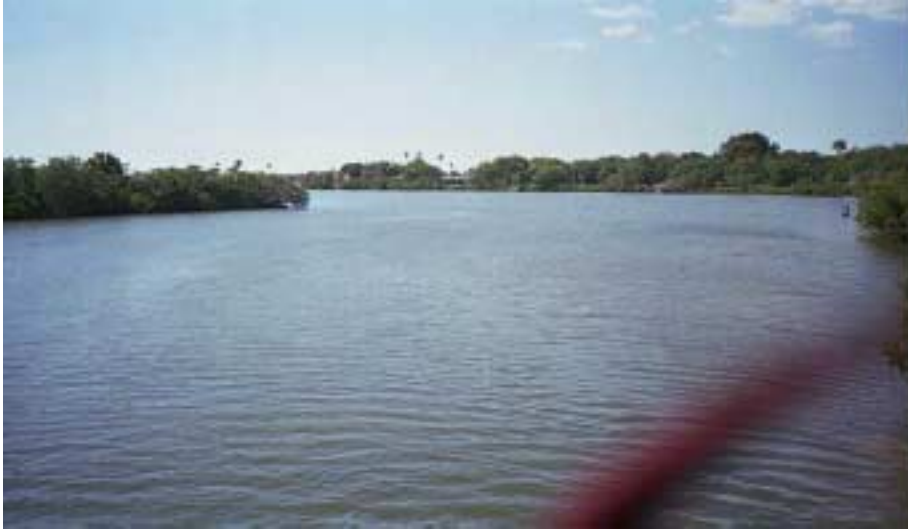
The photo to the left was taken on the north bank of Stevenson Creek west of the Douglas Avenue Bridge. The view is to the southeast

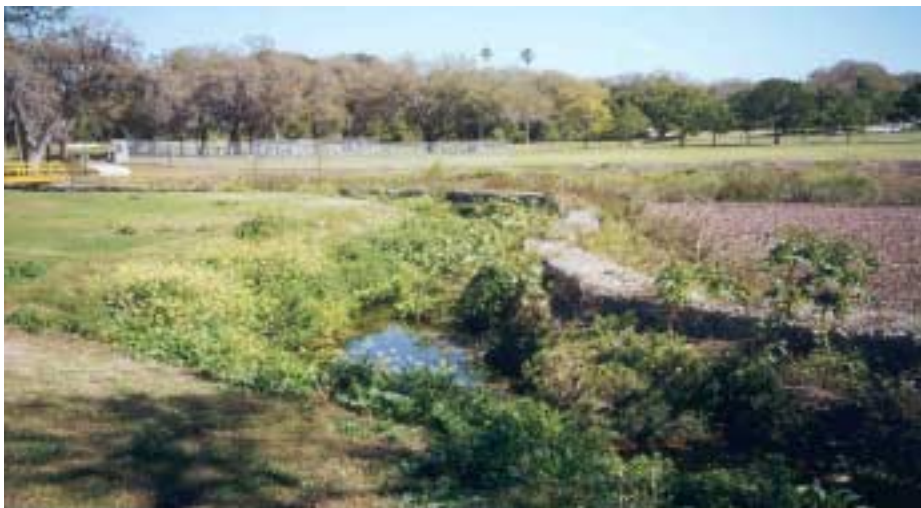
This photo shows the mitigation area within the golf course. The low gabion wall was installed to protect the mitigation area from erosion and the influx of exotic vegetation.

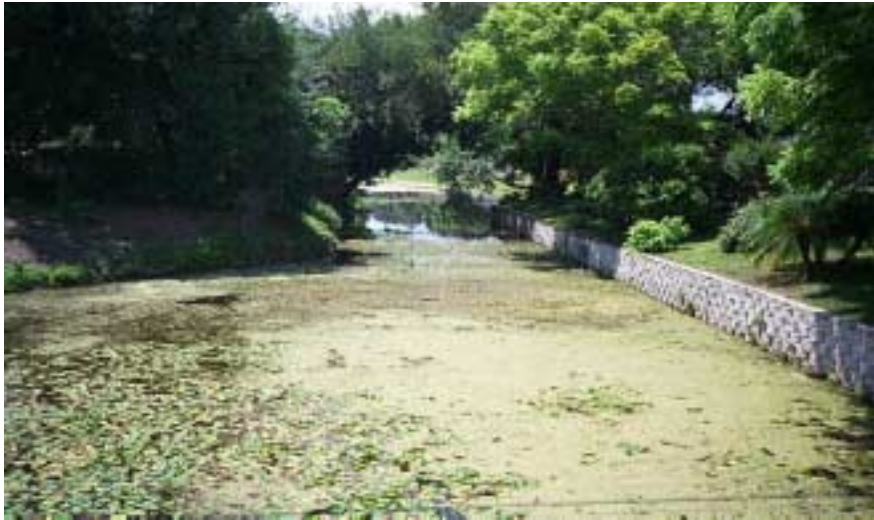
The photo to the left shows a typical section of the creek (Lynn Lake) through the Middle Stevenson Creek Subwatershed. The algal mats on the water surface usually indicate poor water quality.

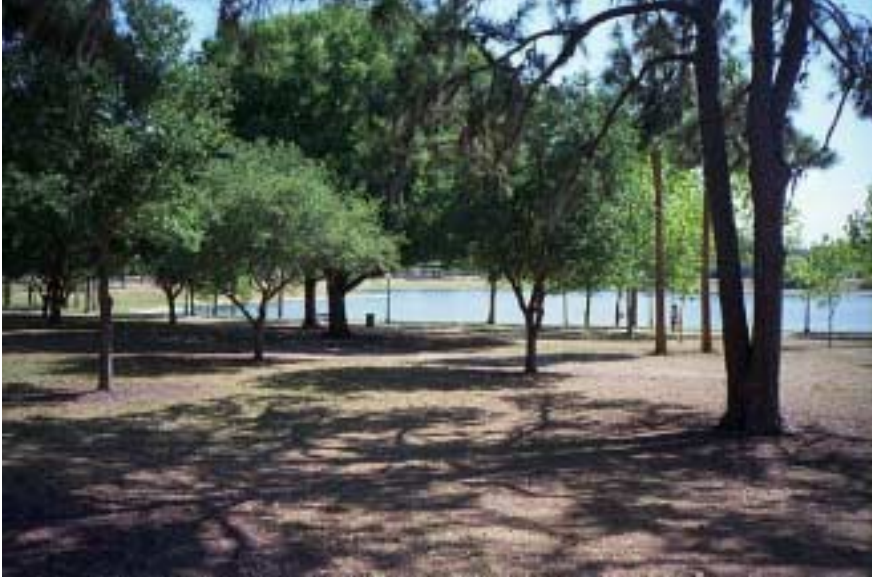
This photograph is a view of Crest Lake from the northeastern corner. The sparseness of the understory vegetation can contribute to erosion and sedimentation in the lake due to stormwater runoff.

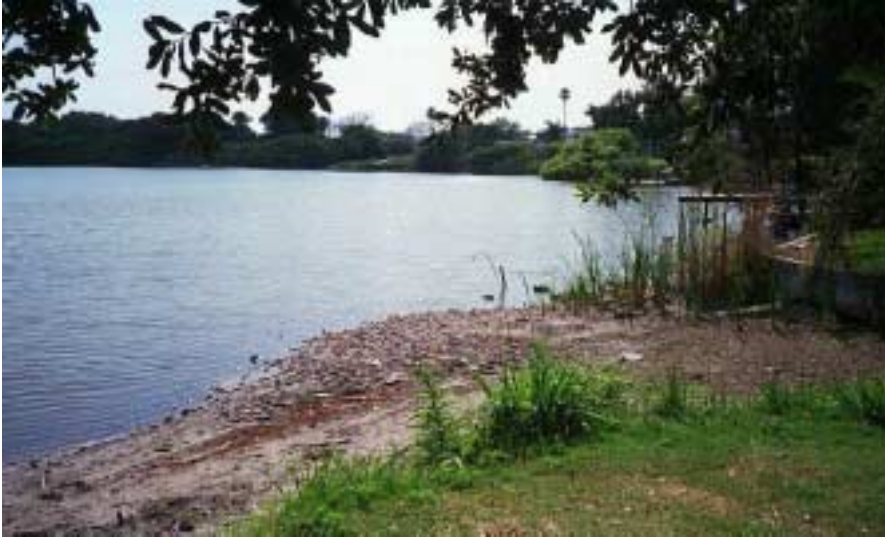
This photograph of Lake Bellview shows the bare shorelines and lack of significant littoral vegetation. The littoral vegetation would provide habitat and water quality benefits.

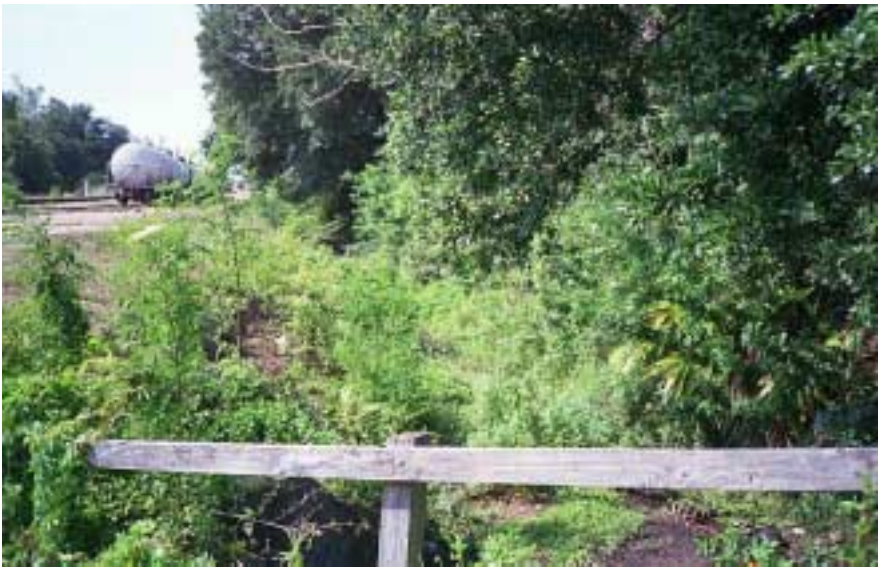
This photograph was taken on the southwestern corner of the lake and shows the nuisance vegetation infestation. Cleaning up this area would enhance the wildlife habitat provided by this area.

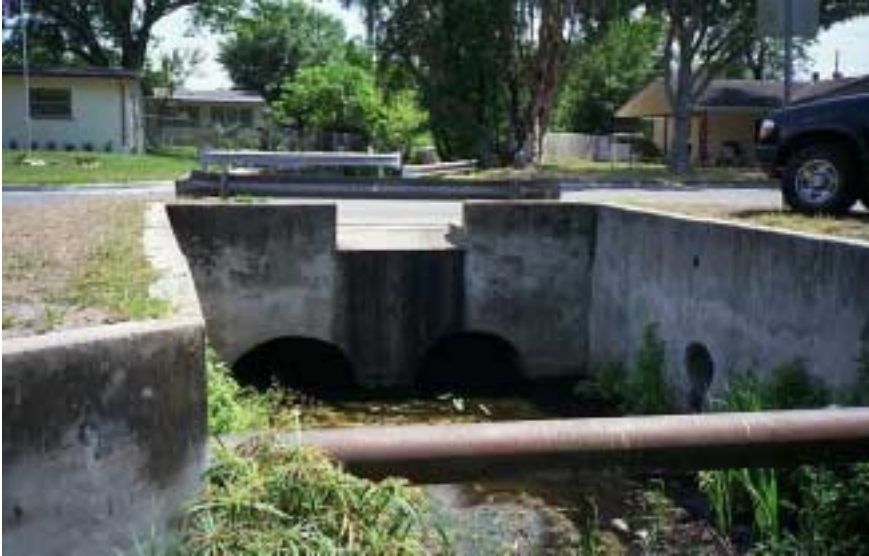
This is an example of one of the culverts within the Upper Stevenson Creek Subwatershed. This culvert is near the intersection of Hillcrest and Browning.

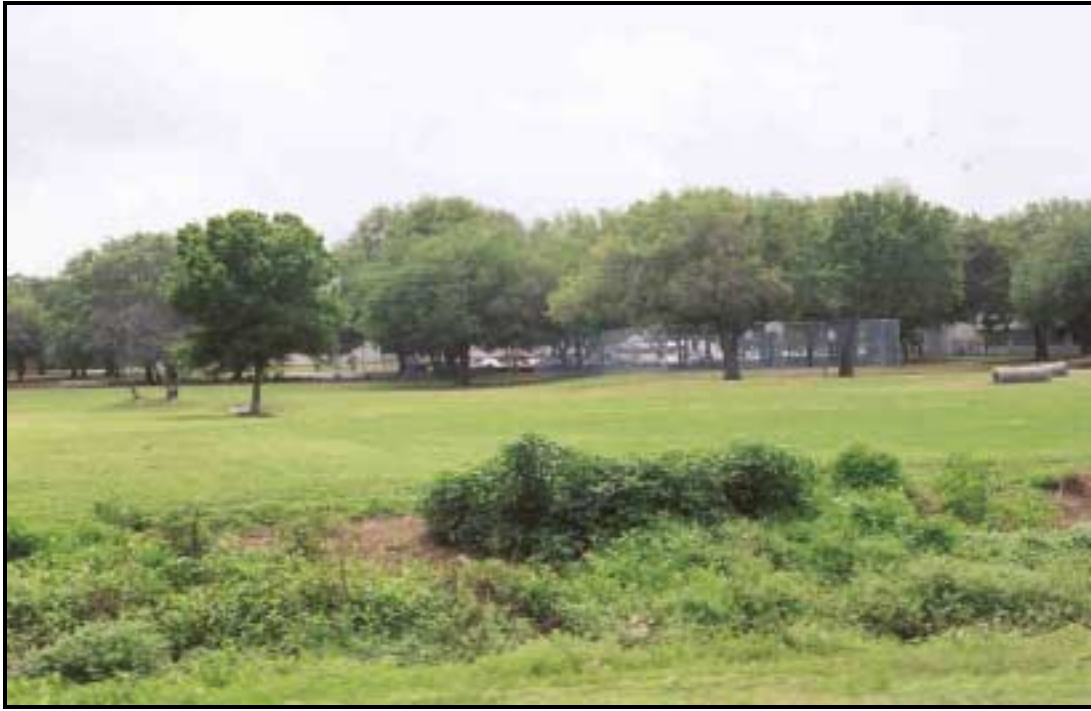
Figure 3.1-7. This photograph shows the area on the south side of Sunset Point Road that could be excavated to create the stormwater detention facility.

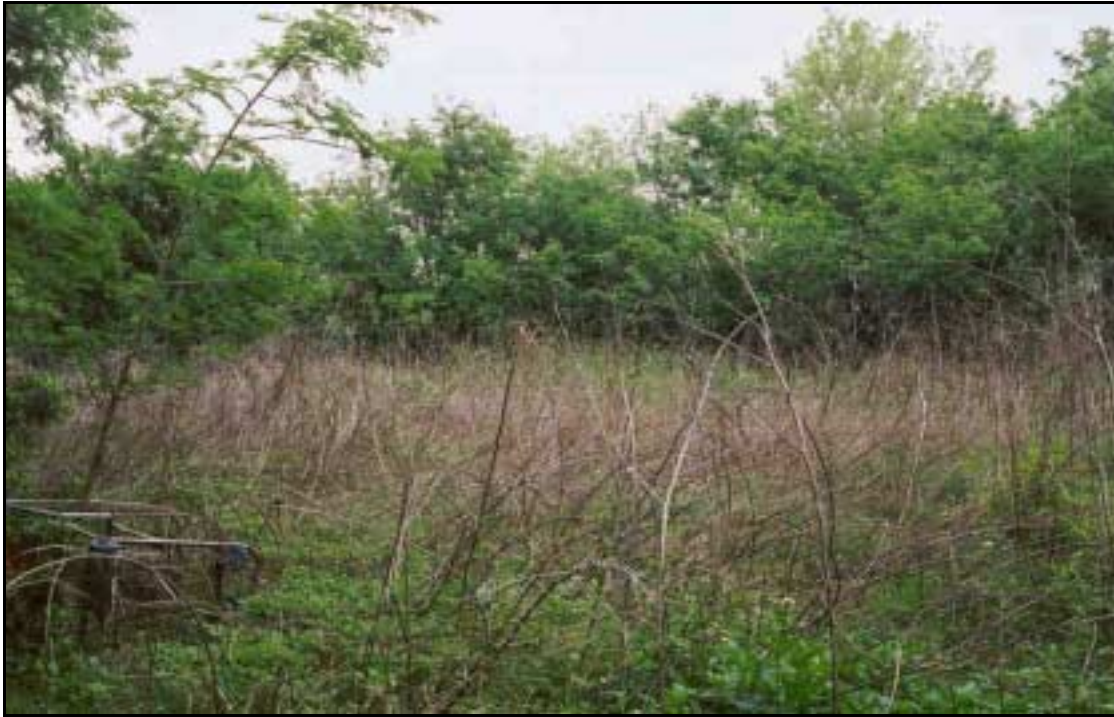
Figure 3.1-16. This photograph shows the nuisance vegetation and trash on the 9-acre vacant land parcel adjacent to the west side of the auto salvage.

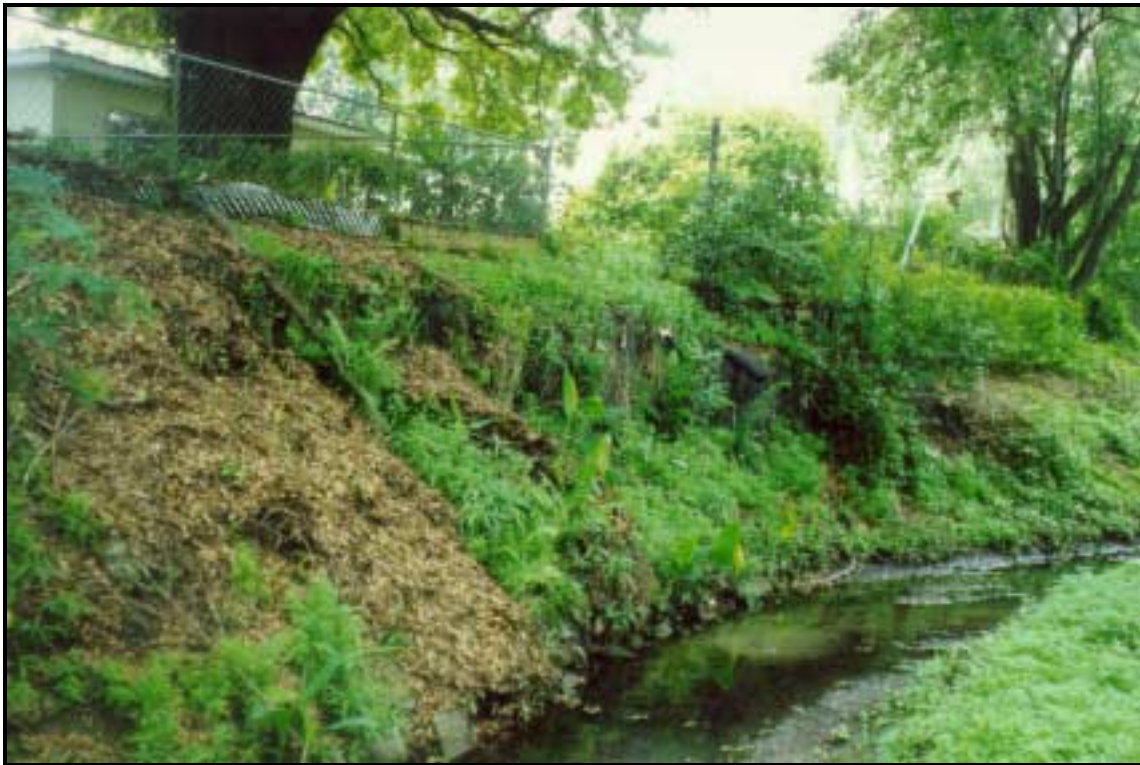
Figure 3.6-1 Yard waste (Oak leaves) dumped by a resident on the banks of Upper Stevenson Creek.

The City Should actively seek to educate its residents on the negative effects of the dumping of yard waste into its creeks, ditches, and storm sewers. If necessary, these education efforts should be followed by active enforcement of the applicable ordinances.

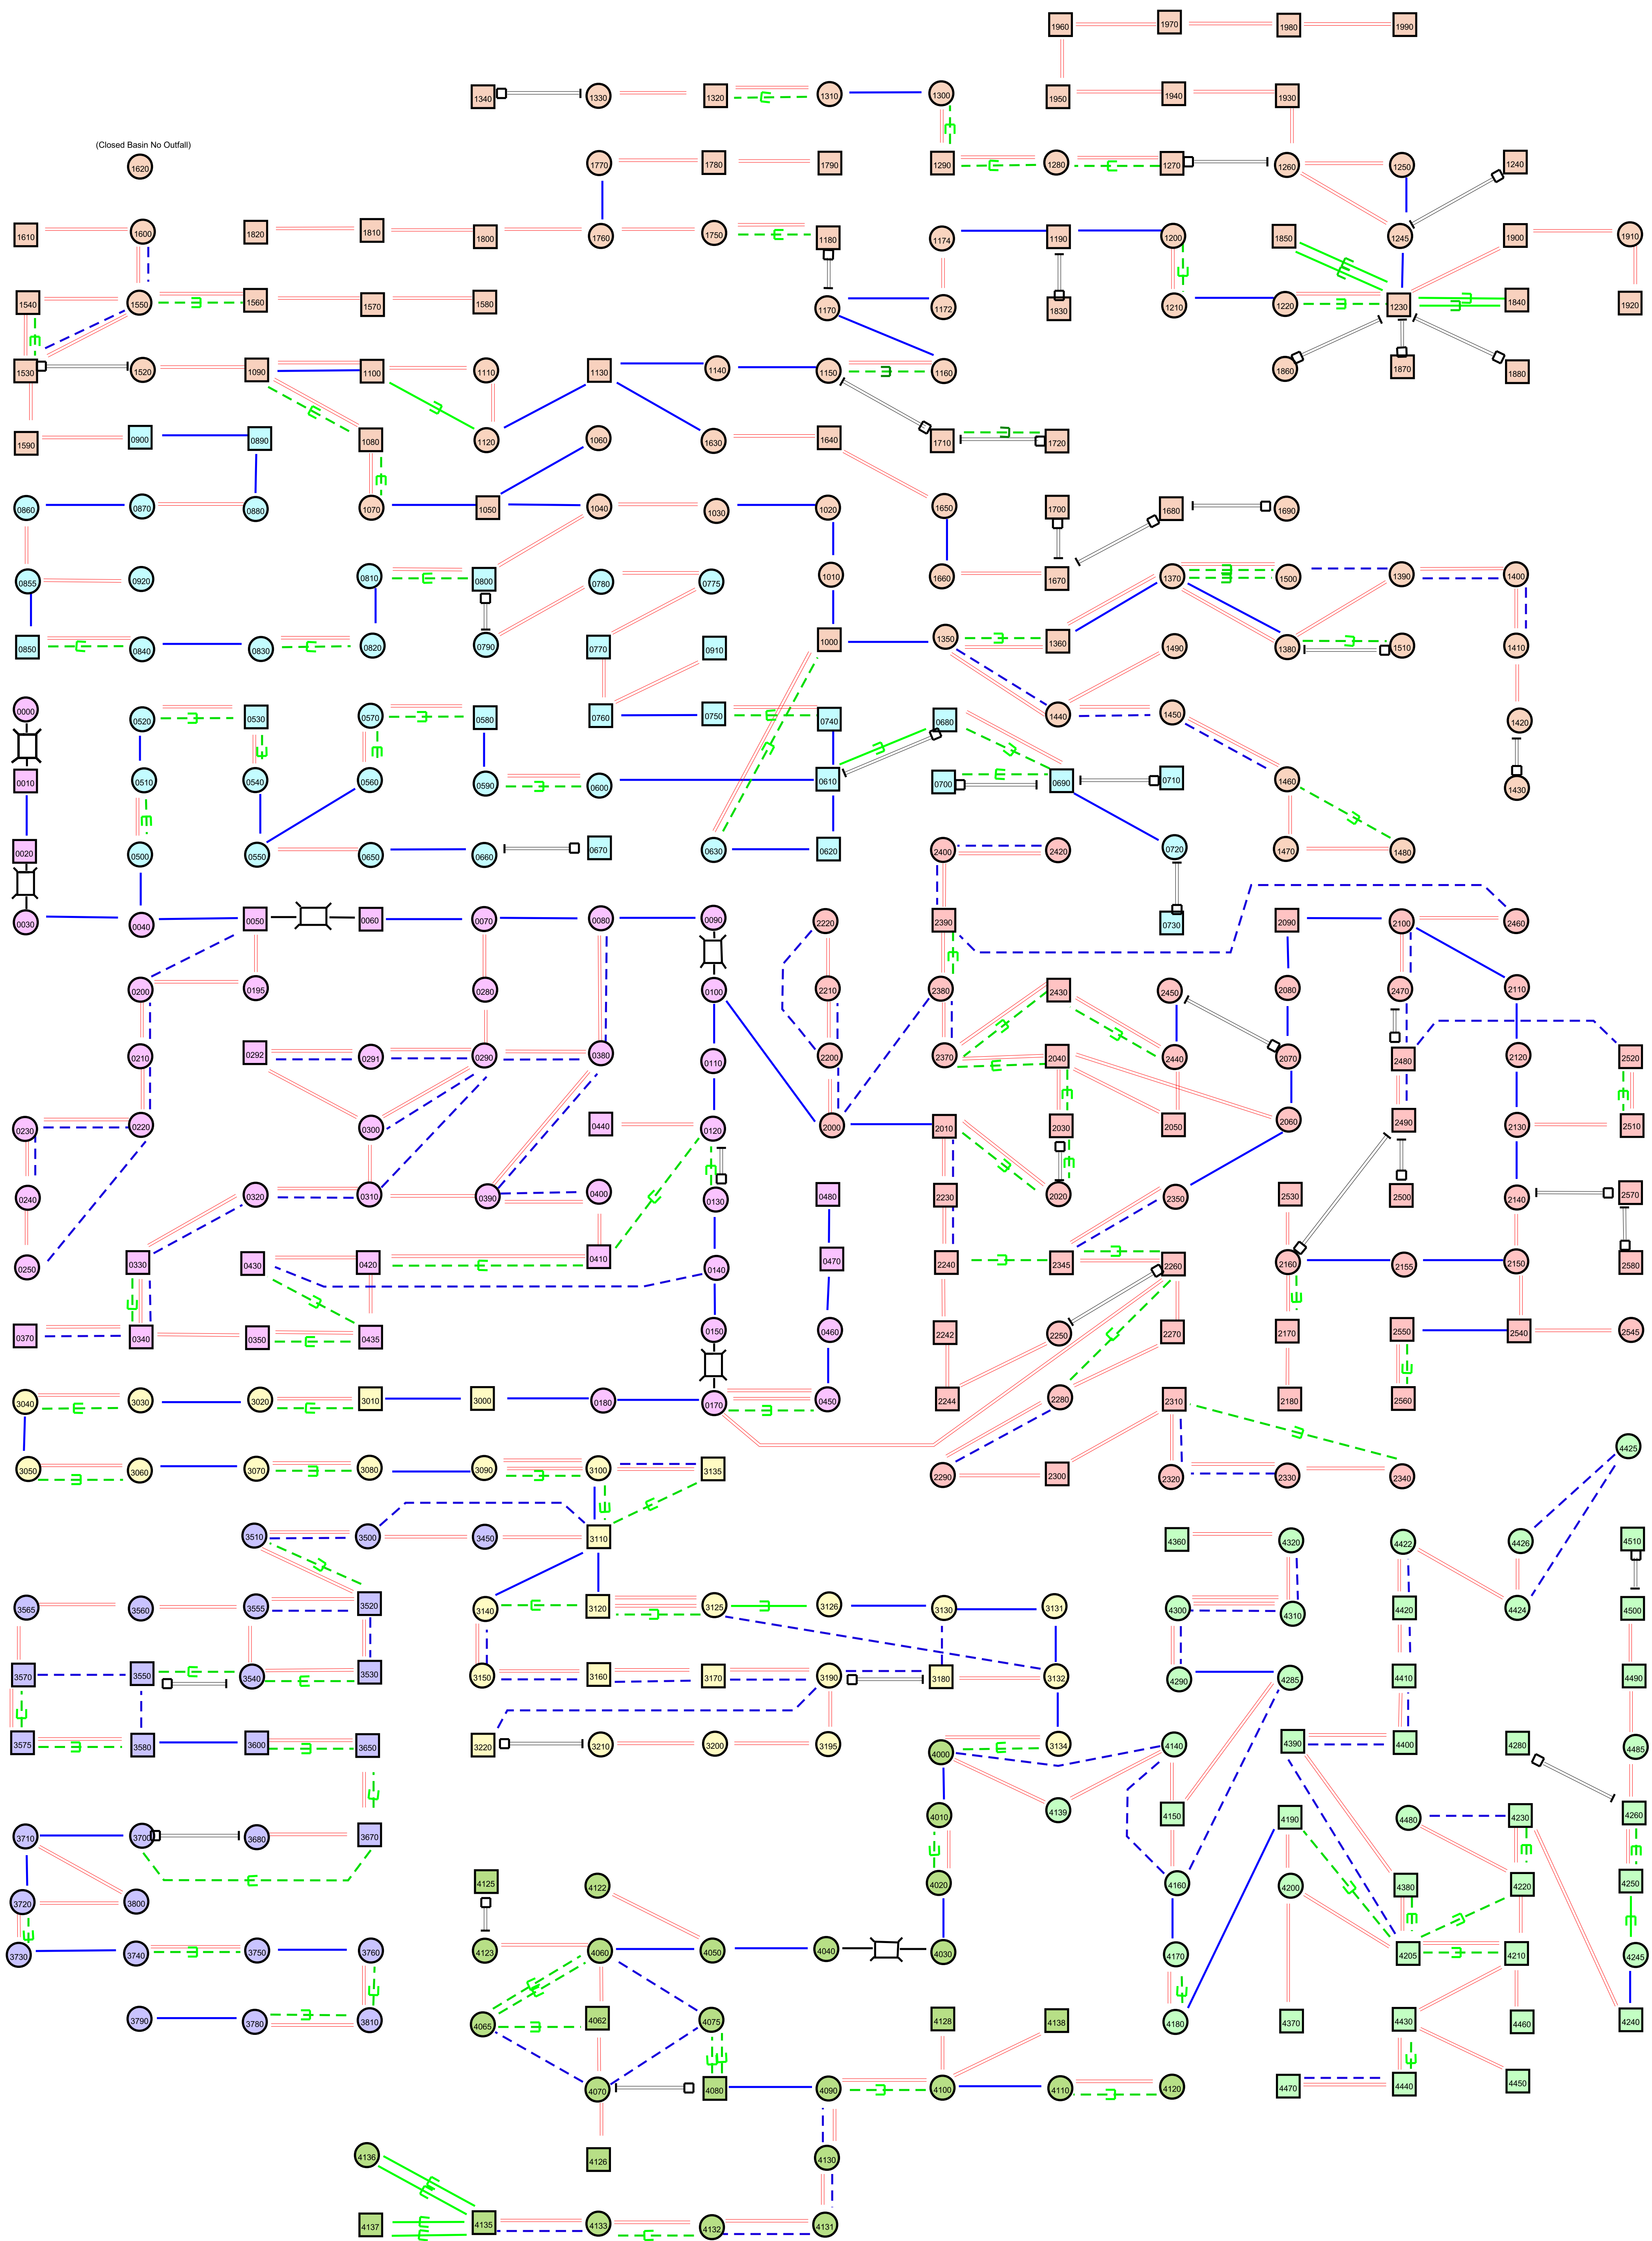
Figure 2.1.-4

Stevenson Creek Watershed
AdICPR Node-Reach Schematic
Existing Conditions

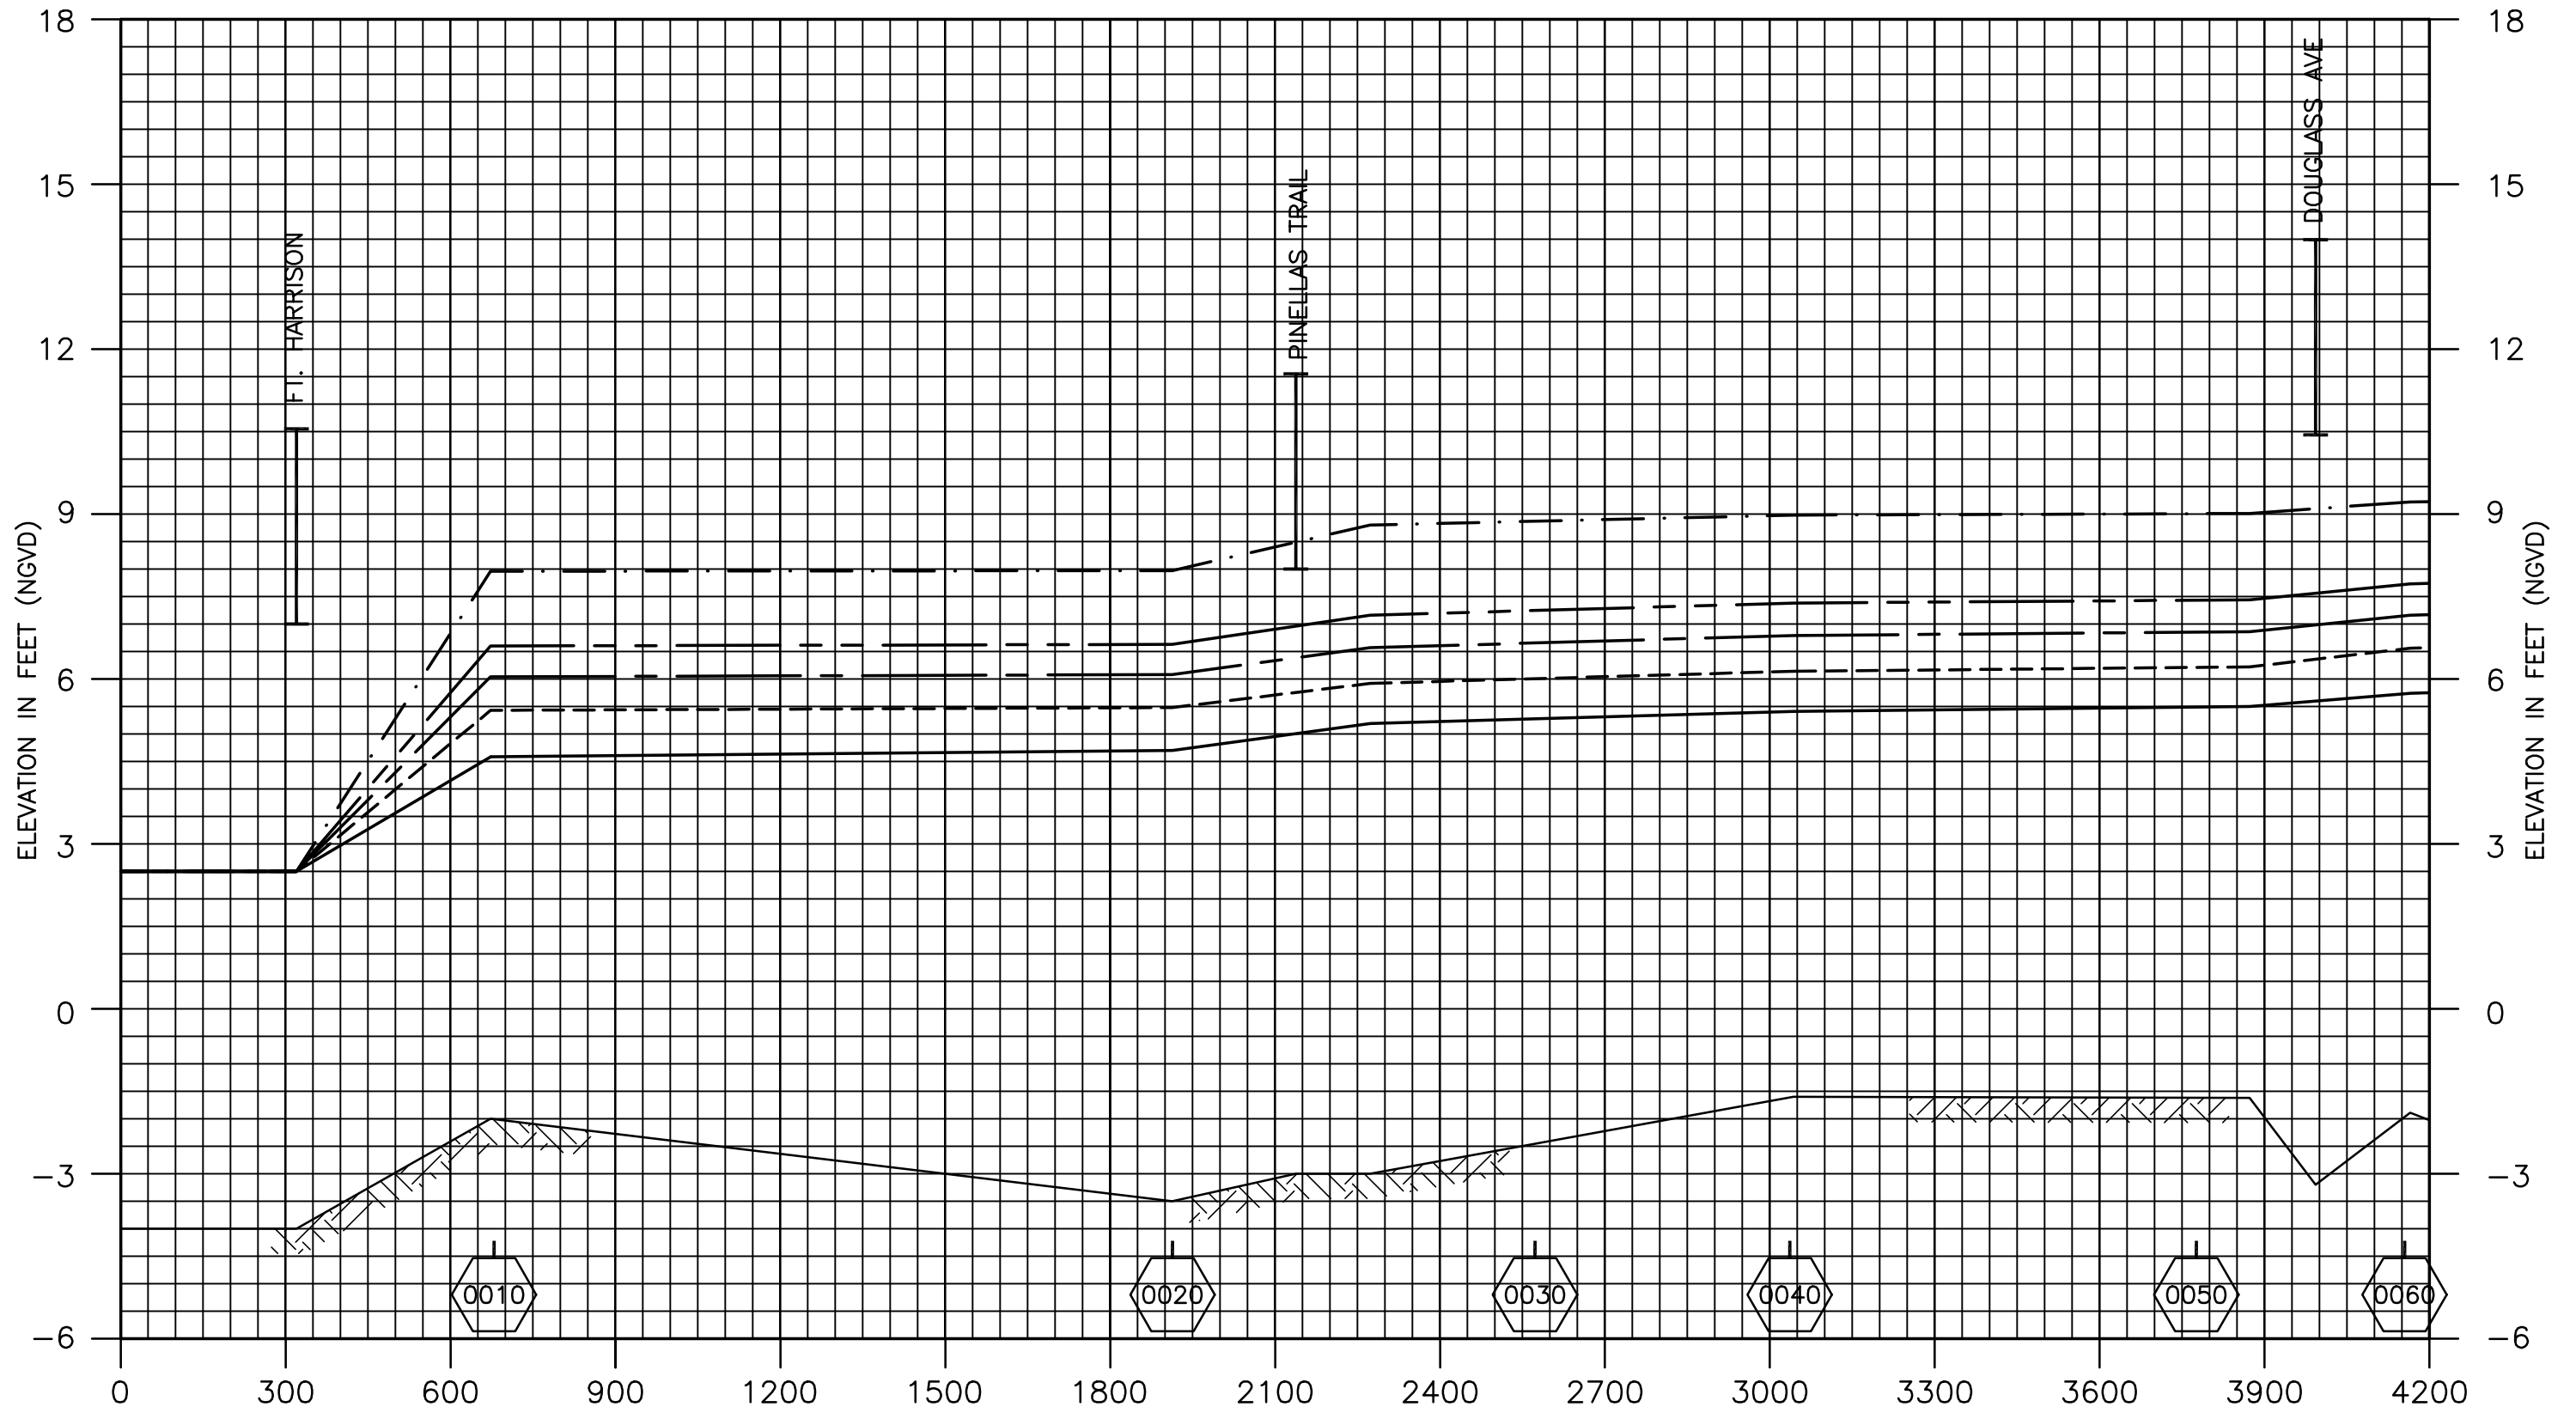
FIGURE 2.1-17
FLOOD PROFILE
EXISTING CONDITIONS
STEVENSON CREEK
CITY OF CLEARWATER, FL
PARSONS ENGINEERING SCIENCE, INC.

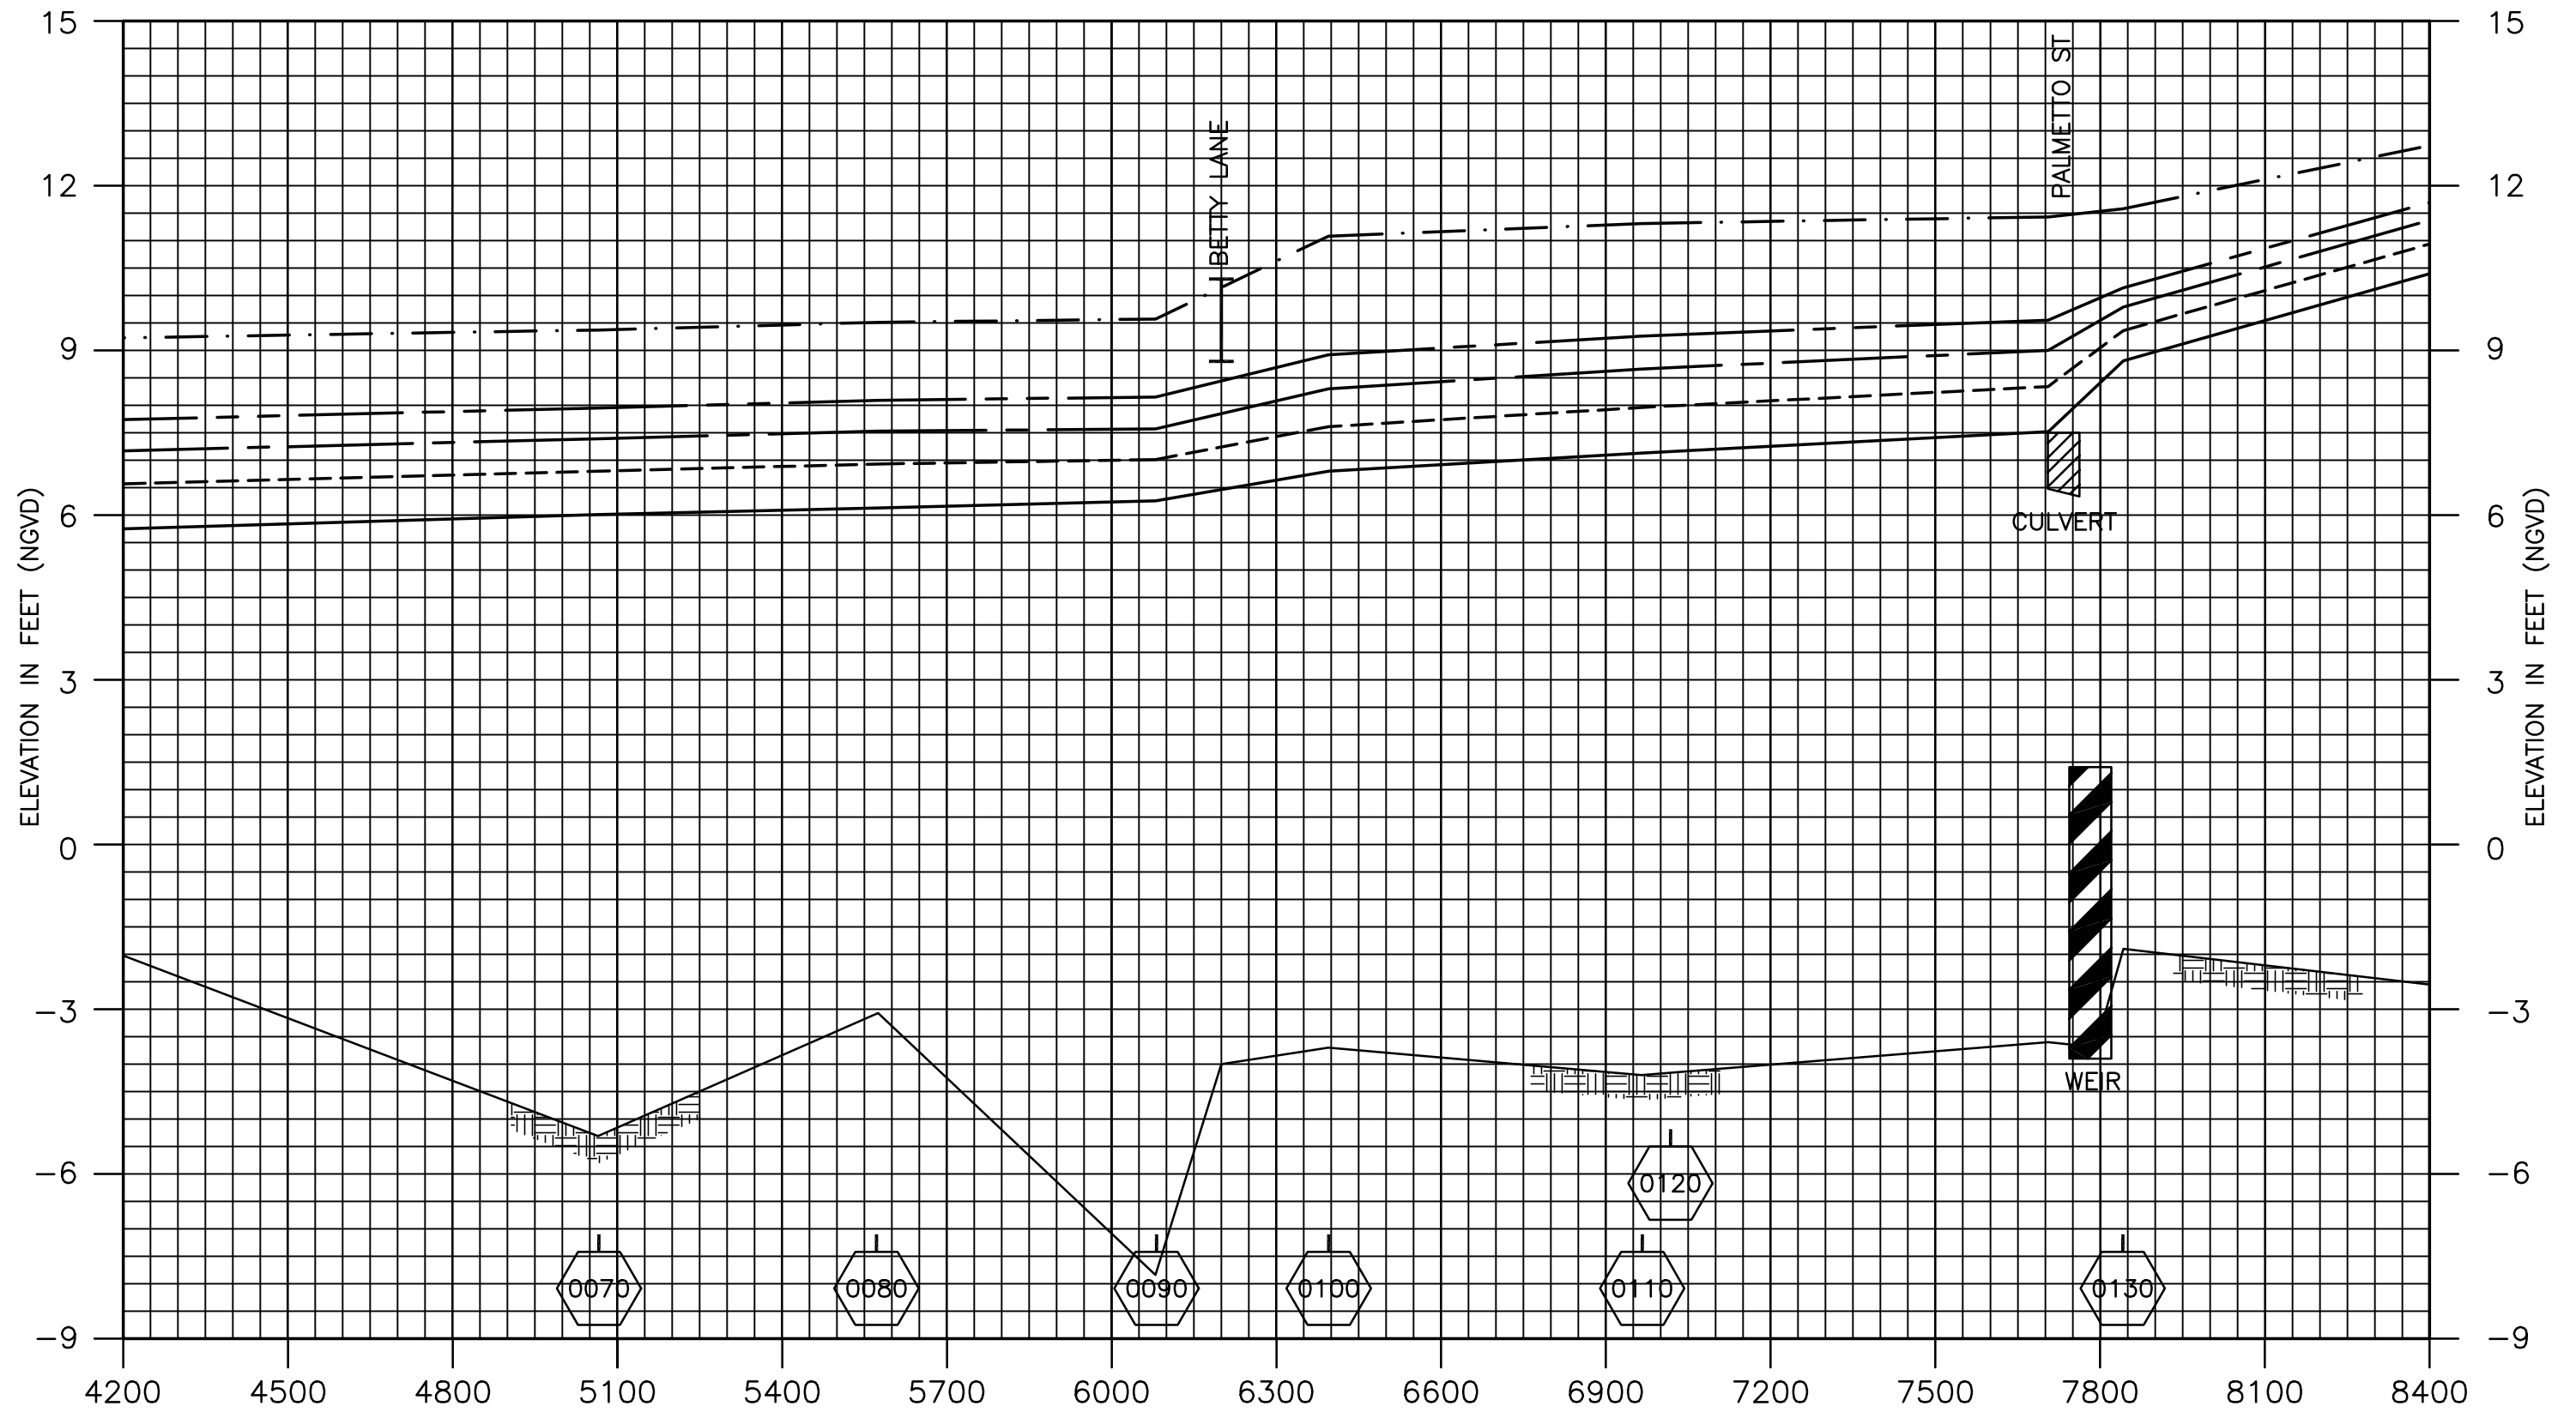
FIGURE 2.1-18
FLOOD PROFILE
EXISTING CONDITIONS
STEVENSON CREEK
CITY OF CLEARWATER, FL
PARSONS ENGINEERING SCIENCE, INC.

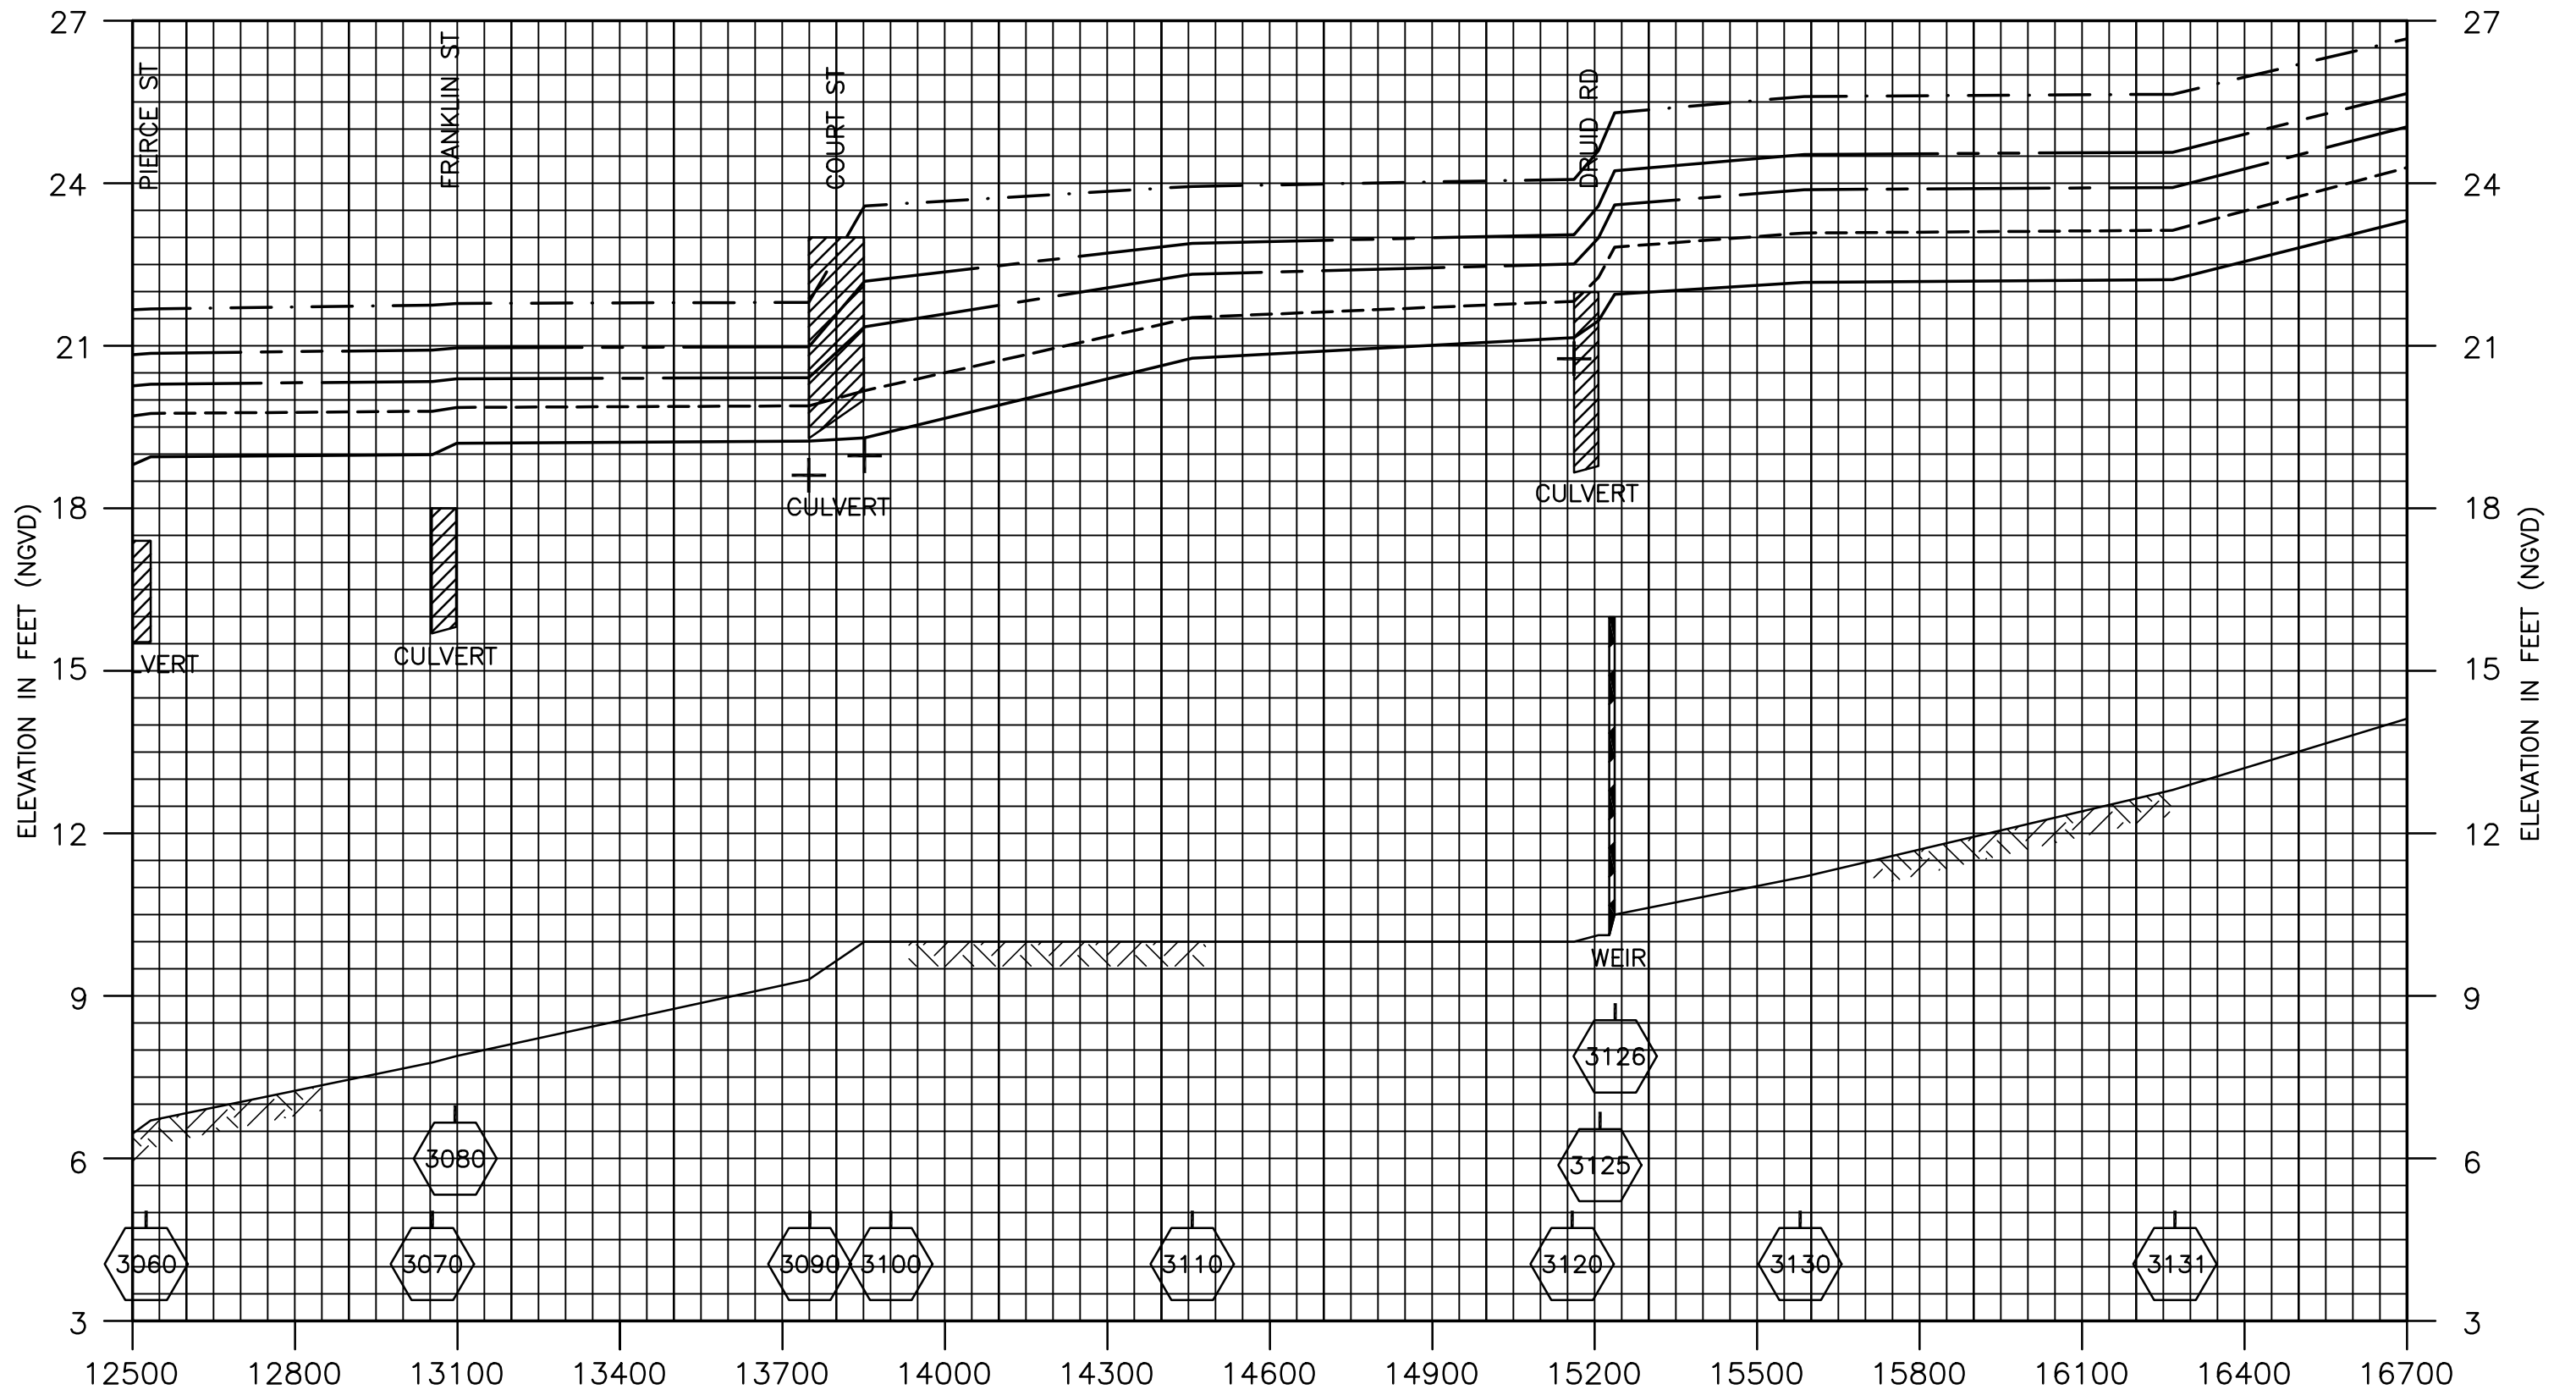
FIGURE 2.1-20
FLOOD PROFILE
EXISTING CONDITIONS
STEVENSON CREEK
CITY OF CLEARWATER, FL
PARSONS ENGINEERING SCIENCE, INC.
