STEVENSON CREEK WATERSHED MANAGEMENT PLAN

FINAL REPORT

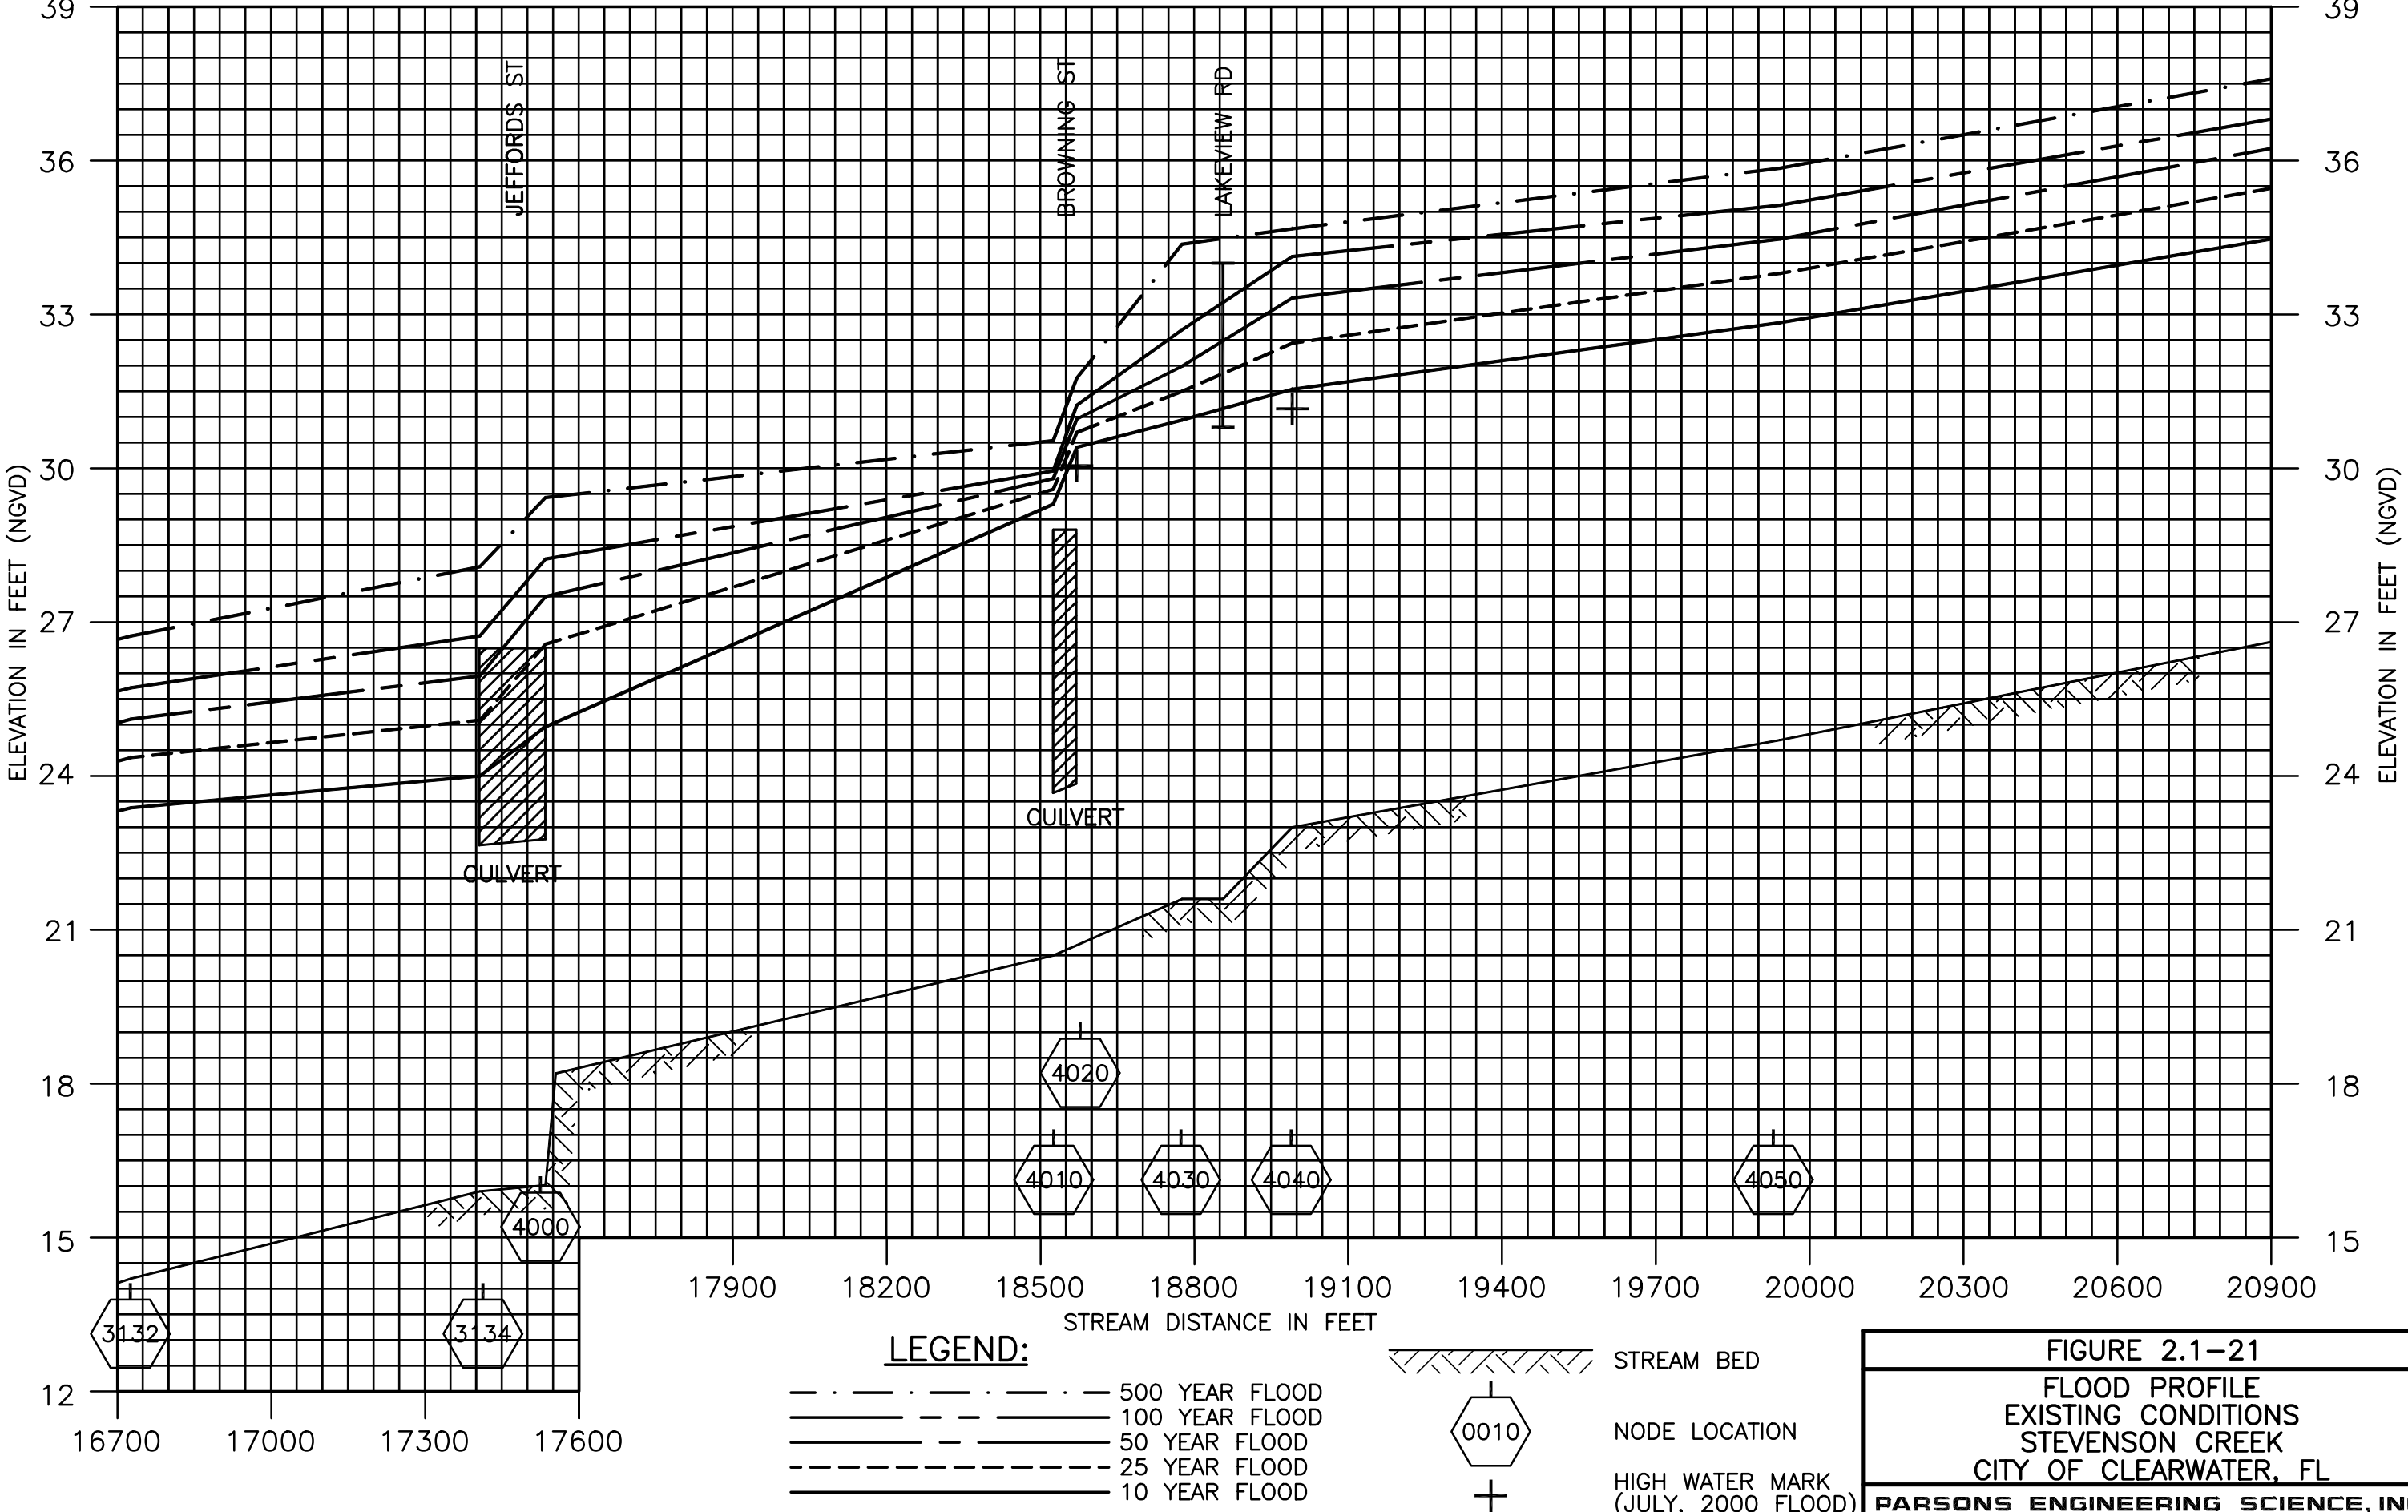
- STREAM BED
- NODE LOCATION
- HIGH WATER MARK (JULY, 2000 FLOOD)

FIGURE 2.1-21
FLOOD PROFILE
EXISTING CONDITIONS
STEVENSON CREEK
CITY OF CLEARWATER, FL
PARSONS ENGINEERING SCIENCE, INC.

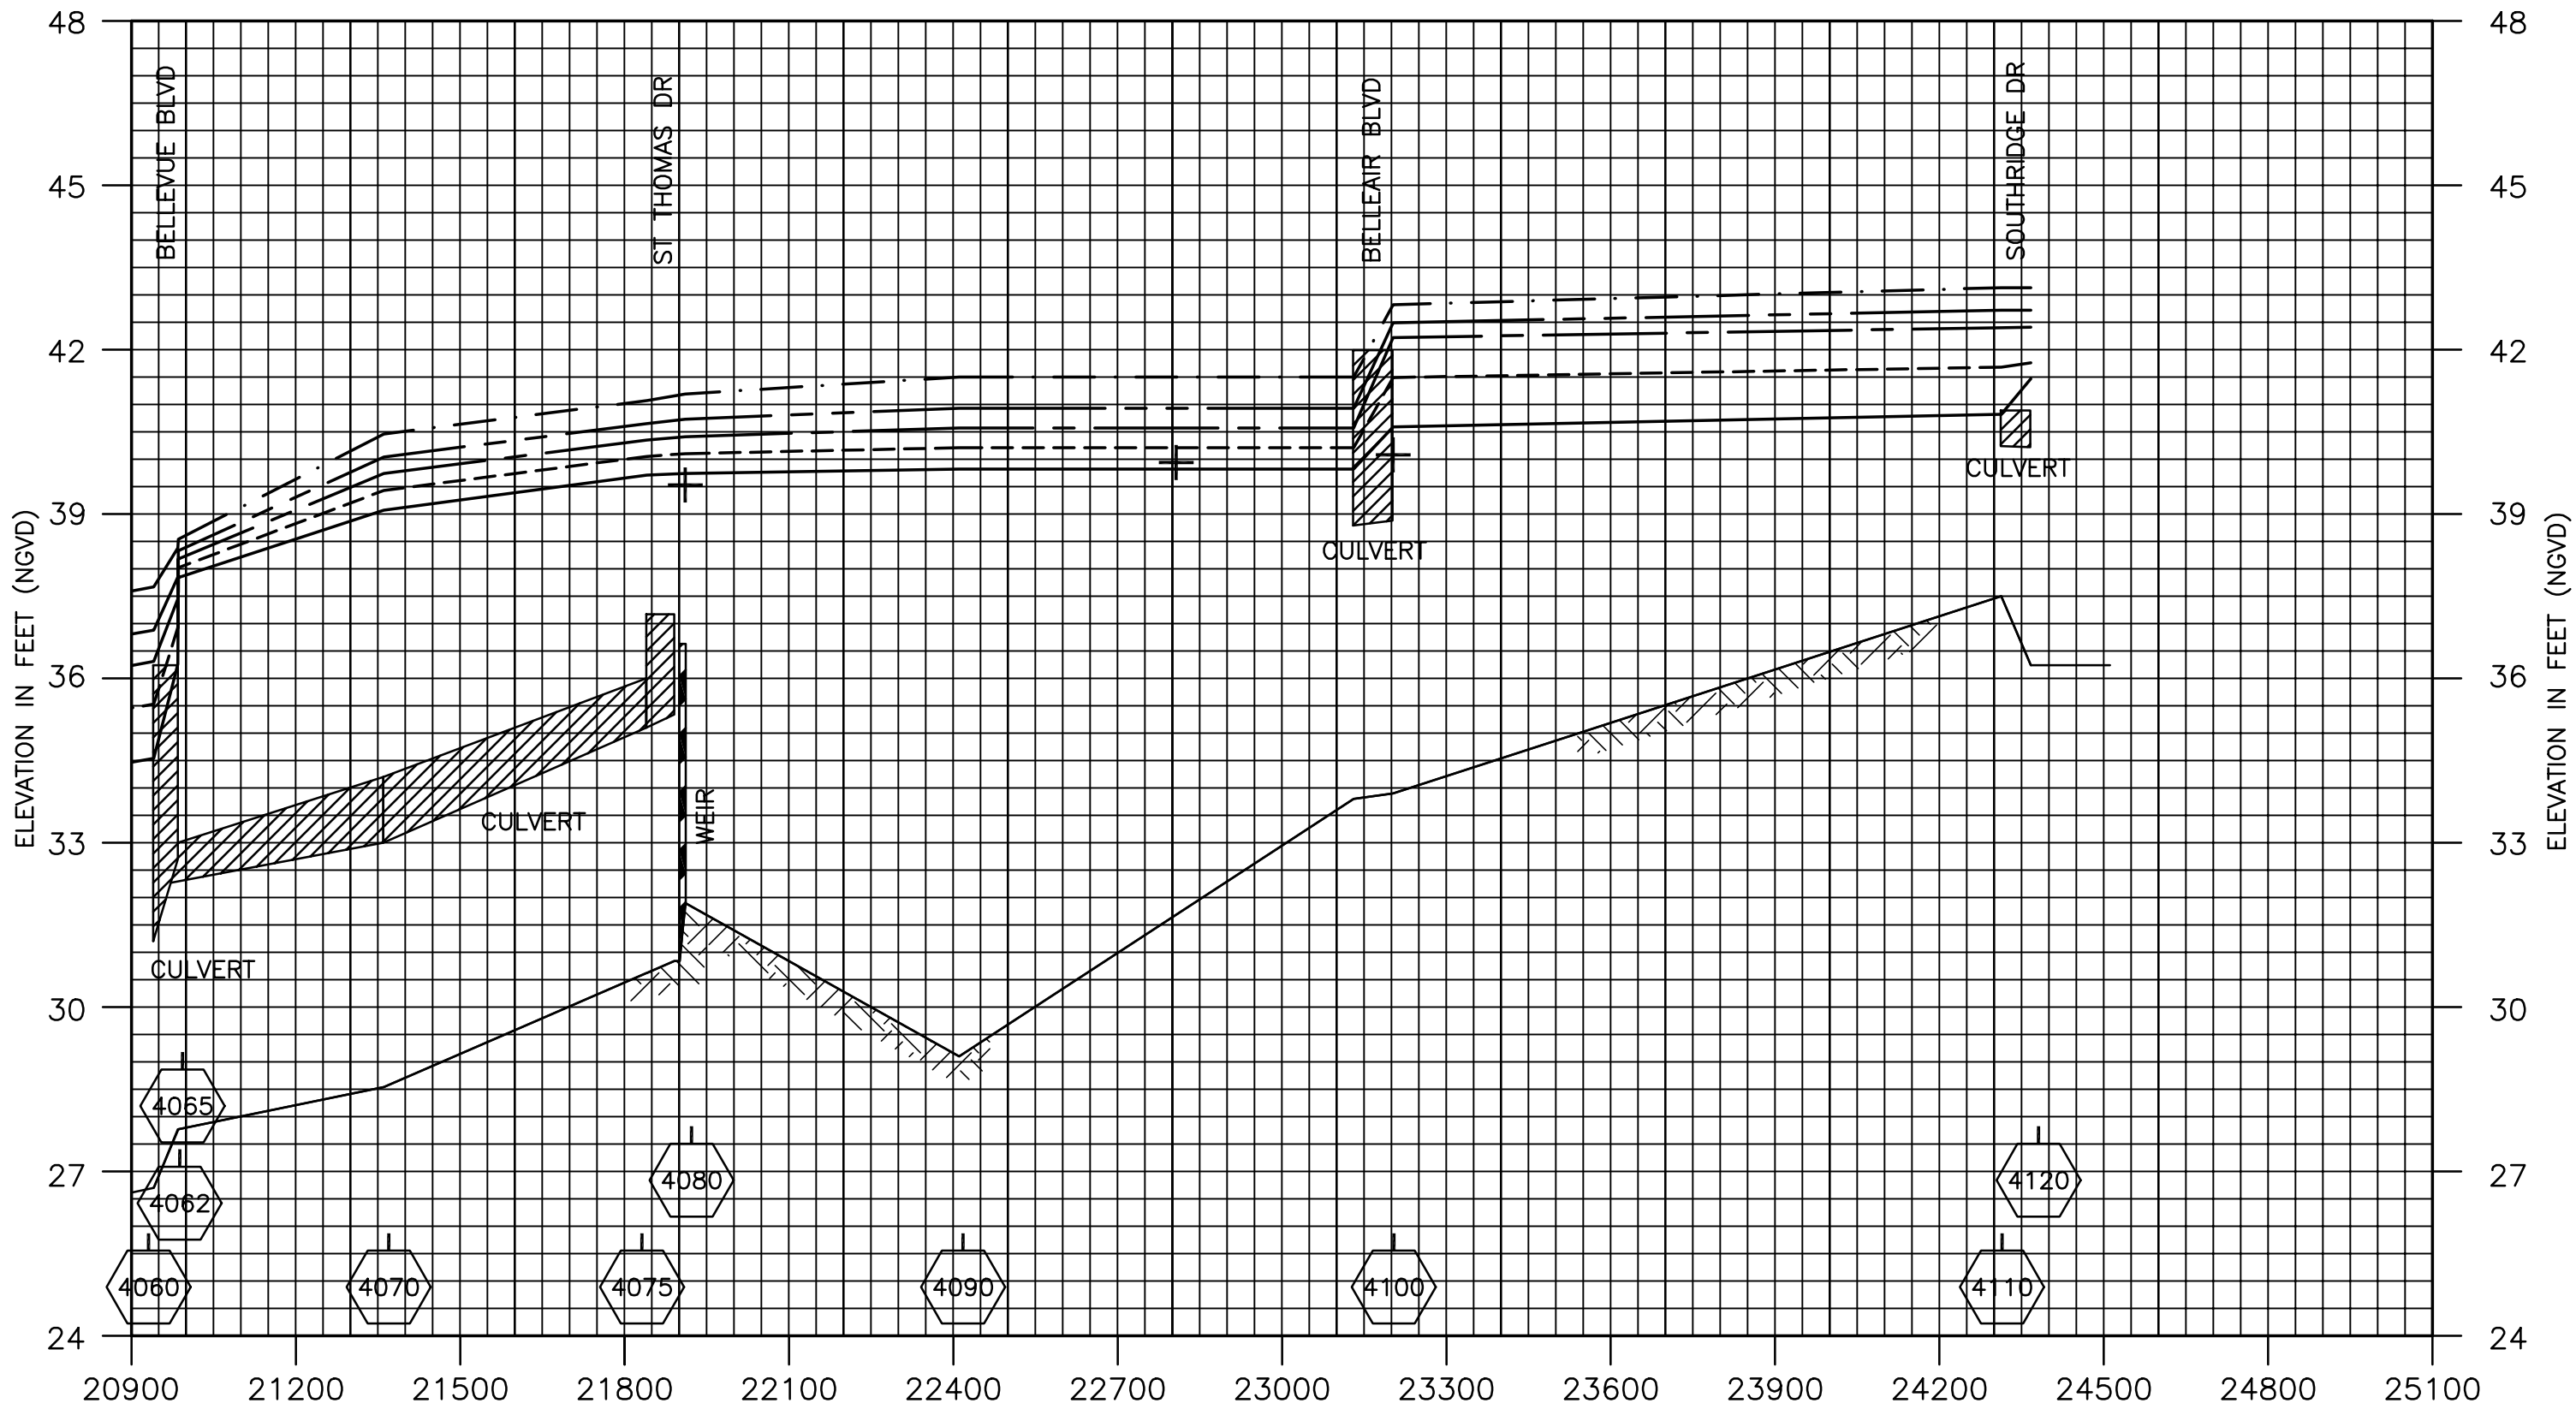
FIGURE 2-1.22

FLOOD PROFILE
EXISTING CONDITIONS
STEVENSON CREEK
CITY OF CLEARWATER, FL

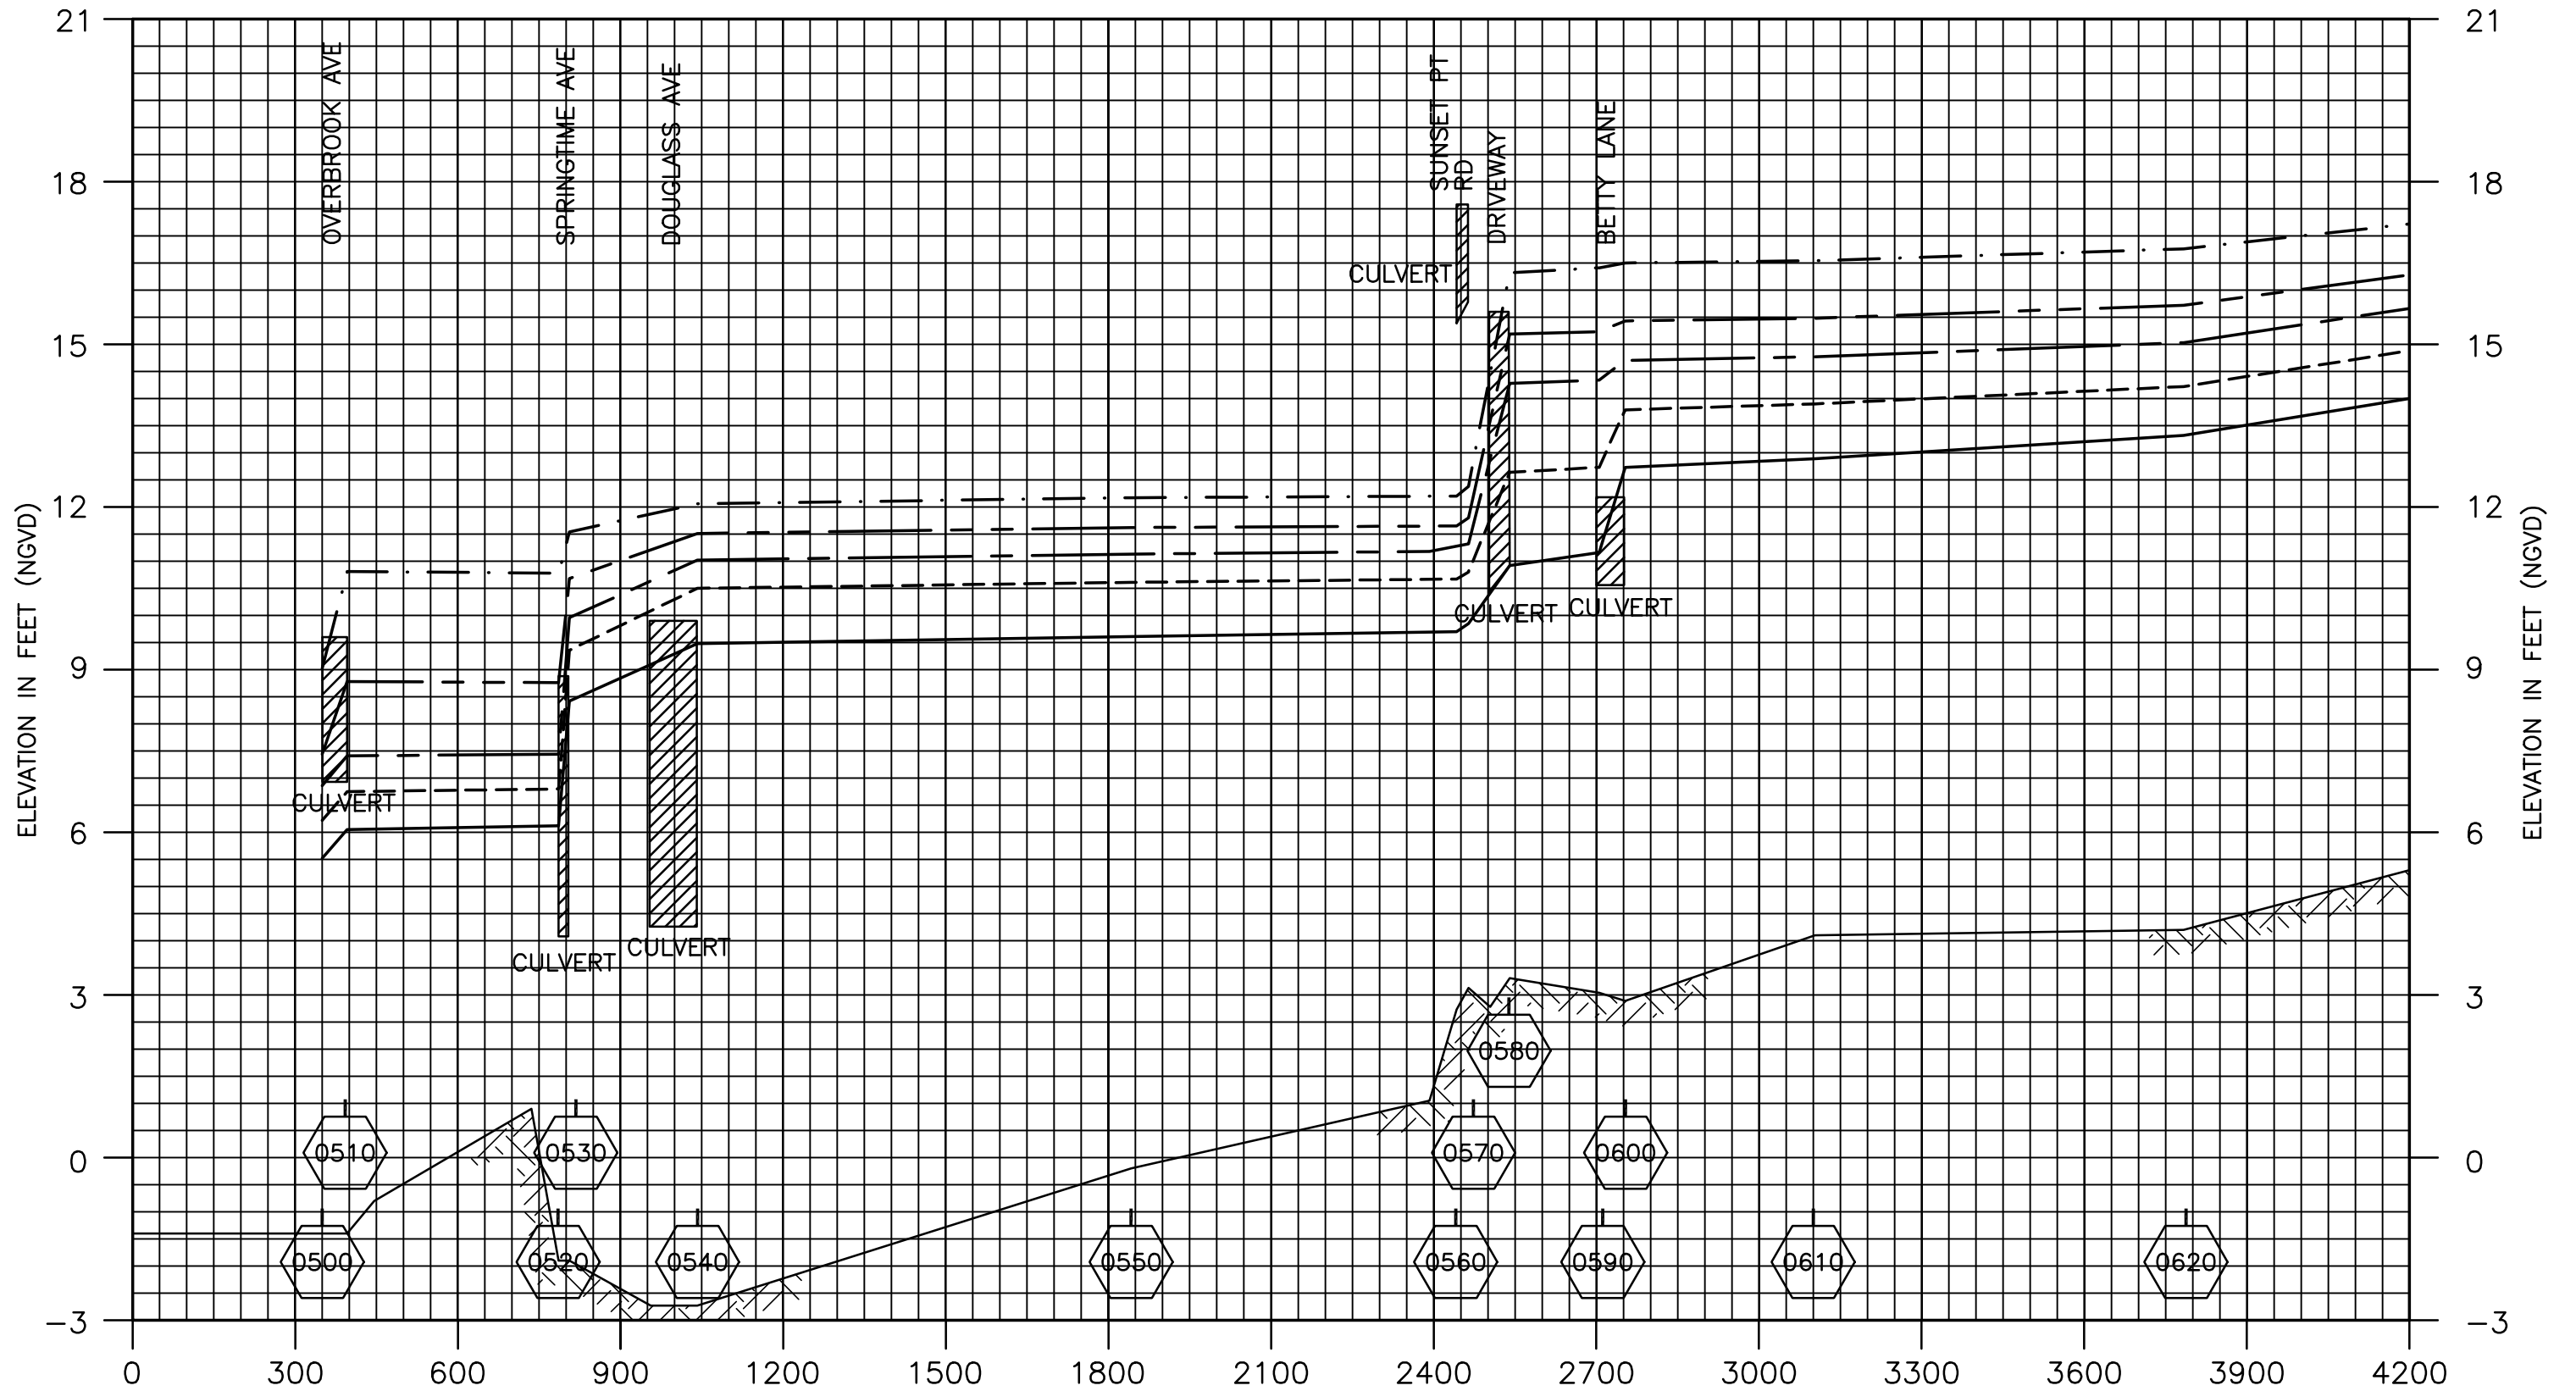
HIGH WATER MARK (JULY, 2000 FLOOD)

FIGURE 2.1-23
FLOOD PROFILE
EXISTING CONDITIONS
SPRING BRANCH
CITY OF CLEARWATER, FL
PARSONS ENGINEERING SCIENCE, INC.

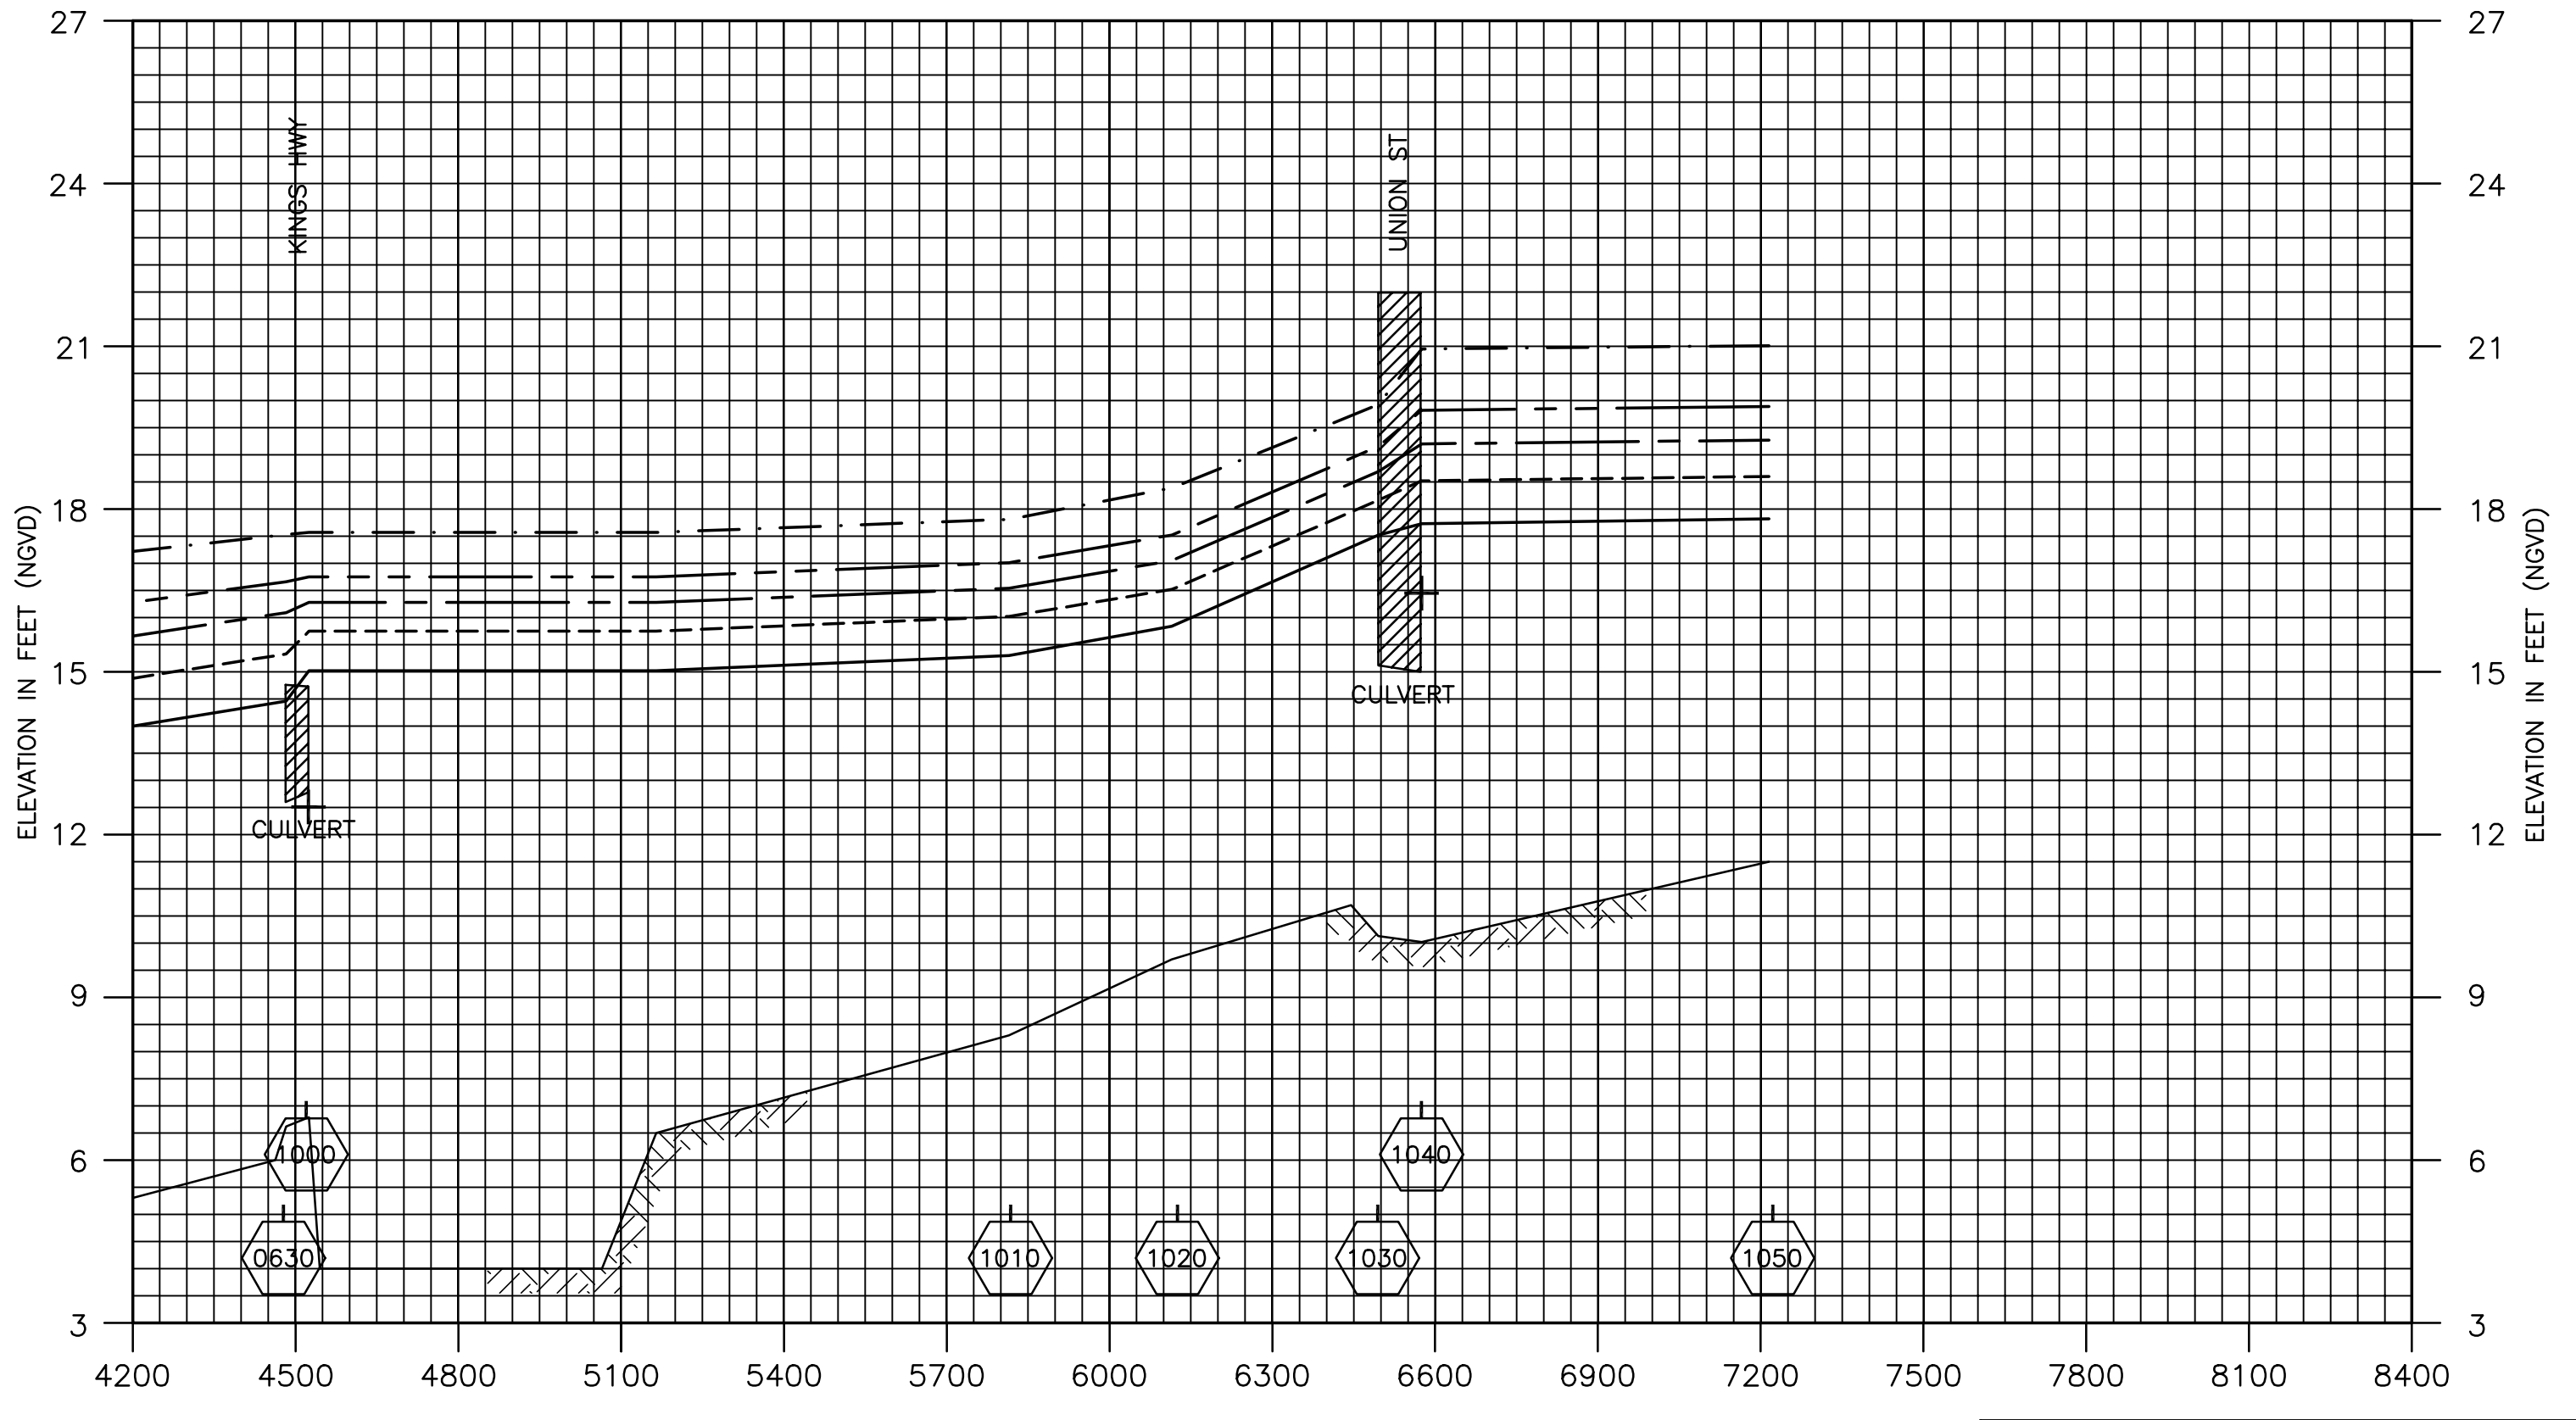
FIGURE 2-1.24
FLOOD PROFILE
EXISTING CONDITIONS
SPRING BRANCH
CITY OF CLEARWATER, FL
PARSONS ENGINEERING SCIENCE, INC.

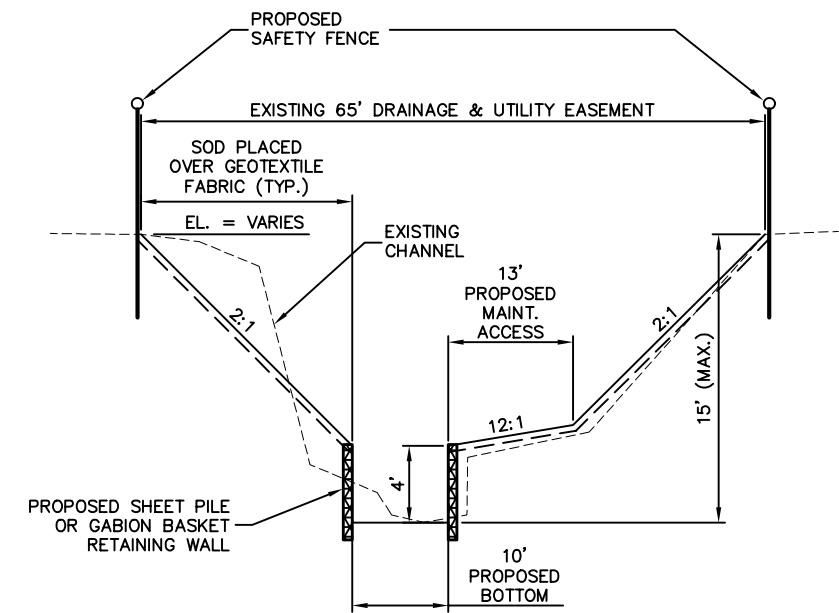
TYPICAL CROSS SECTION
ALTERNATE 'A'
SCALE: 1"=20' H, 1"=10' V

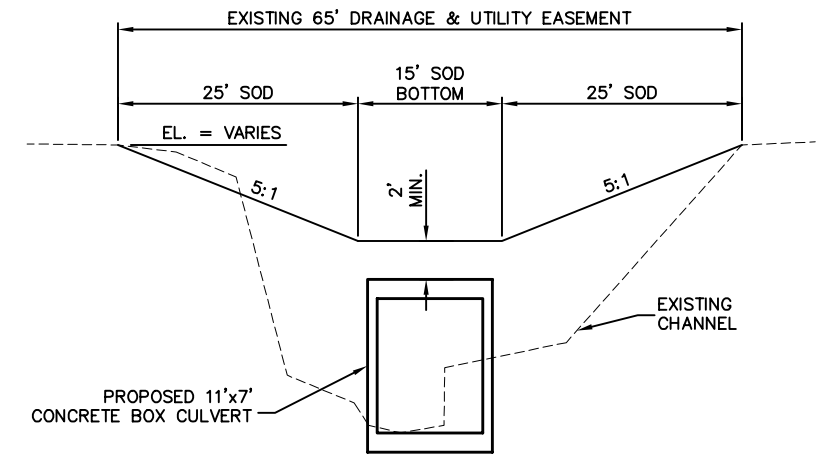
TYPICAL CROSS SECTION
ALTERNATE 'B'
SCALE: 1"=20' H, 1"=10' V

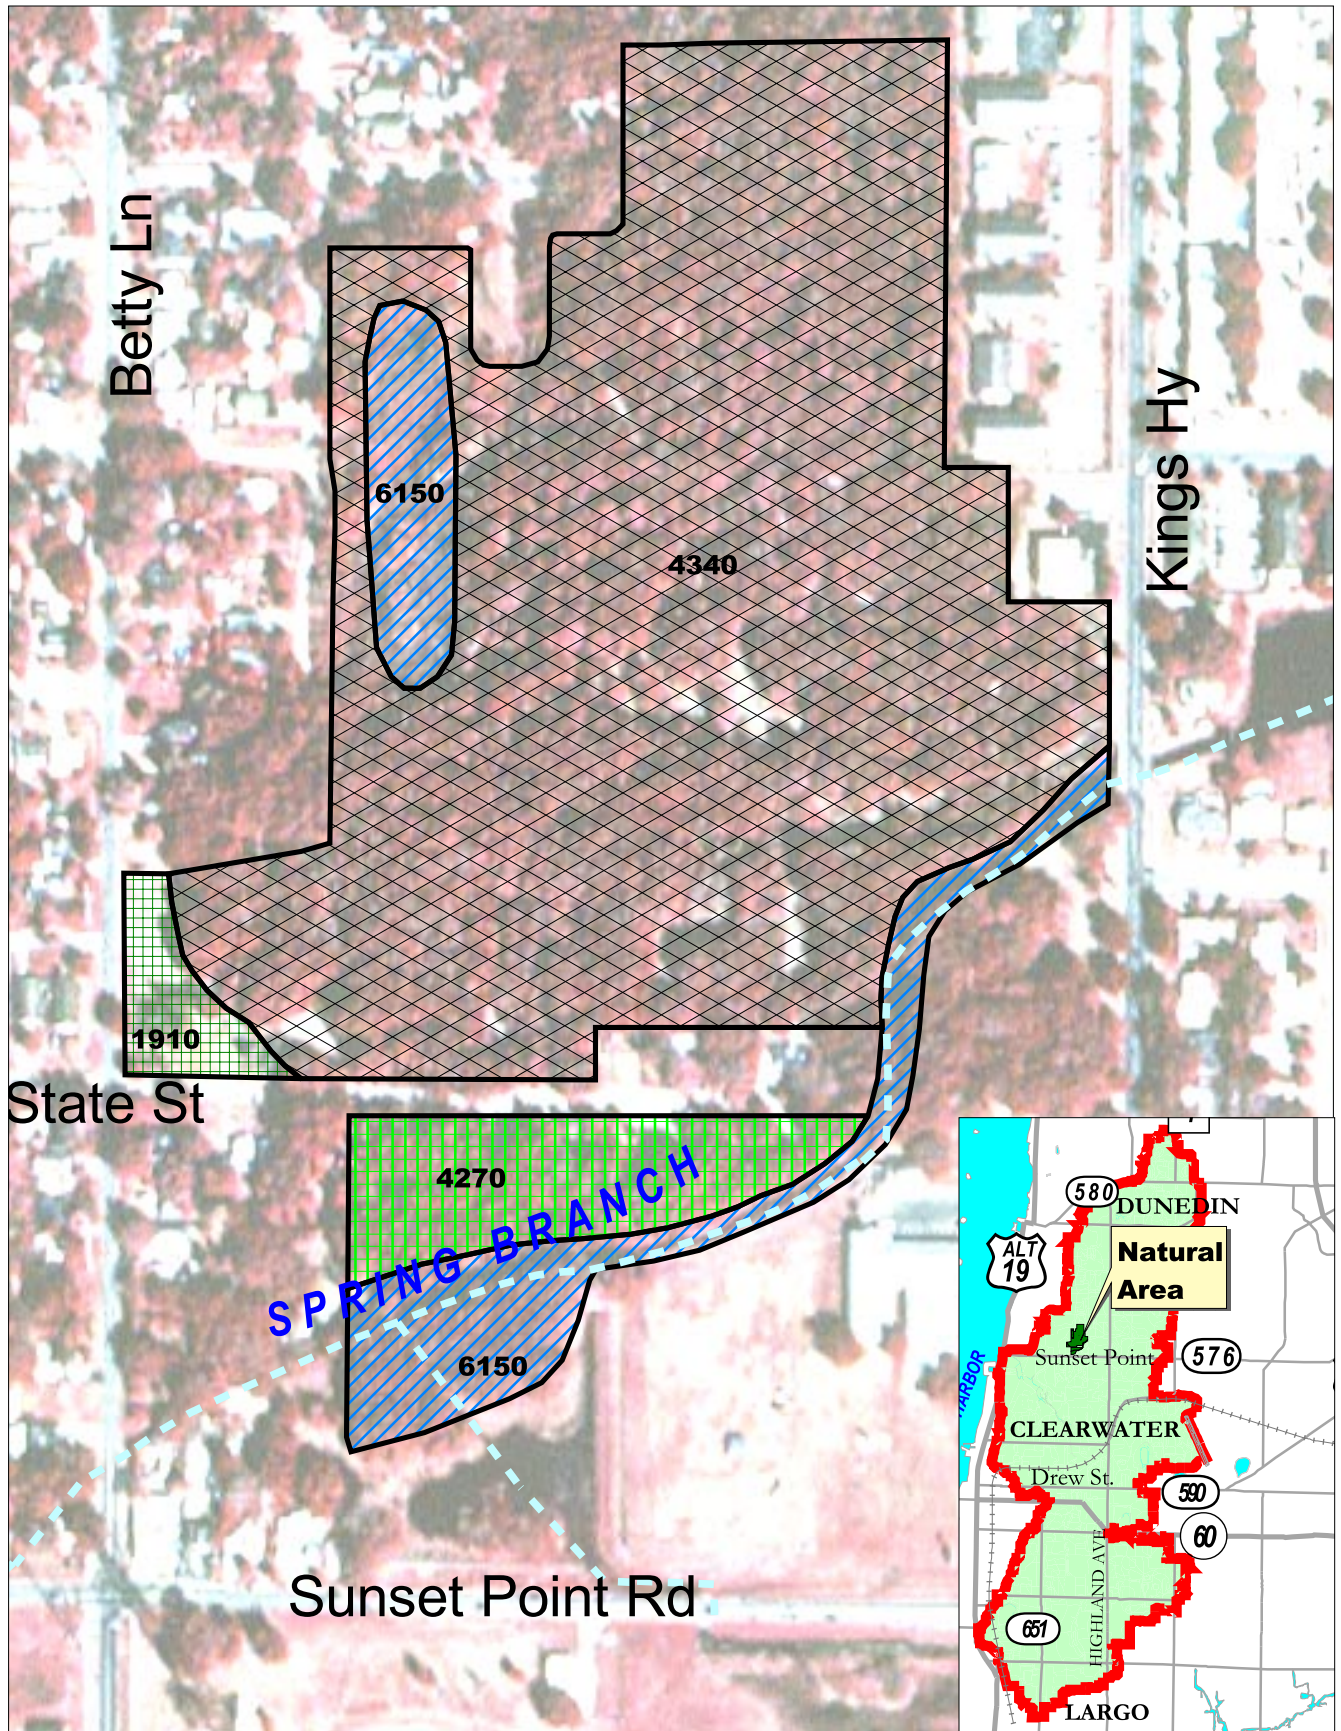
Figure 3.1-12
Stevenson Creek Watershed
Potential Natural Resource
Improvement Area

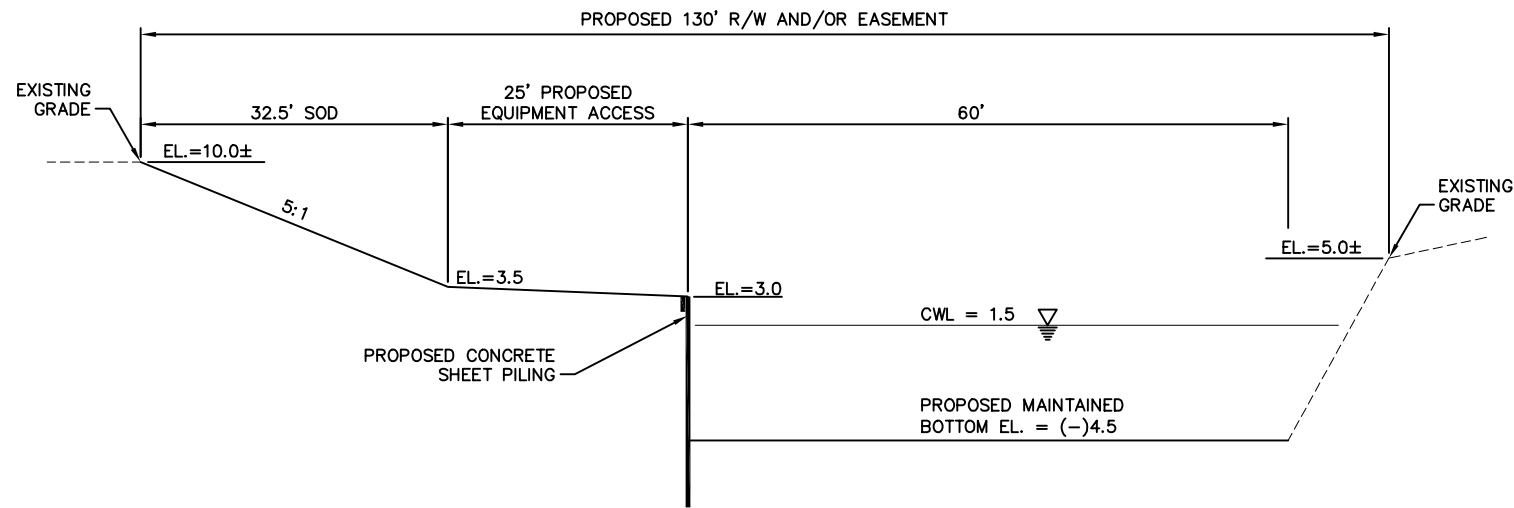
| STEVENSON CREEK WATERSHED MANAGEMENT PLAN | | FIGURE 3.1-13 |

SEDIMENT SUMP
TYPICAL CROSS SECTION
PROJECT 2A
SCALE: 1"=20' H, 1"= 10' V

| THE CITY OF CLEARWATER, FLORIDA | PARSONS ENGINEERING SCIENCE, INC. Tampa, Florida (813) 933-4650 | PROJECT 2A PALMETTO STREET SEDIMENT SUMP |

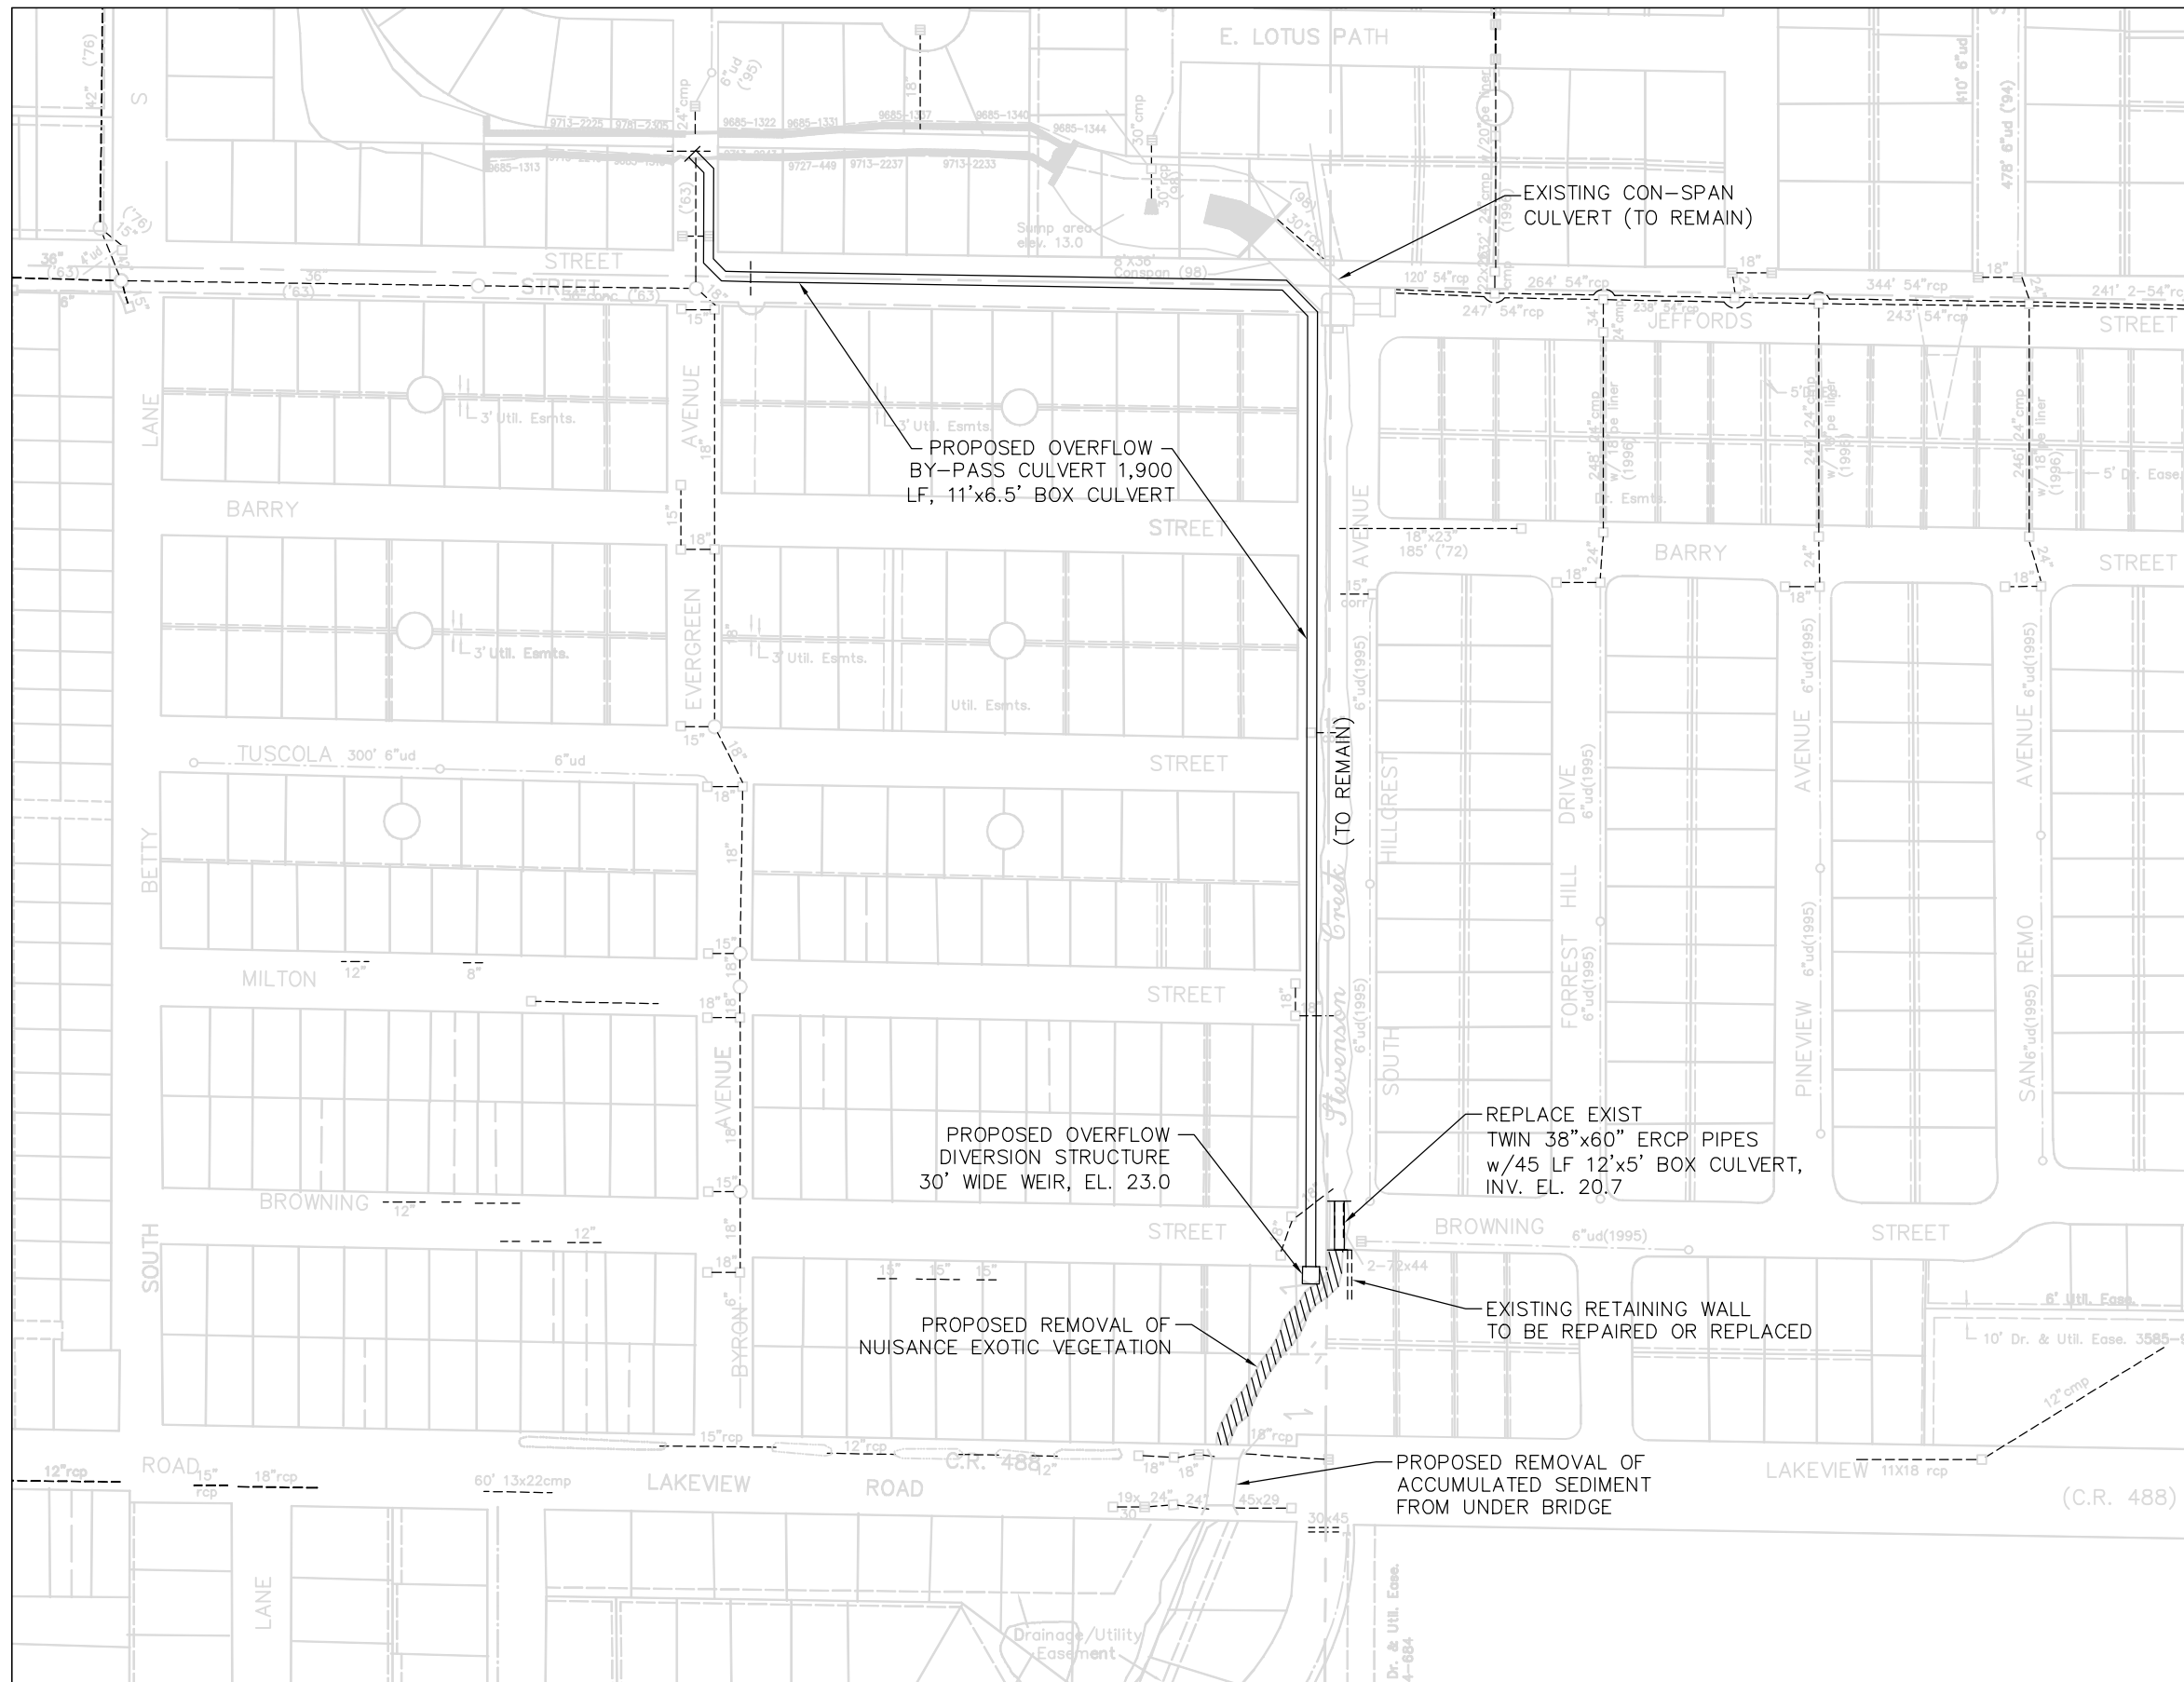
FIGURE 3.1-18

PROJECT 3A GLEN OAKS STORMWATER DETENTION FACILITY
