STEVENSON CREEK WATERSHED MANAGEMENT PLAN

FINAL REPORT

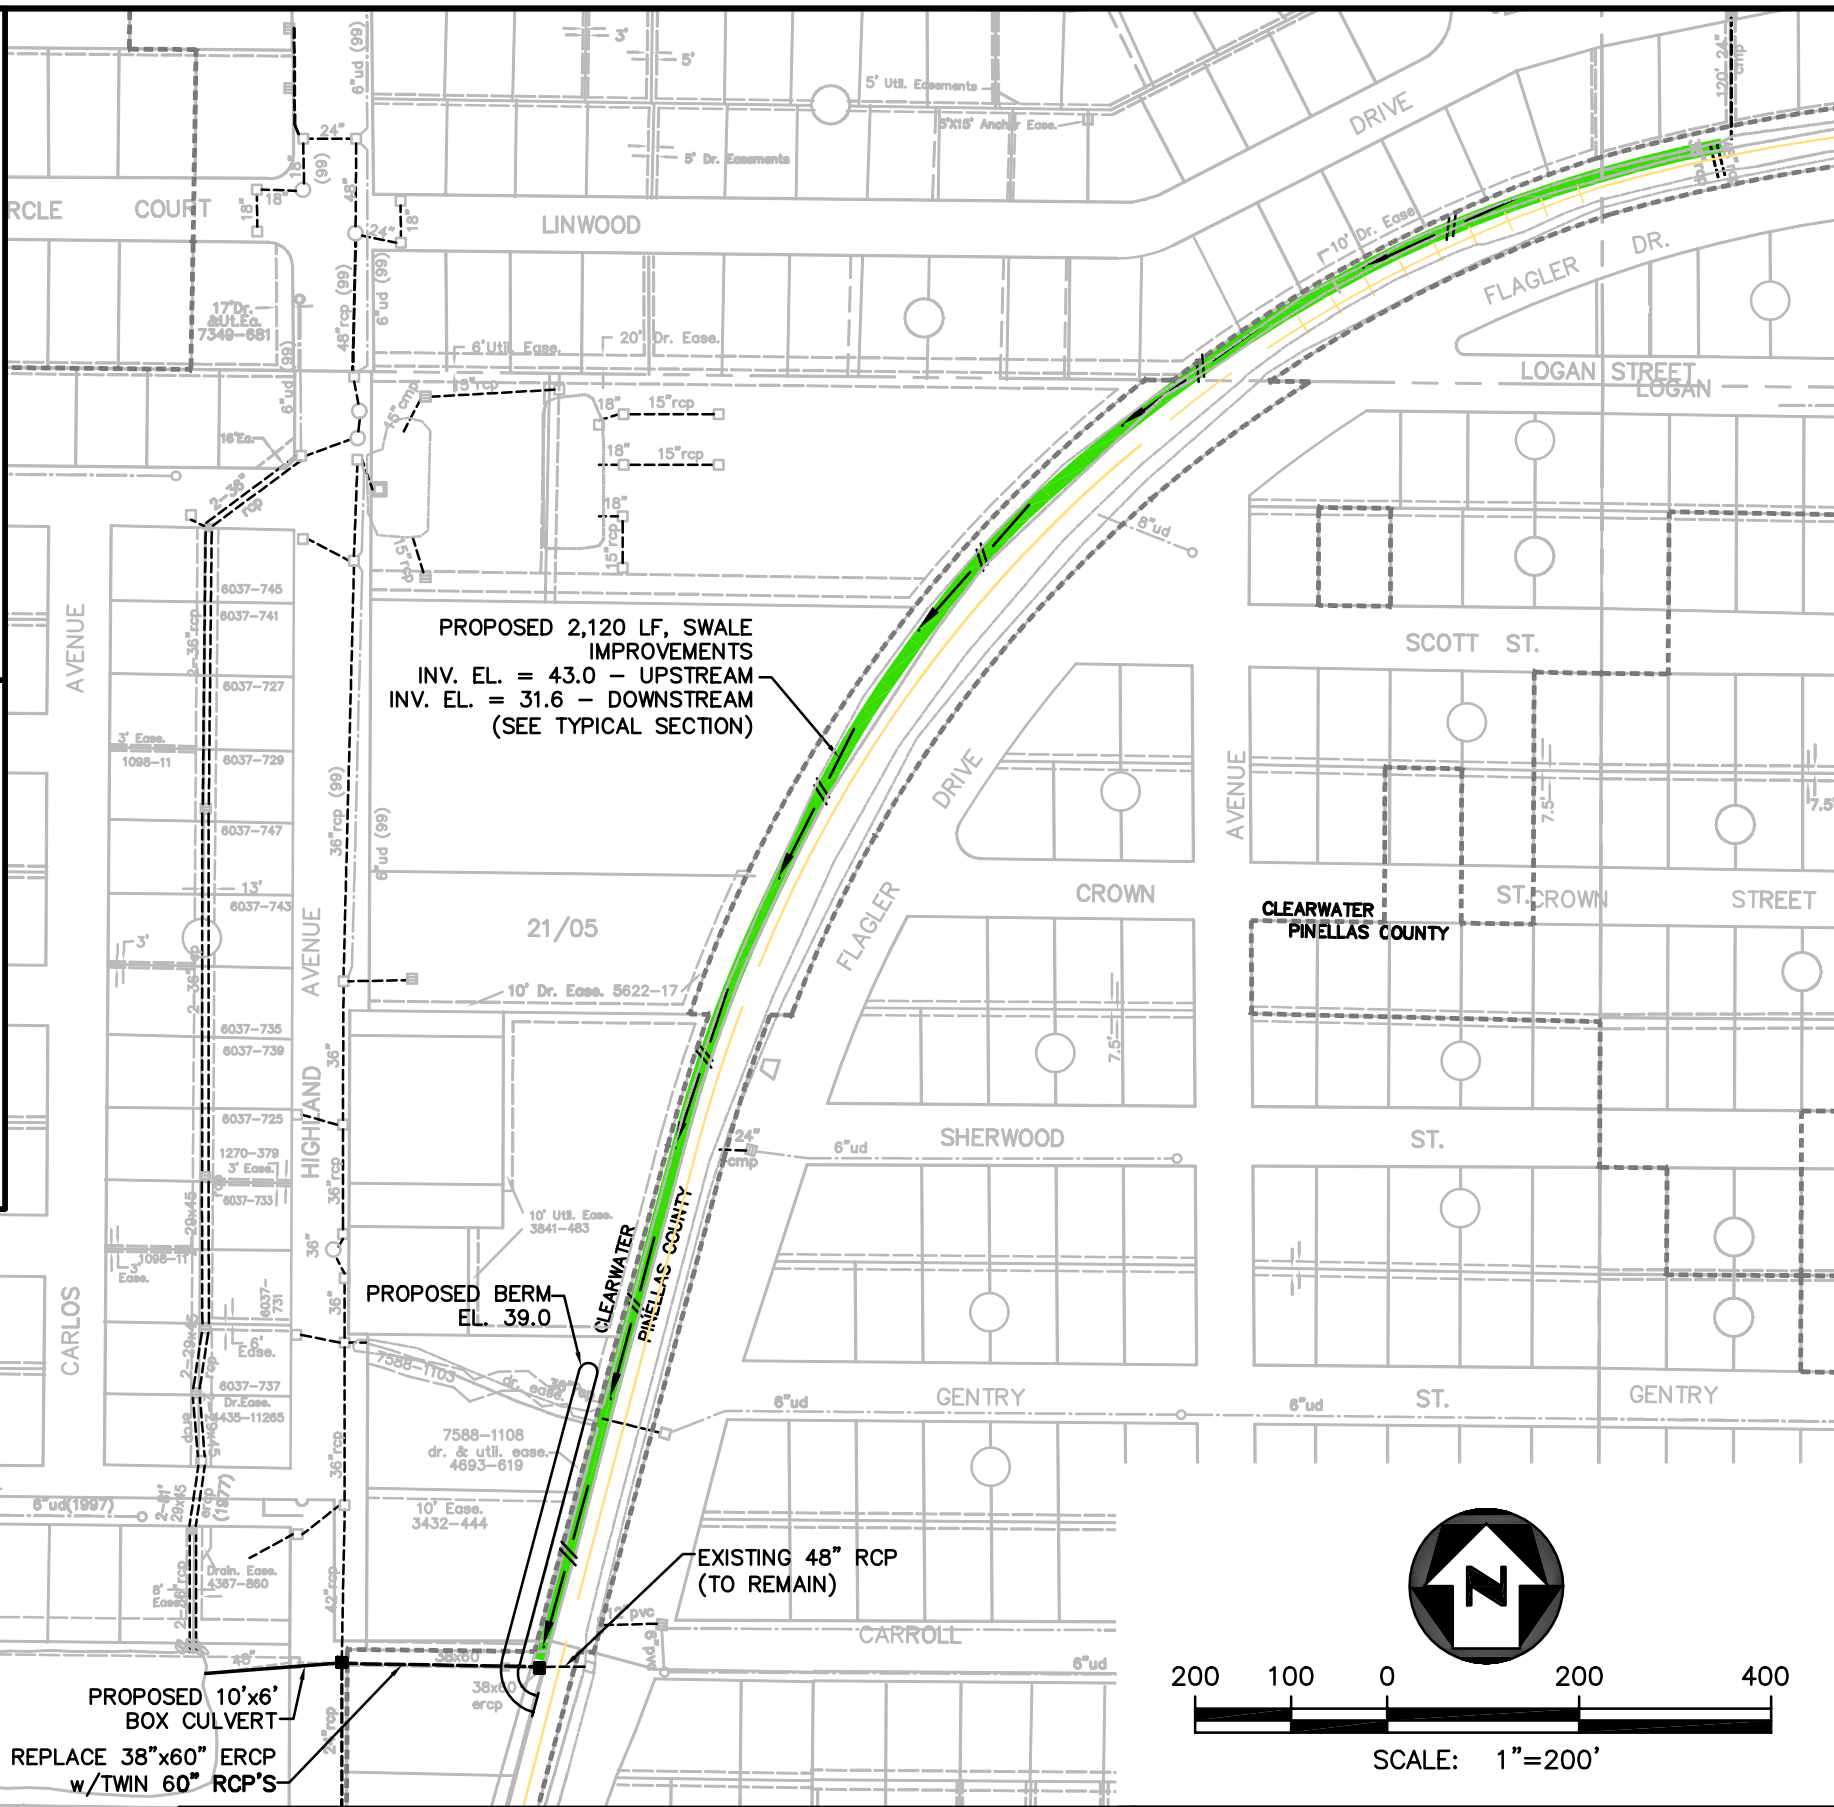
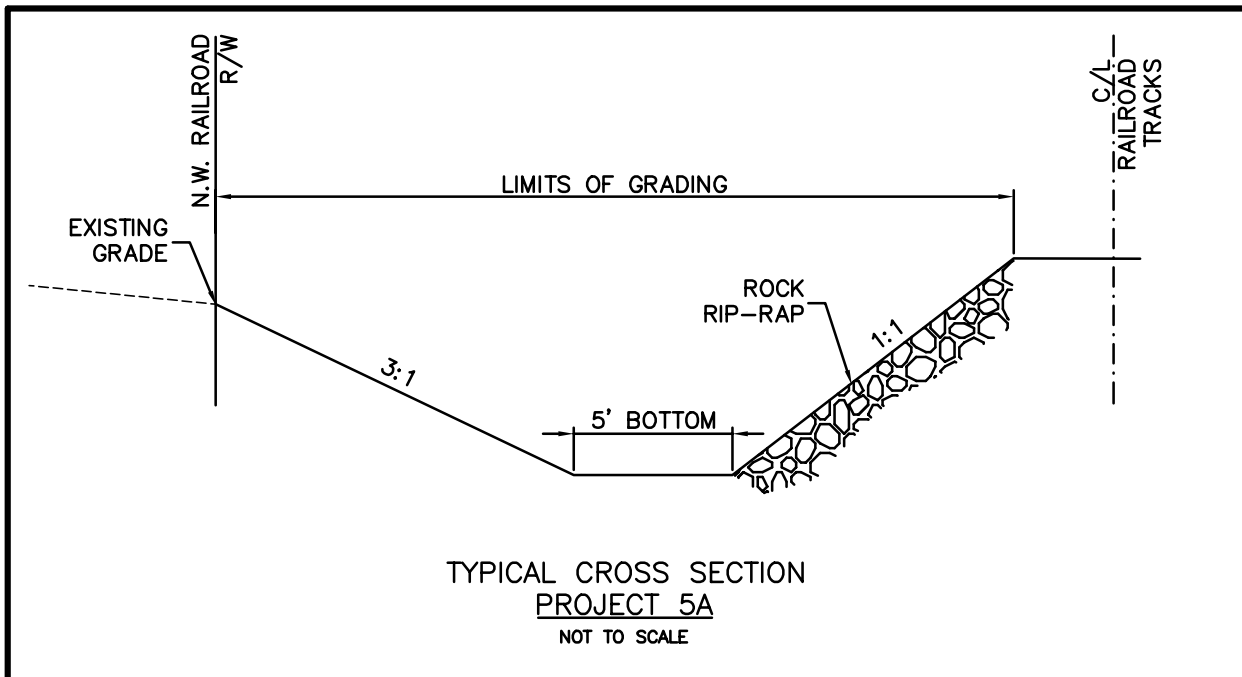
TYPICAL CROSS SECTION
PROJECT 5A
NOT TO SCALE

PROPOSED 2,120 LF, SWALE IMPROVEMENTS
INV. EL. = 43.0 - UPSTREAM
INV. EL. = 31.6 - DOWNSTREAM
(SEE TYPICAL SECTION)

PROPOSED BERM
EL. 39.0

EXISTING 48" RCP
(TO REMAIN)

PROJECT 5A FLAGLER DRIVE / CSX RAILROAD
NORTH SWALE IMPROVEMENTS

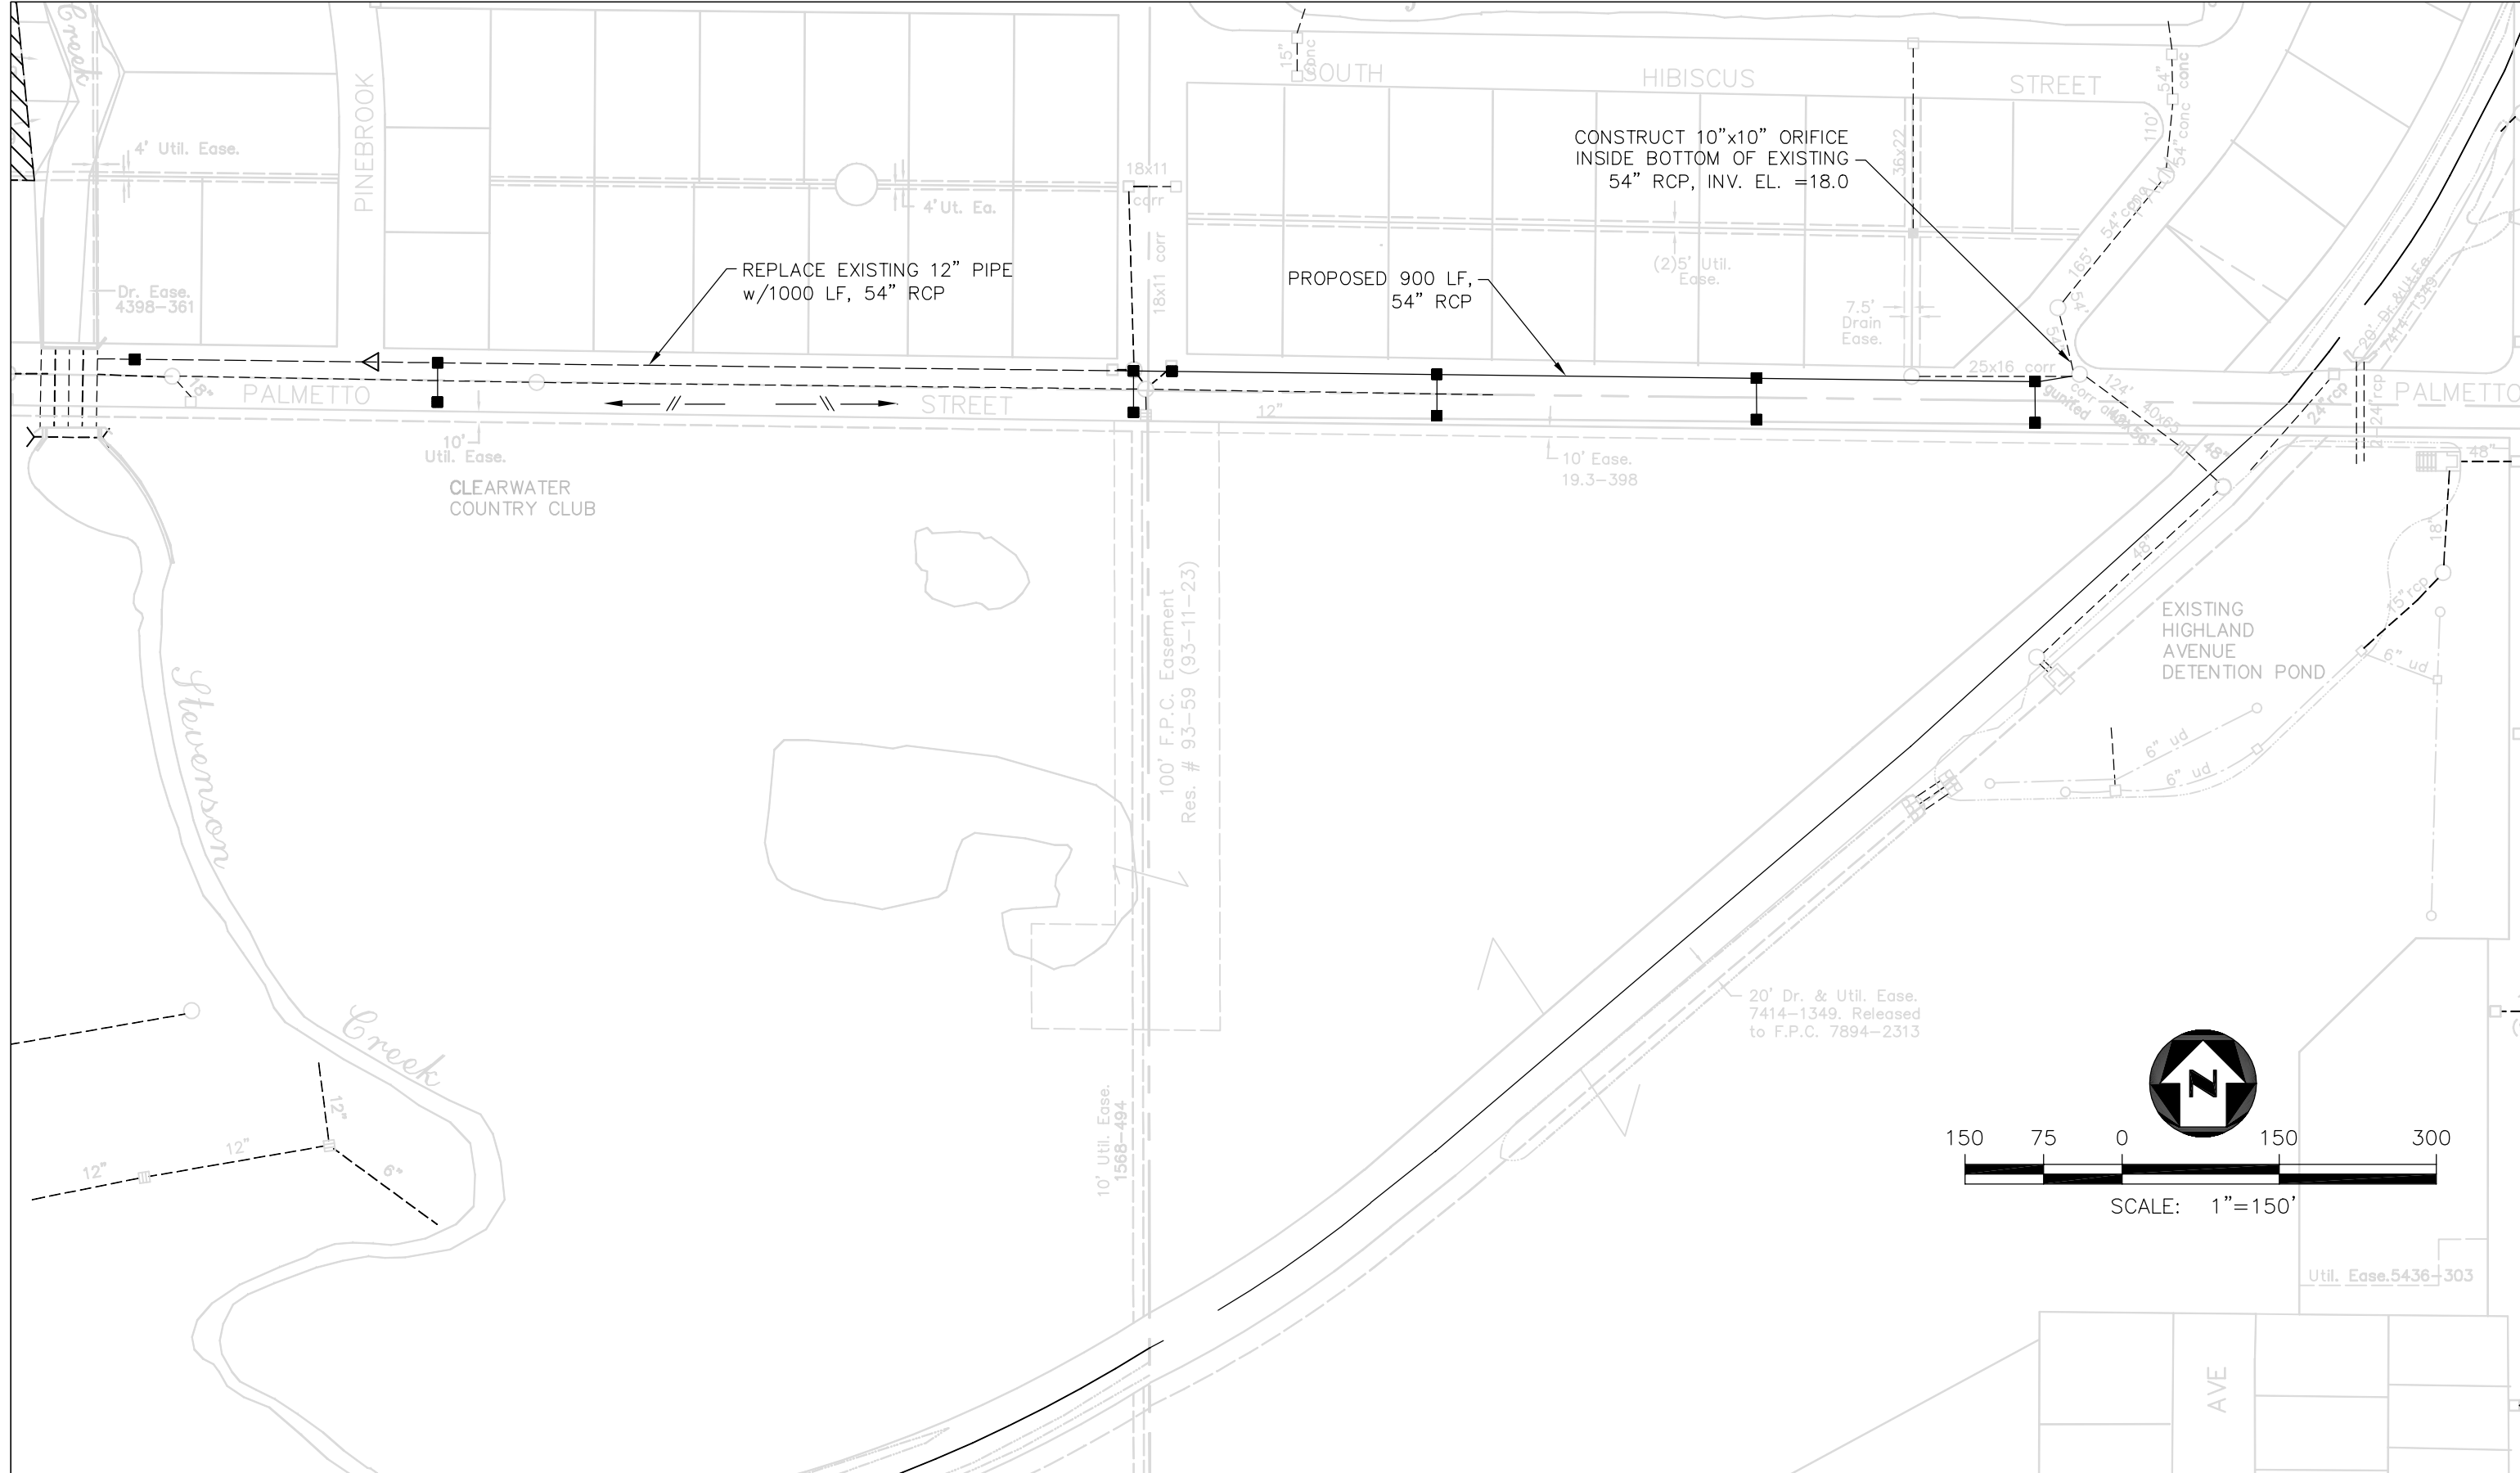
FIGURE 3.1-25

PROJECT 5B PALMETTO STREET
DRAINAGE IMPROVEMENTS

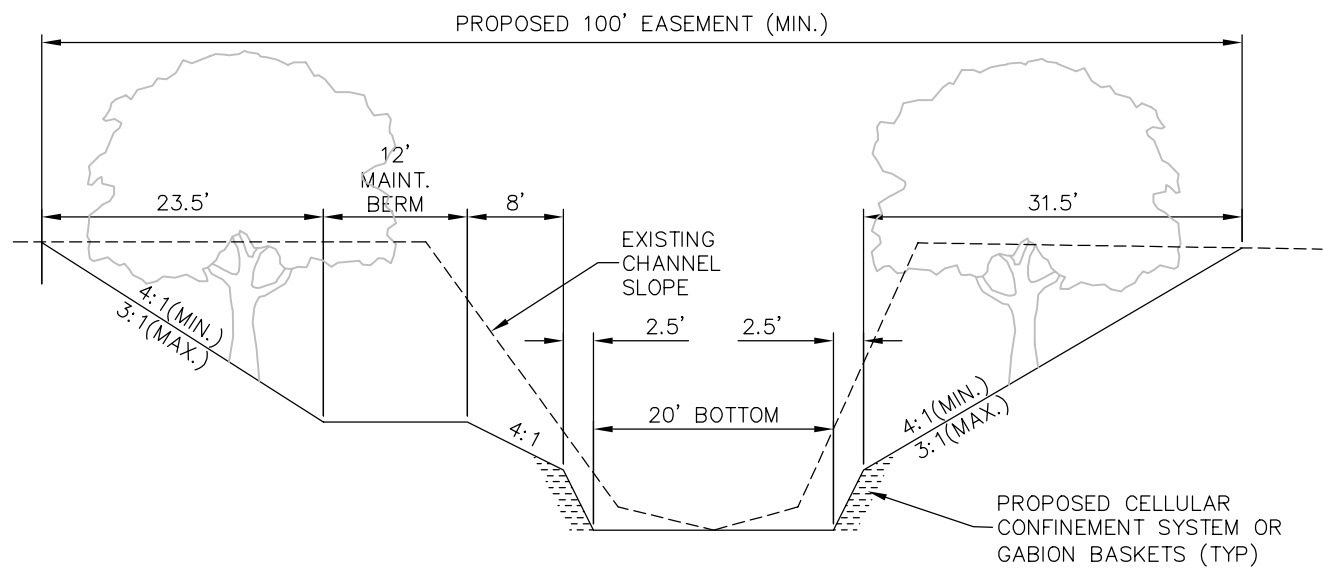
**TYPICAL CHANNEL CROSS SECTION
SPRING BRANCH - PROJECT 1A**

SCALE: 1/16" = 1' H, 1/8" = 1'-0" V

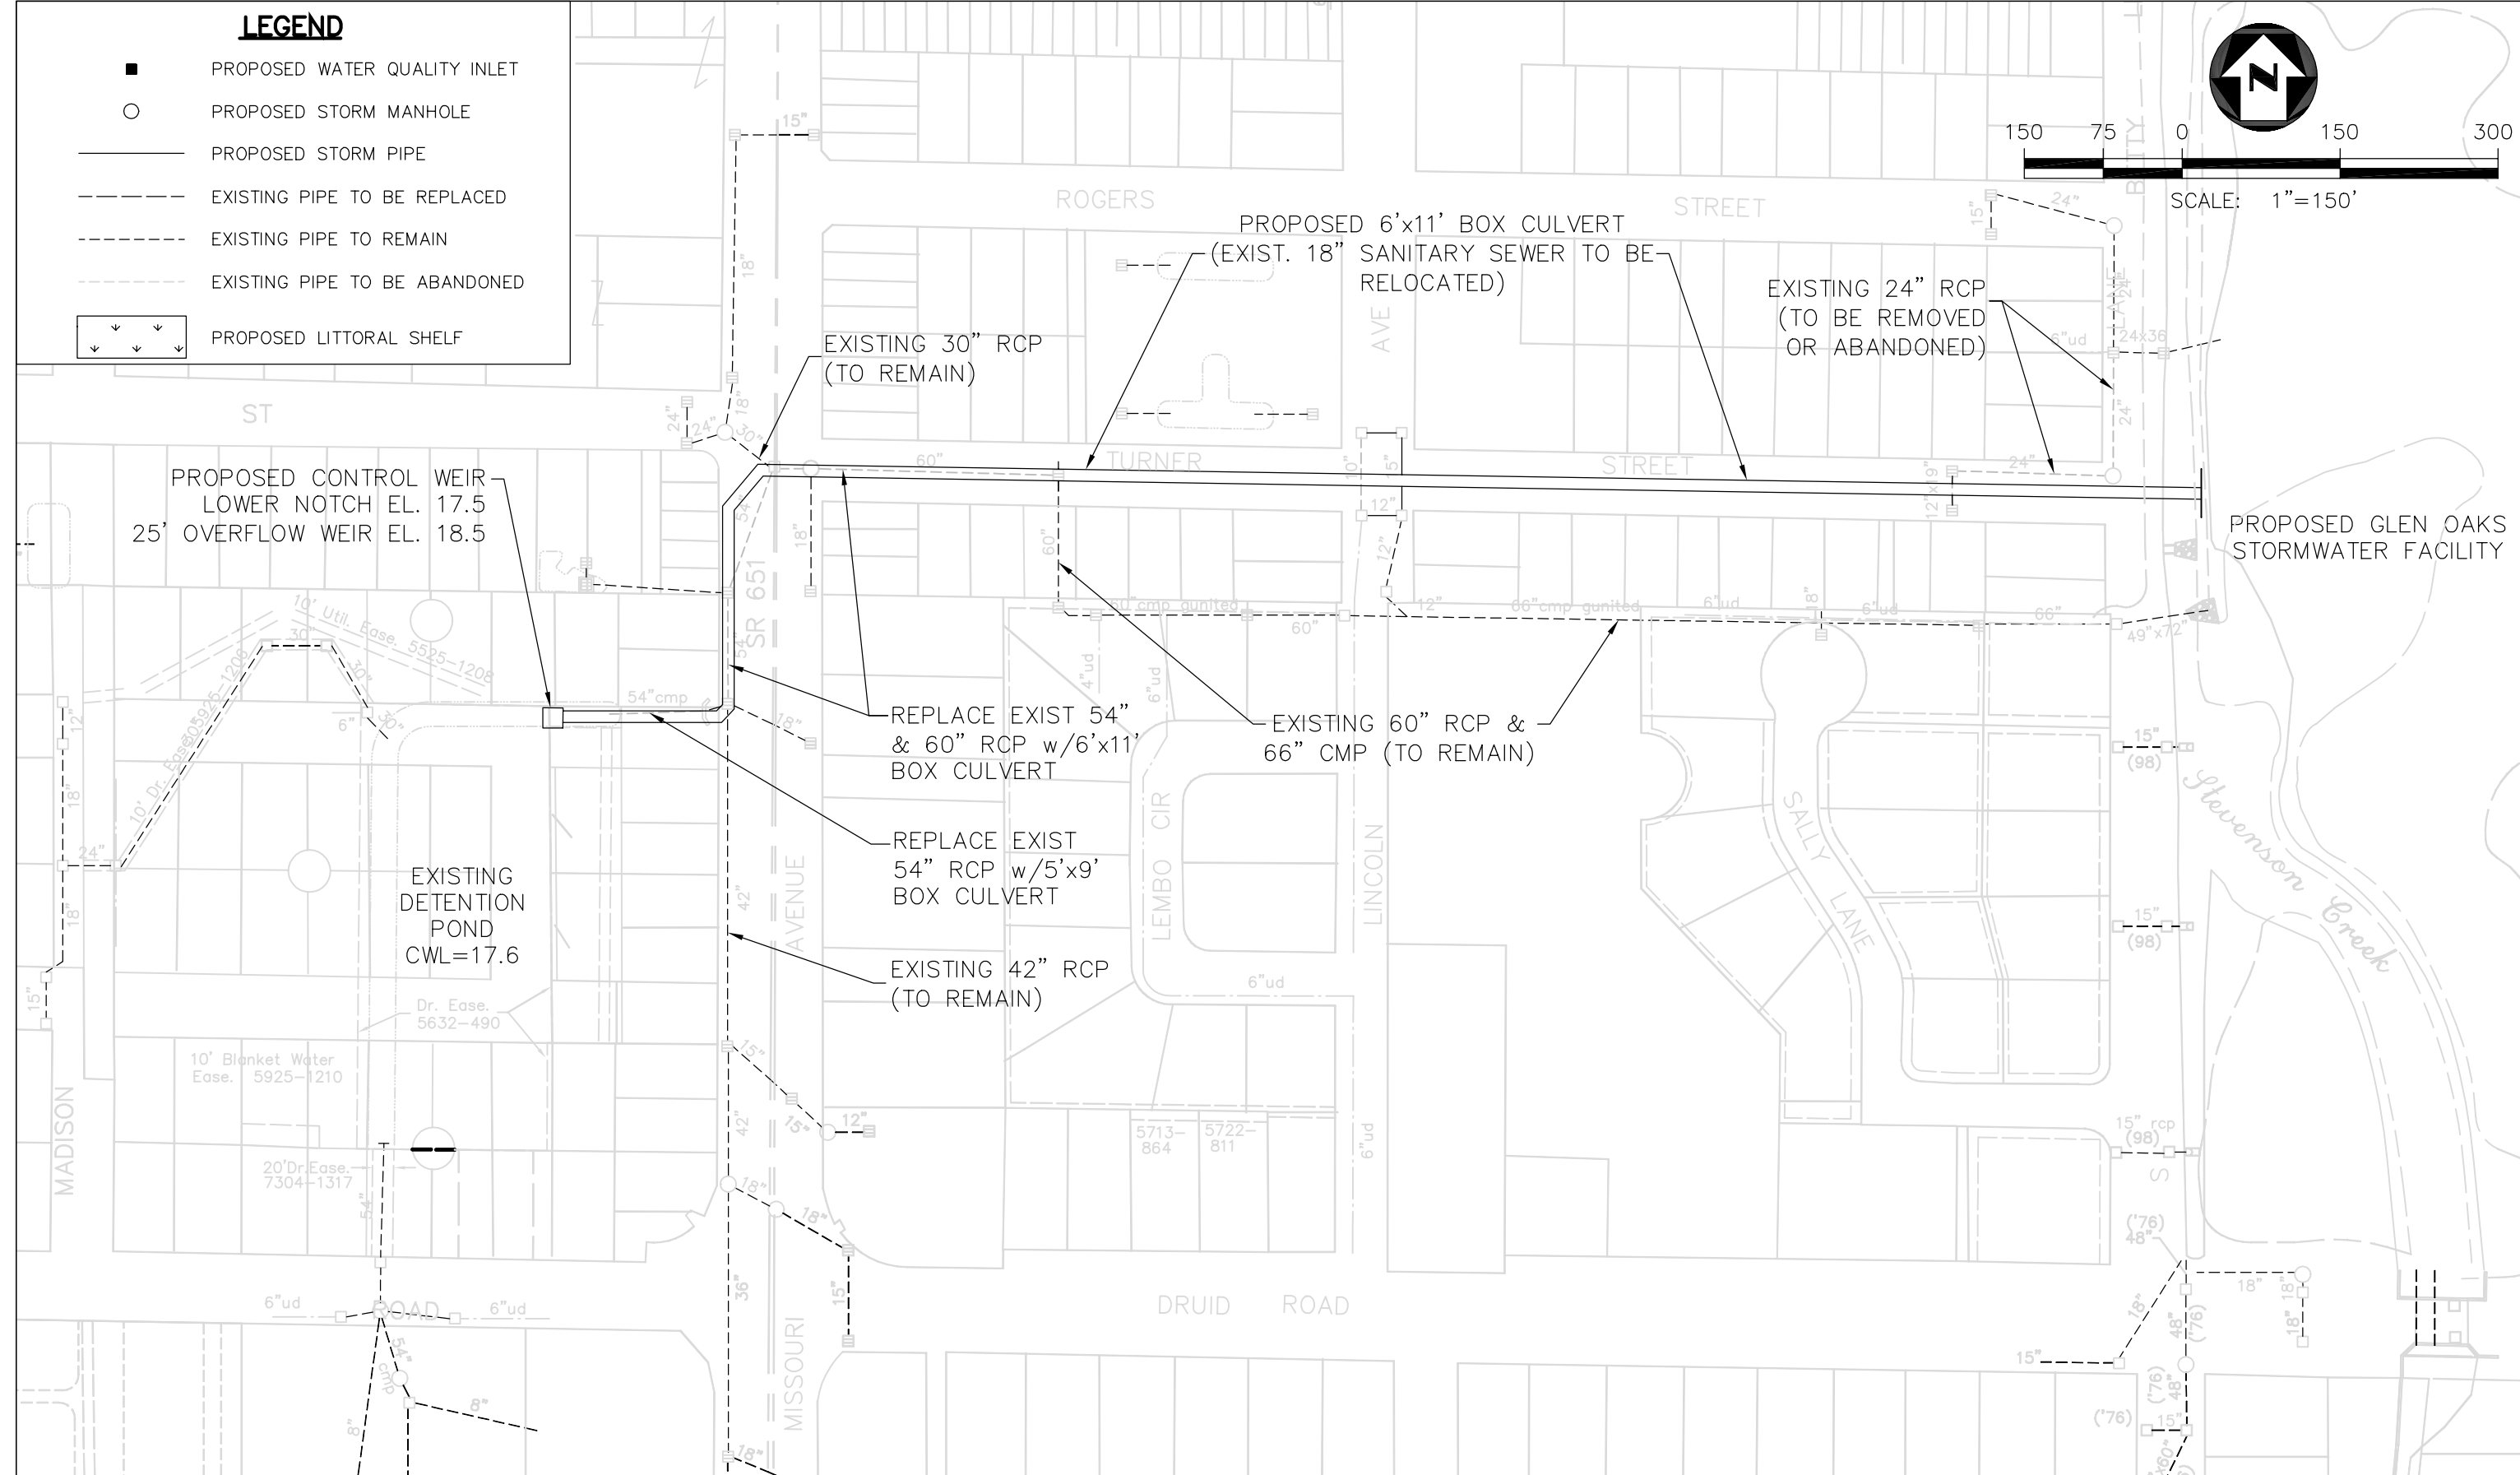
FIGURE 3.1-32

PROJECT 6B TURNER STREET BOX CULVERT

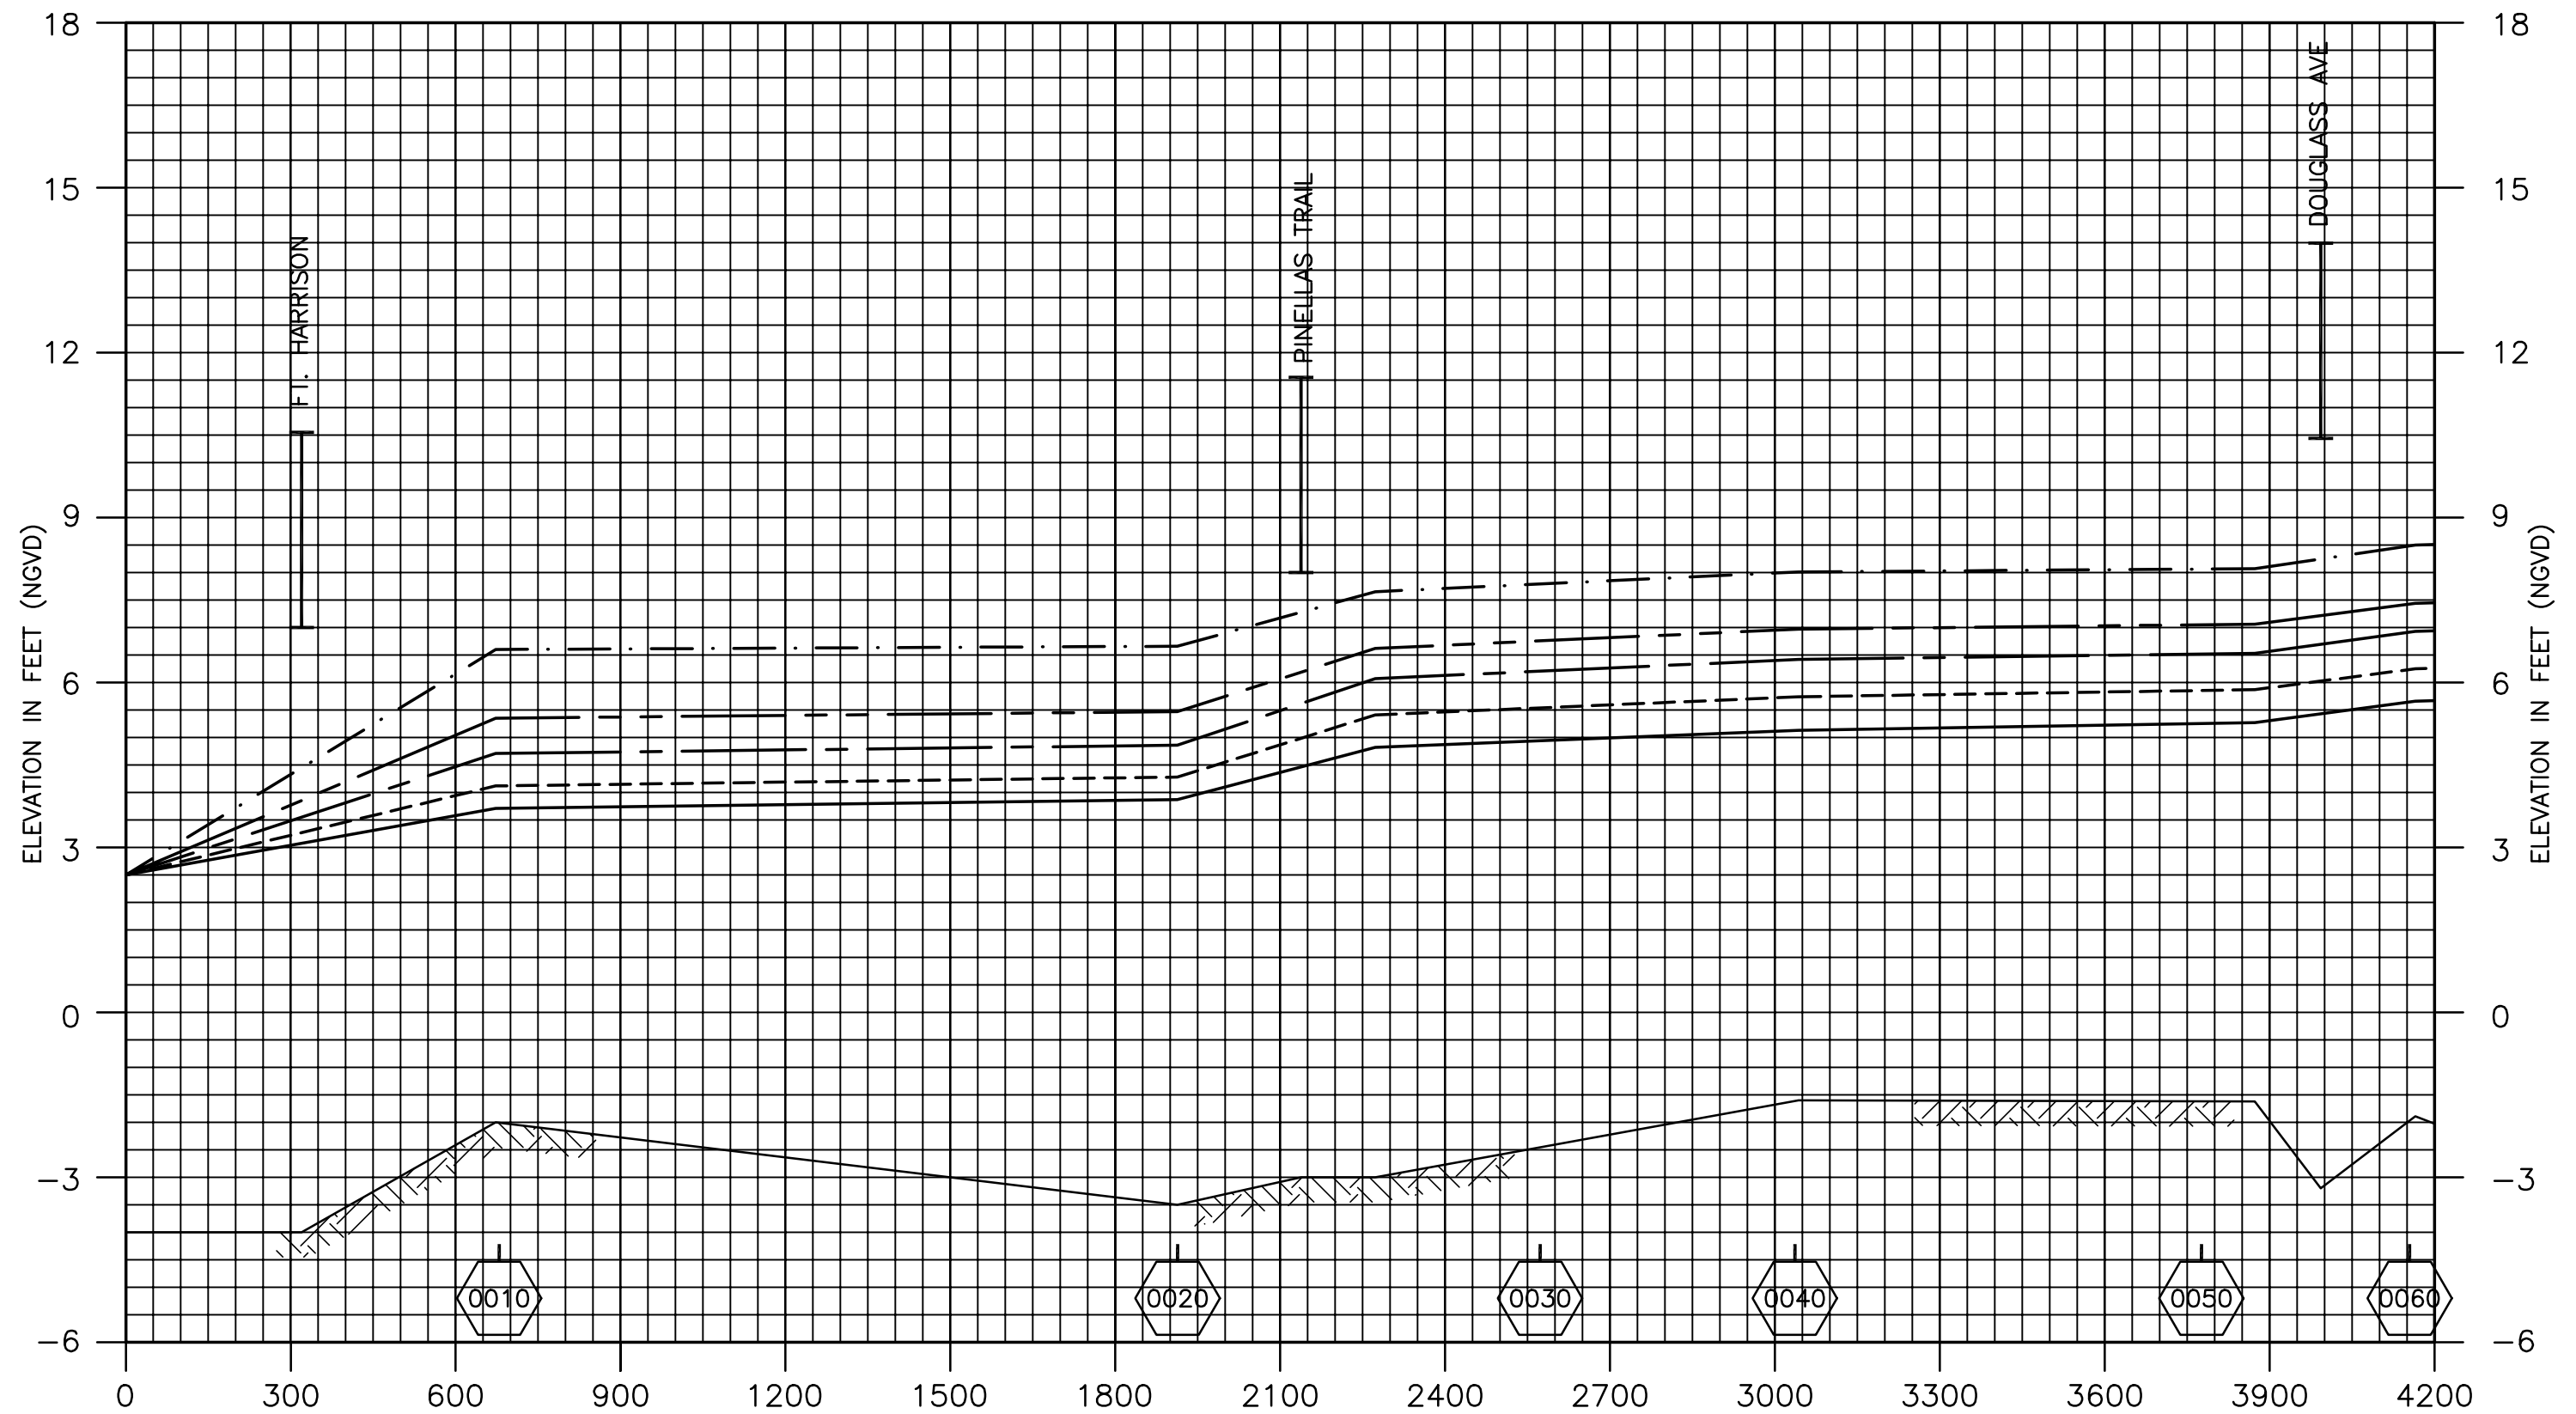
FIGURE 3.1-37
FLOOD PROFILE
PROJECT CONDITIONS
STEVENSON CREEK
CITY OF CLEARWATER, FL
PARSONS ENGINEERING SCIENCE, INC.

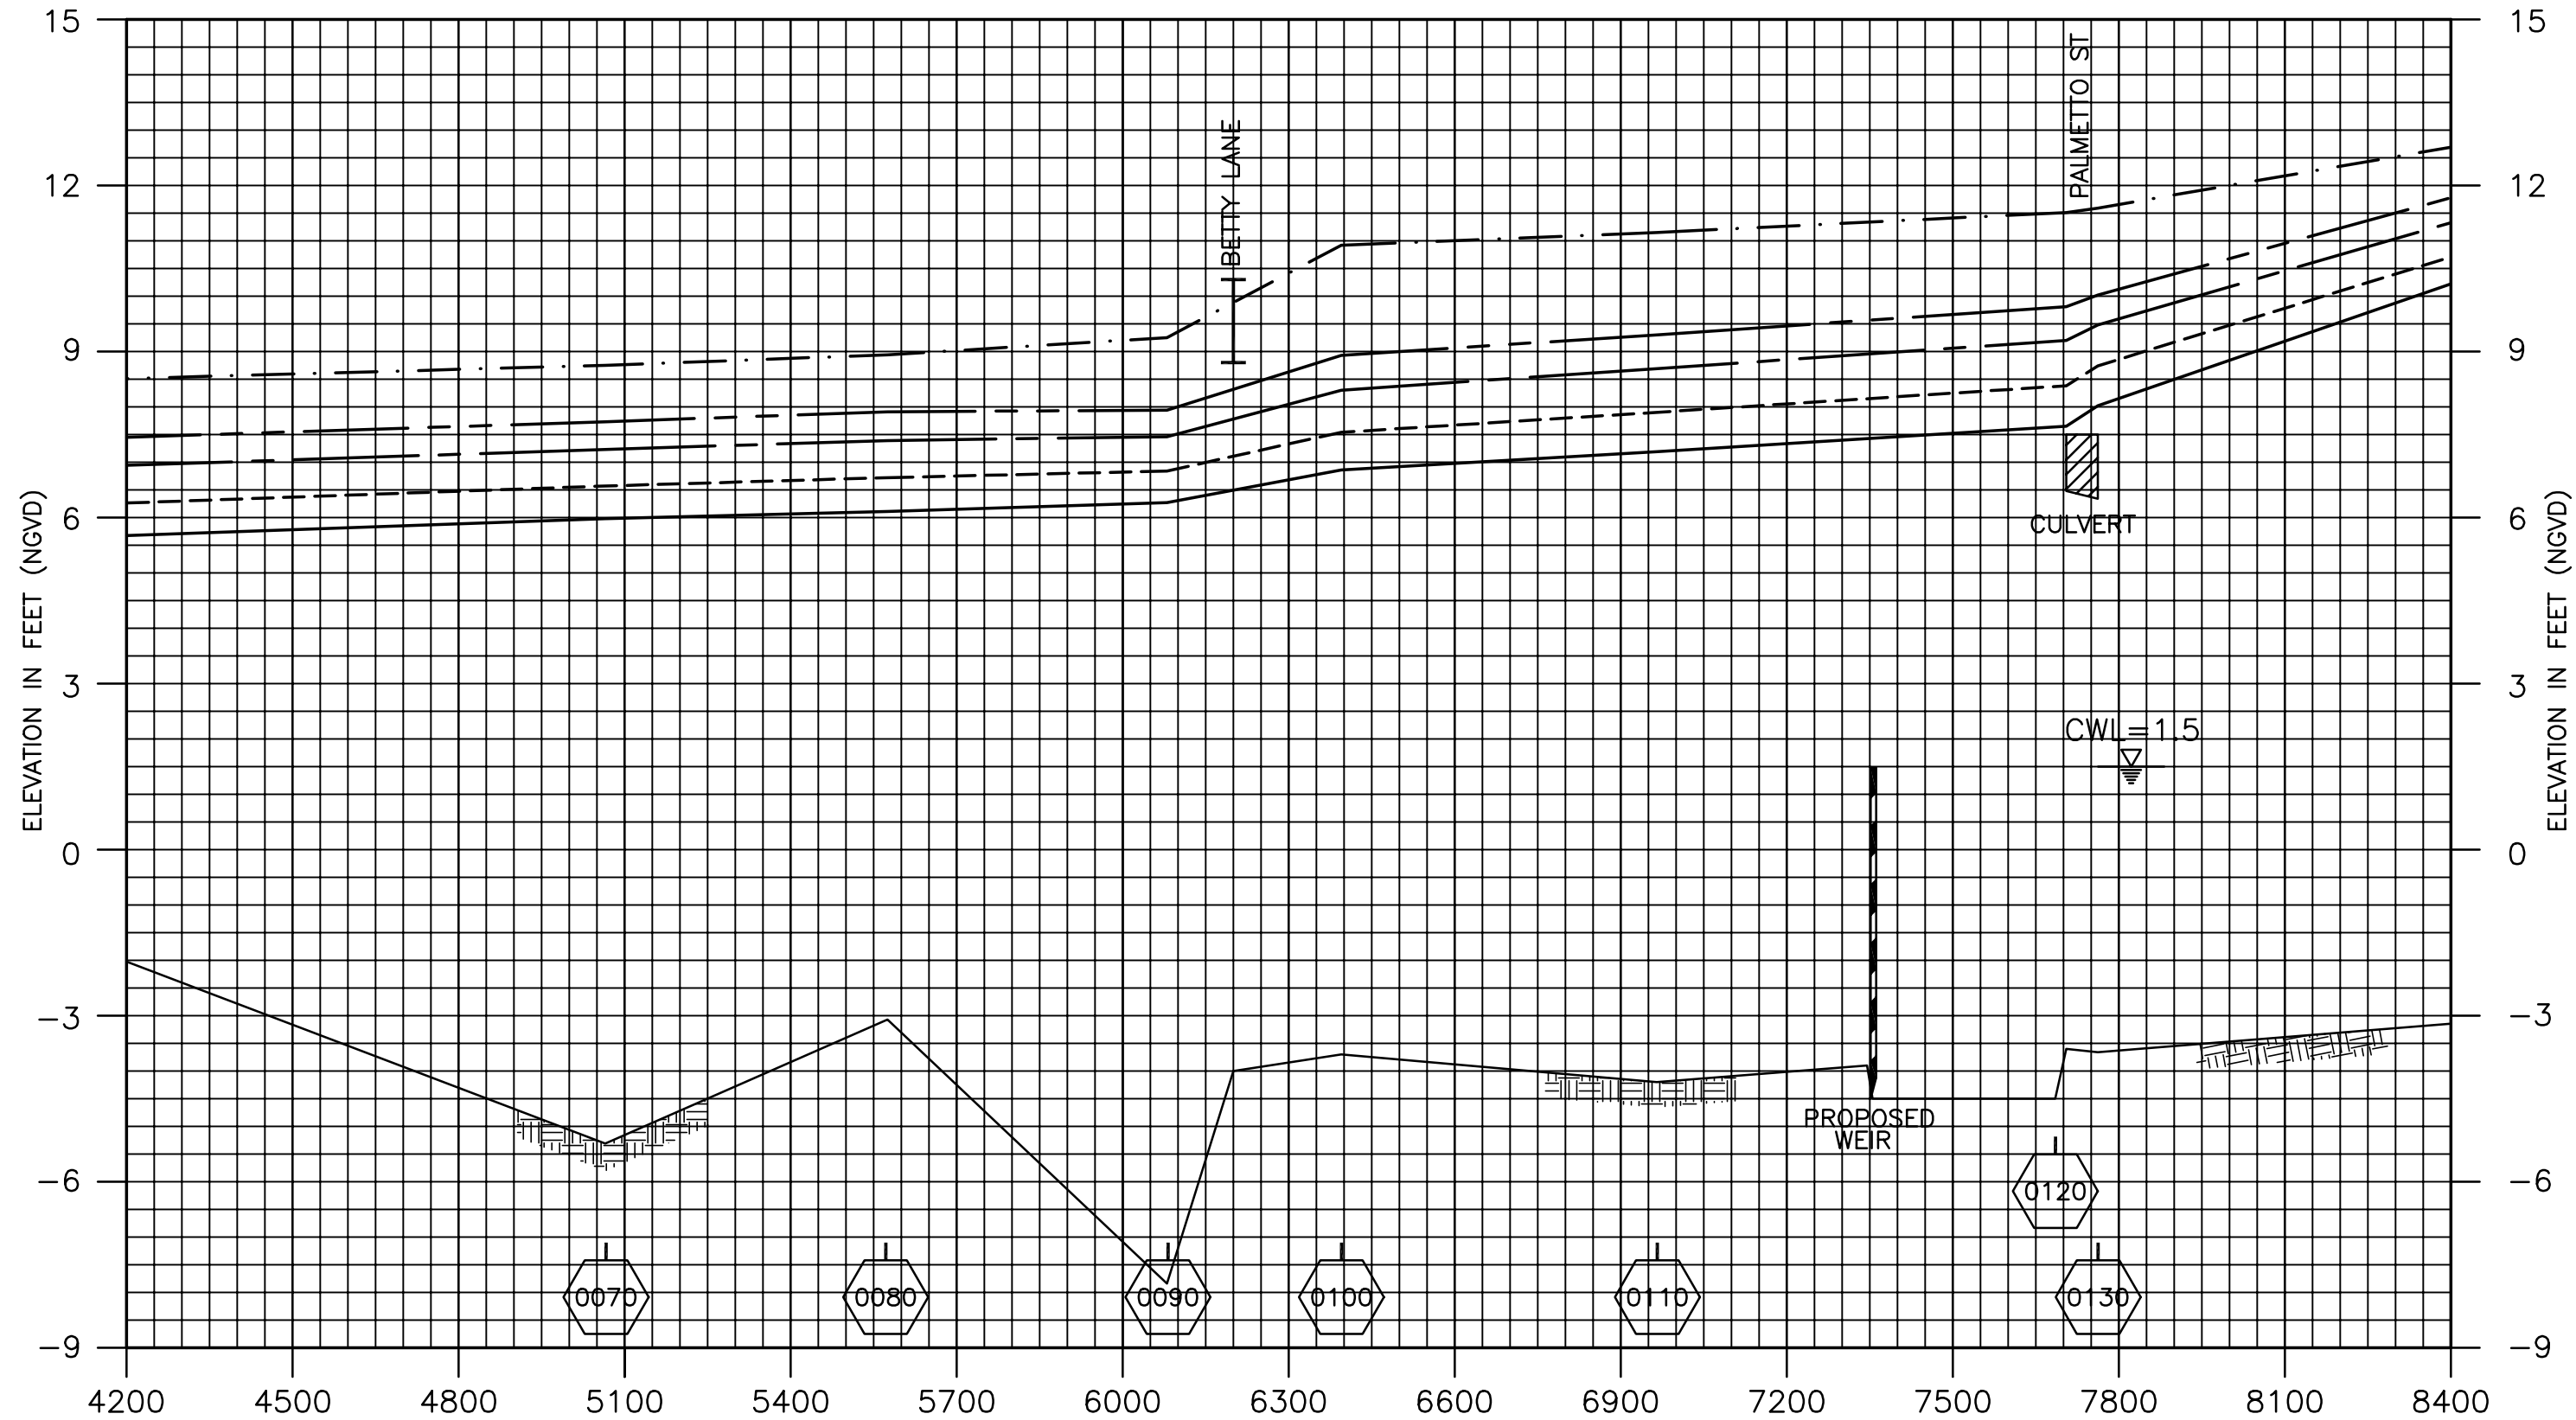
FIGURE 3.1-38
FLOOD PROFILE
PROJECT CONDITIONS
STEVENSON CREEK
CITY OF CLEARWATER, FL
PARSONS ENGINEERING SCIENCE, INC.
