STEVENSON CREEK WATERSHED MANAGEMENT PLAN

FINAL REPORT

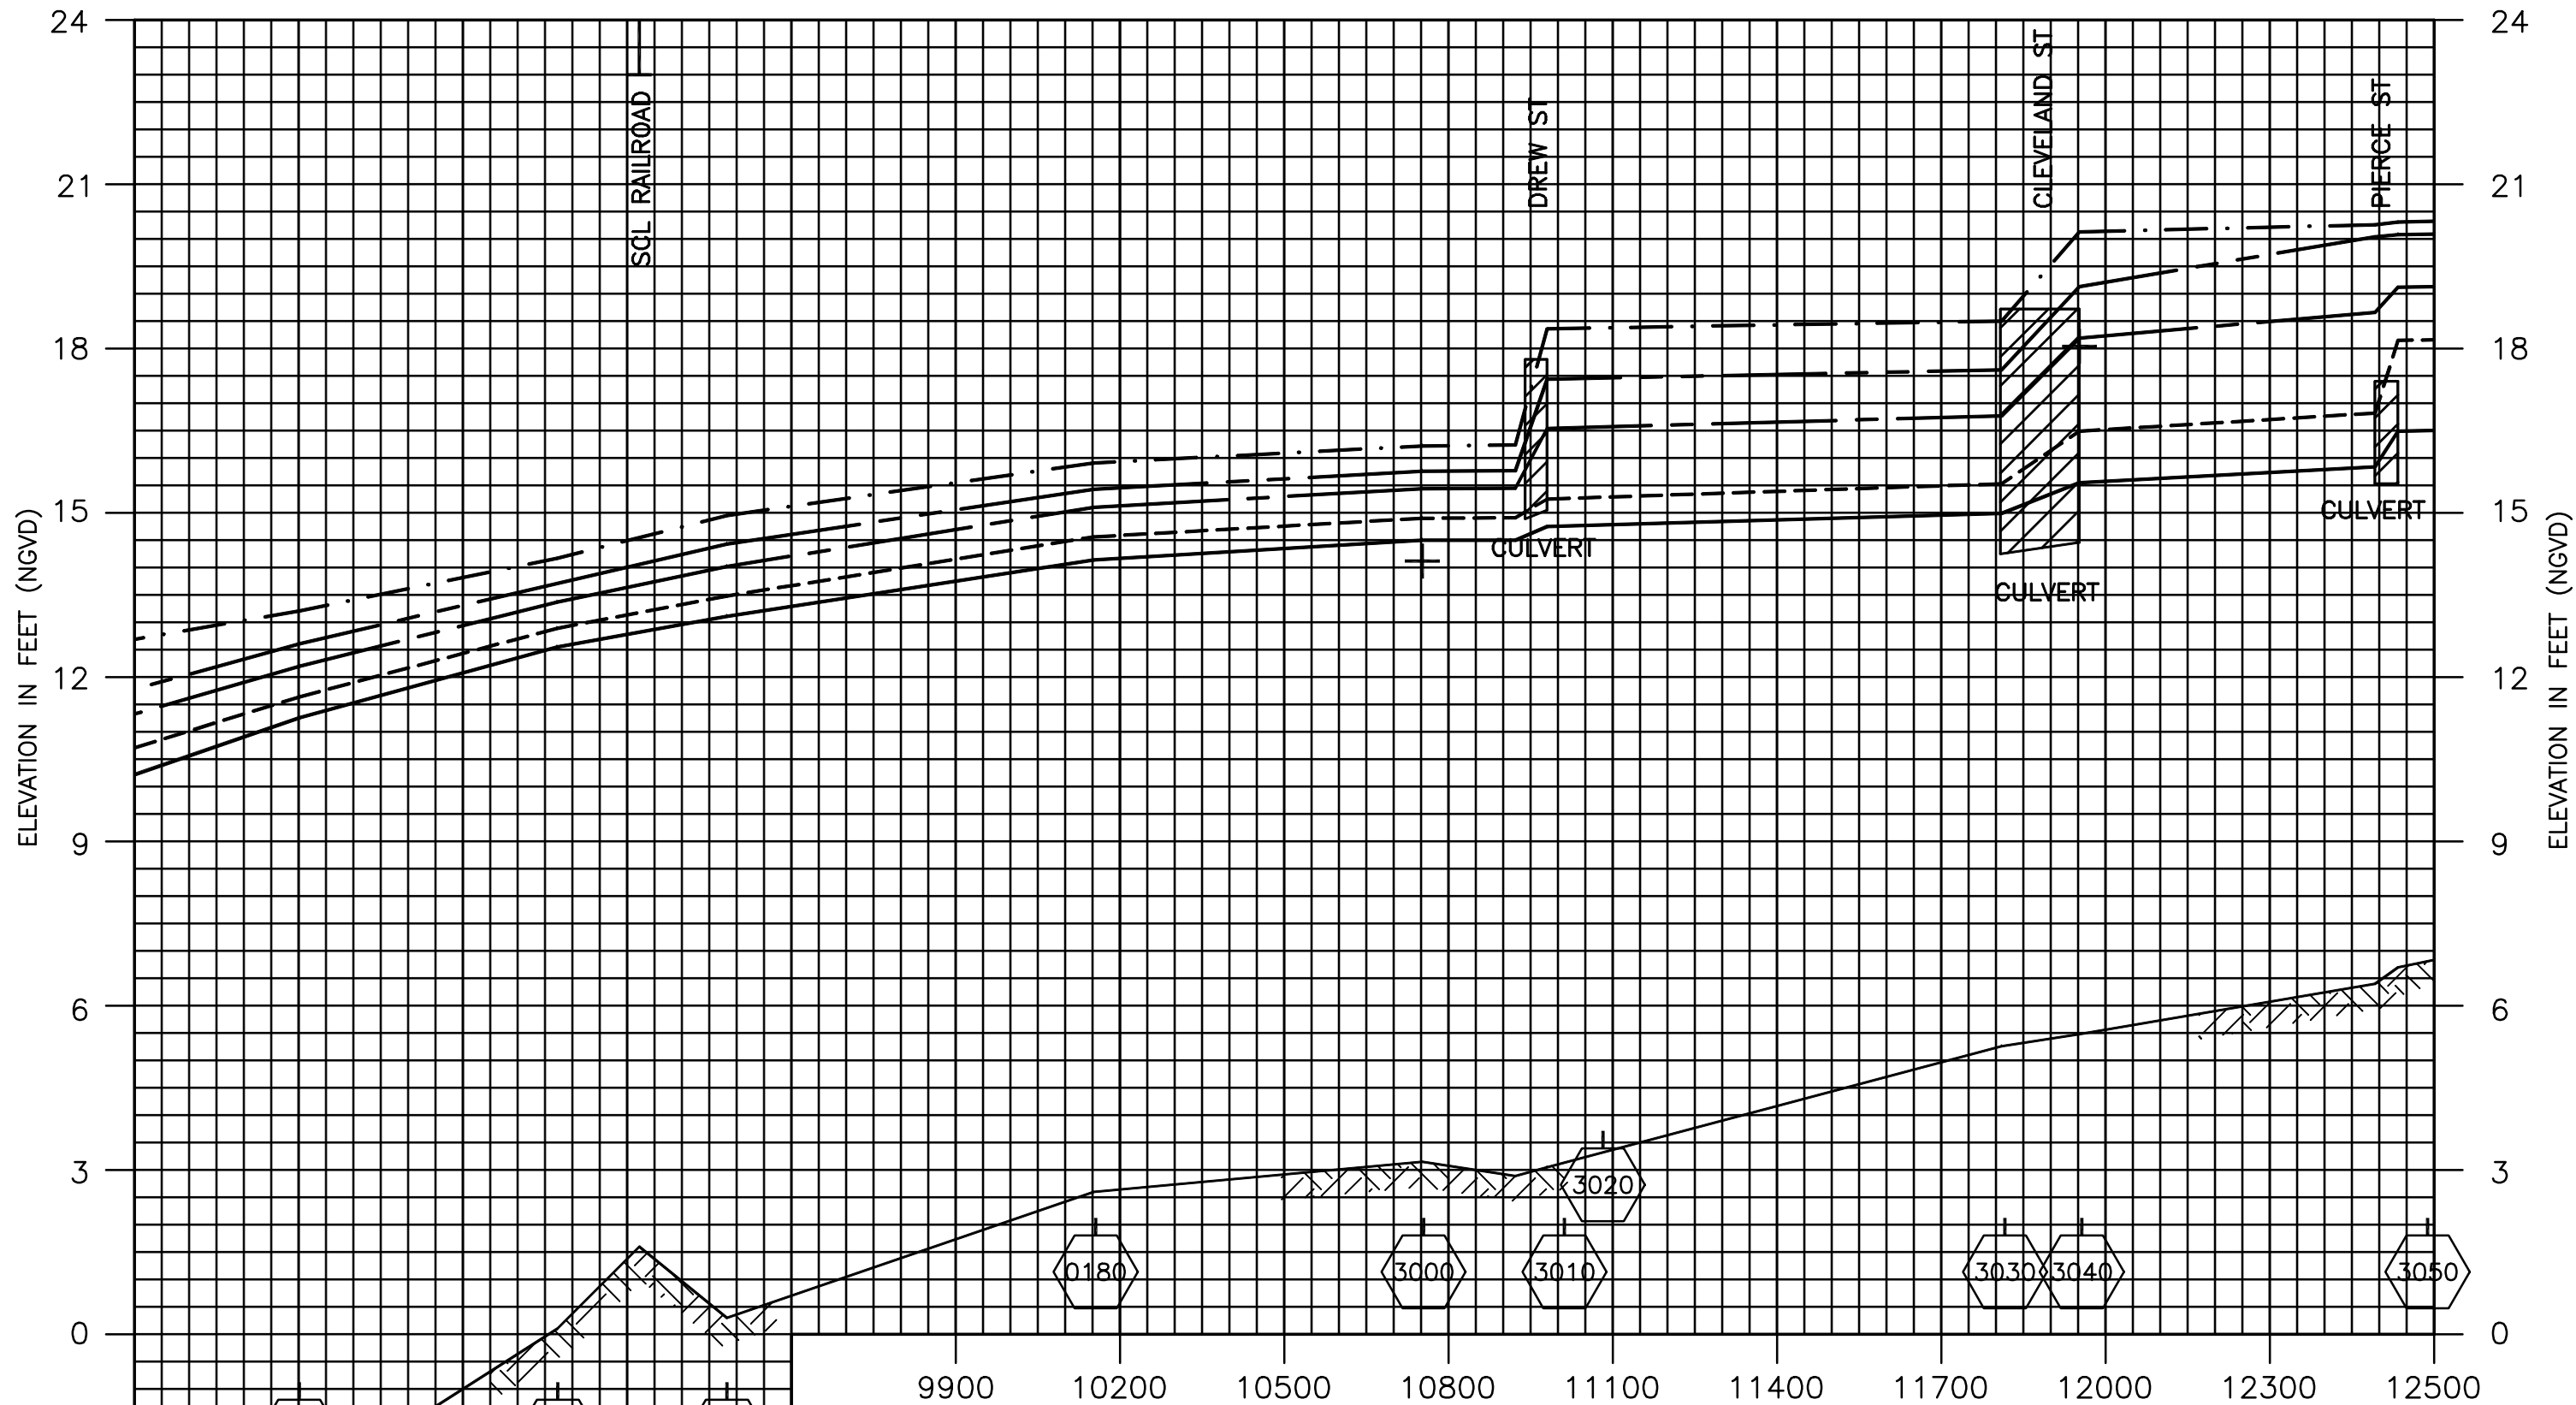
FIGURE 3.1-39
FLOOD PROFILE
PROJECT CONDITIONS
STEVENSON CREEK
CITY OF CLEARWATER, FL
PARSONS ENGINEERING SCIENCE, INC.

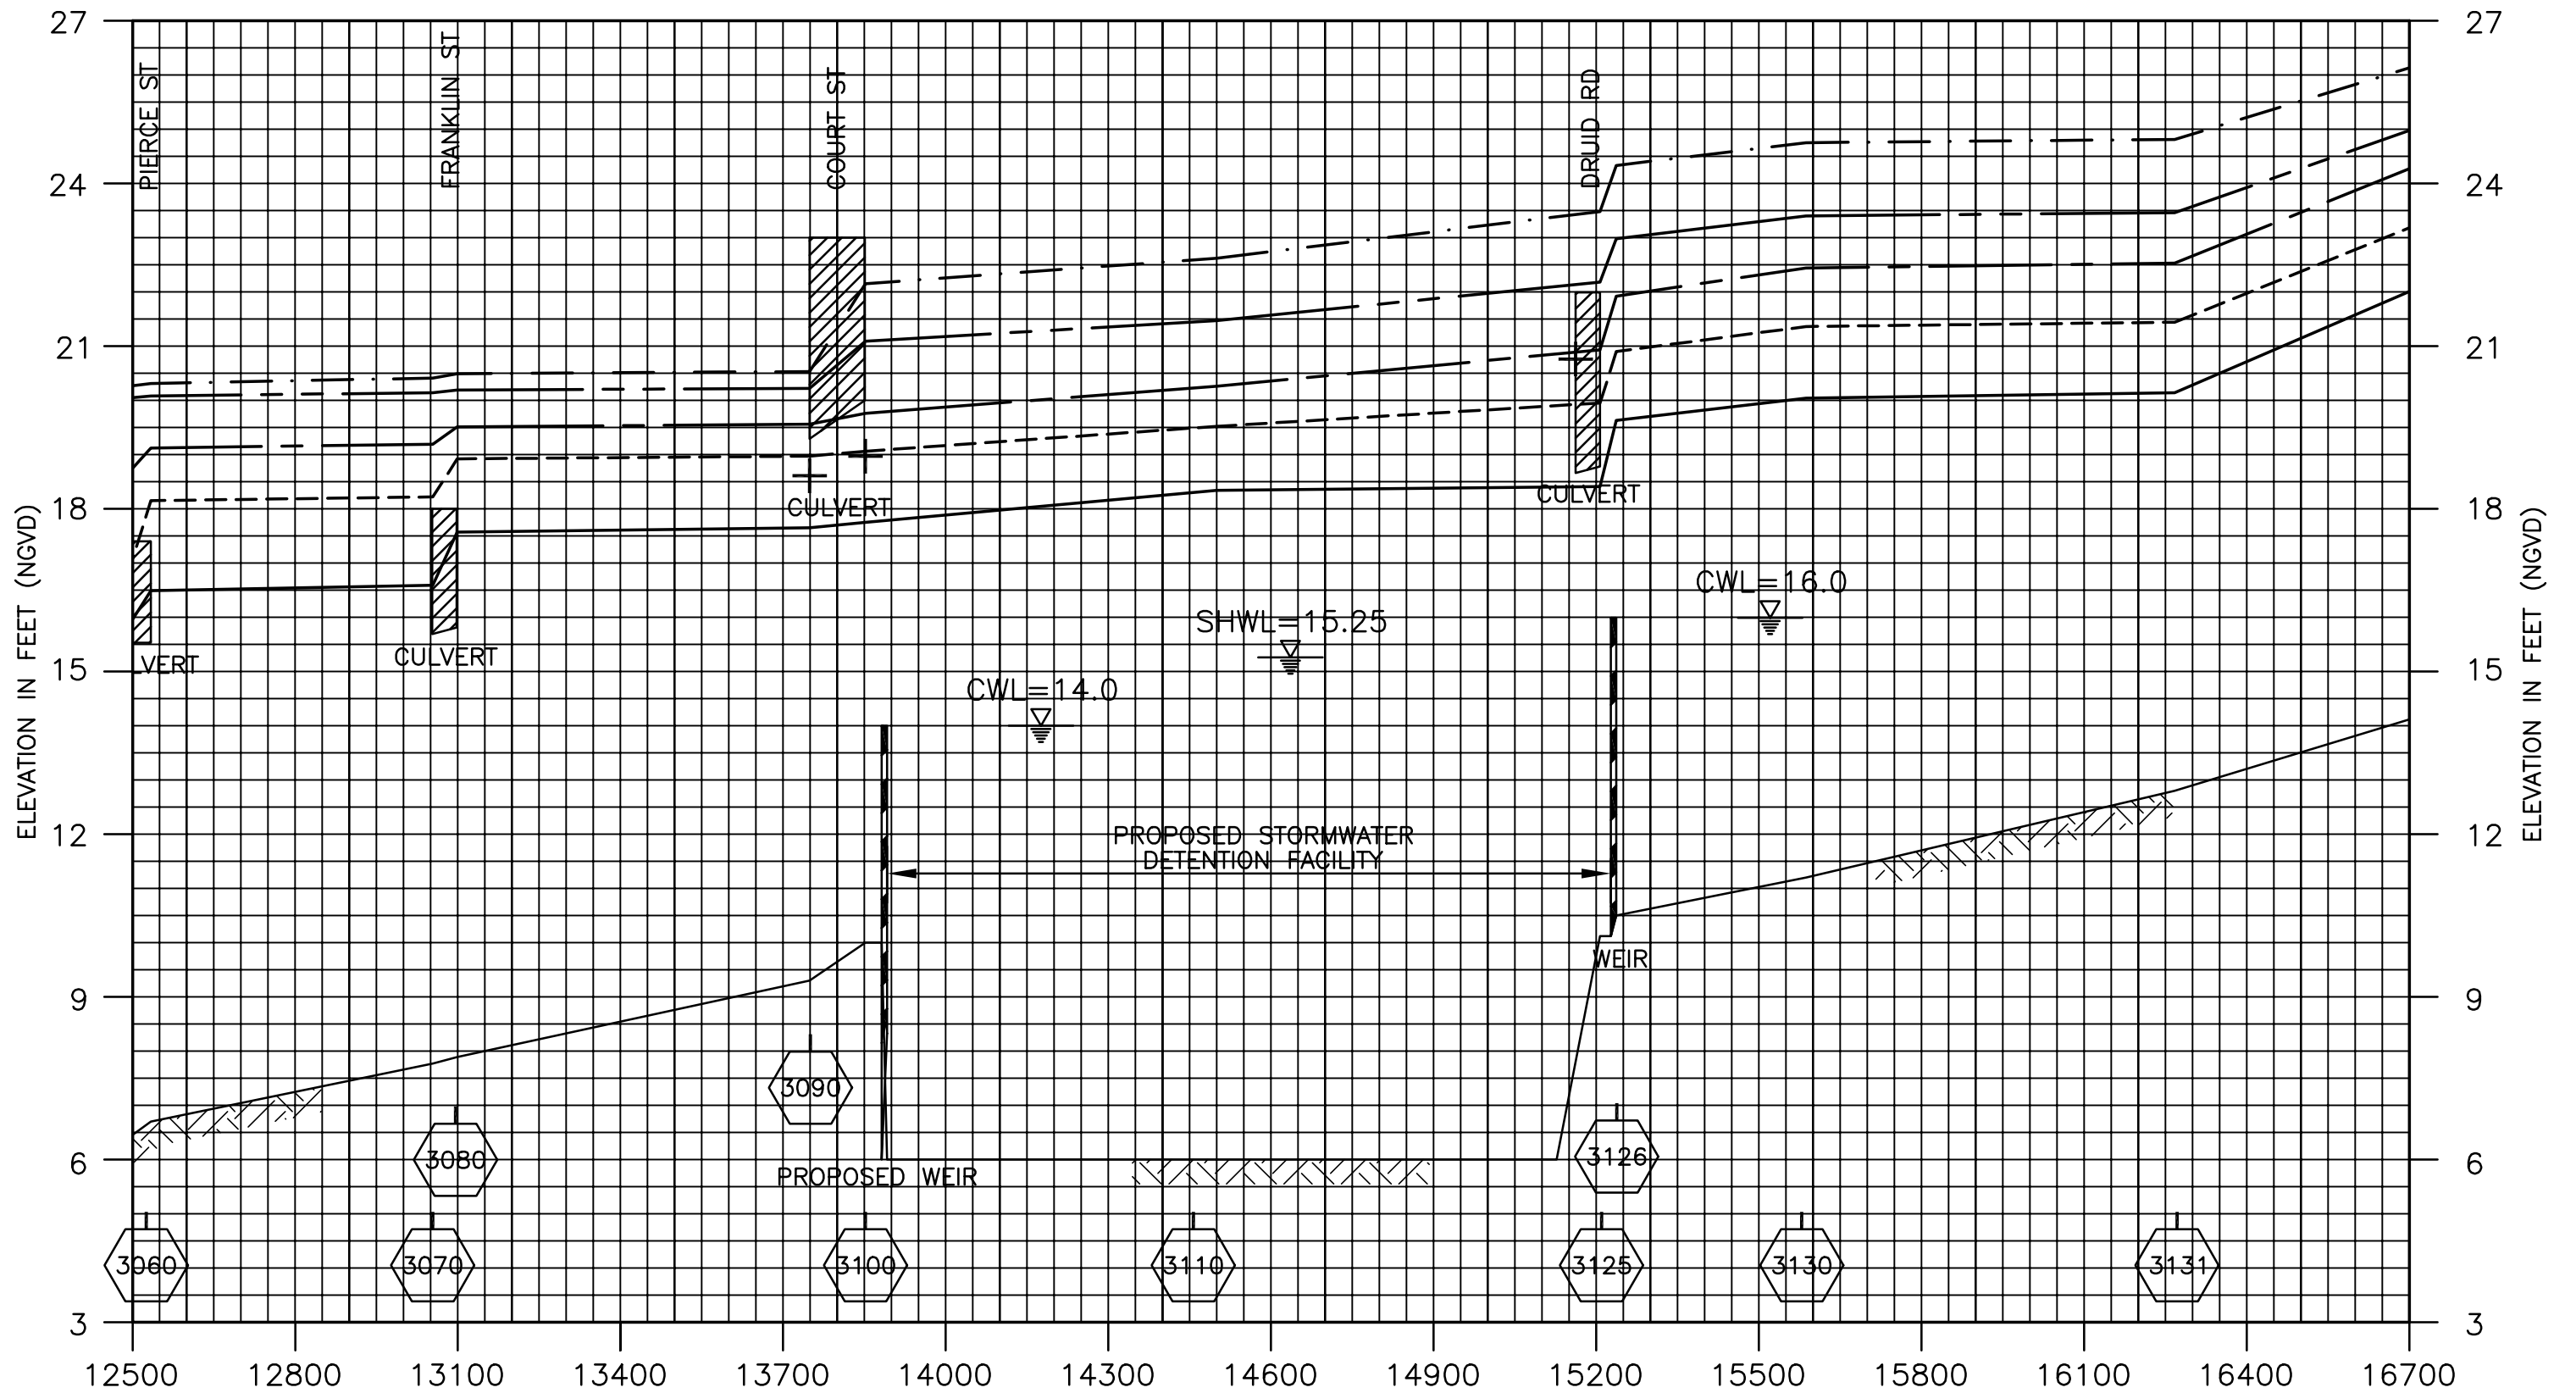
FIGURE 3.1-40
FLOOD PROFILE
PROJECT CONDITIONS
STEVENSON CREEK
CITY OF CLEARWATER, FL
PARSONS ENGINEERING SCIENCE, INC.

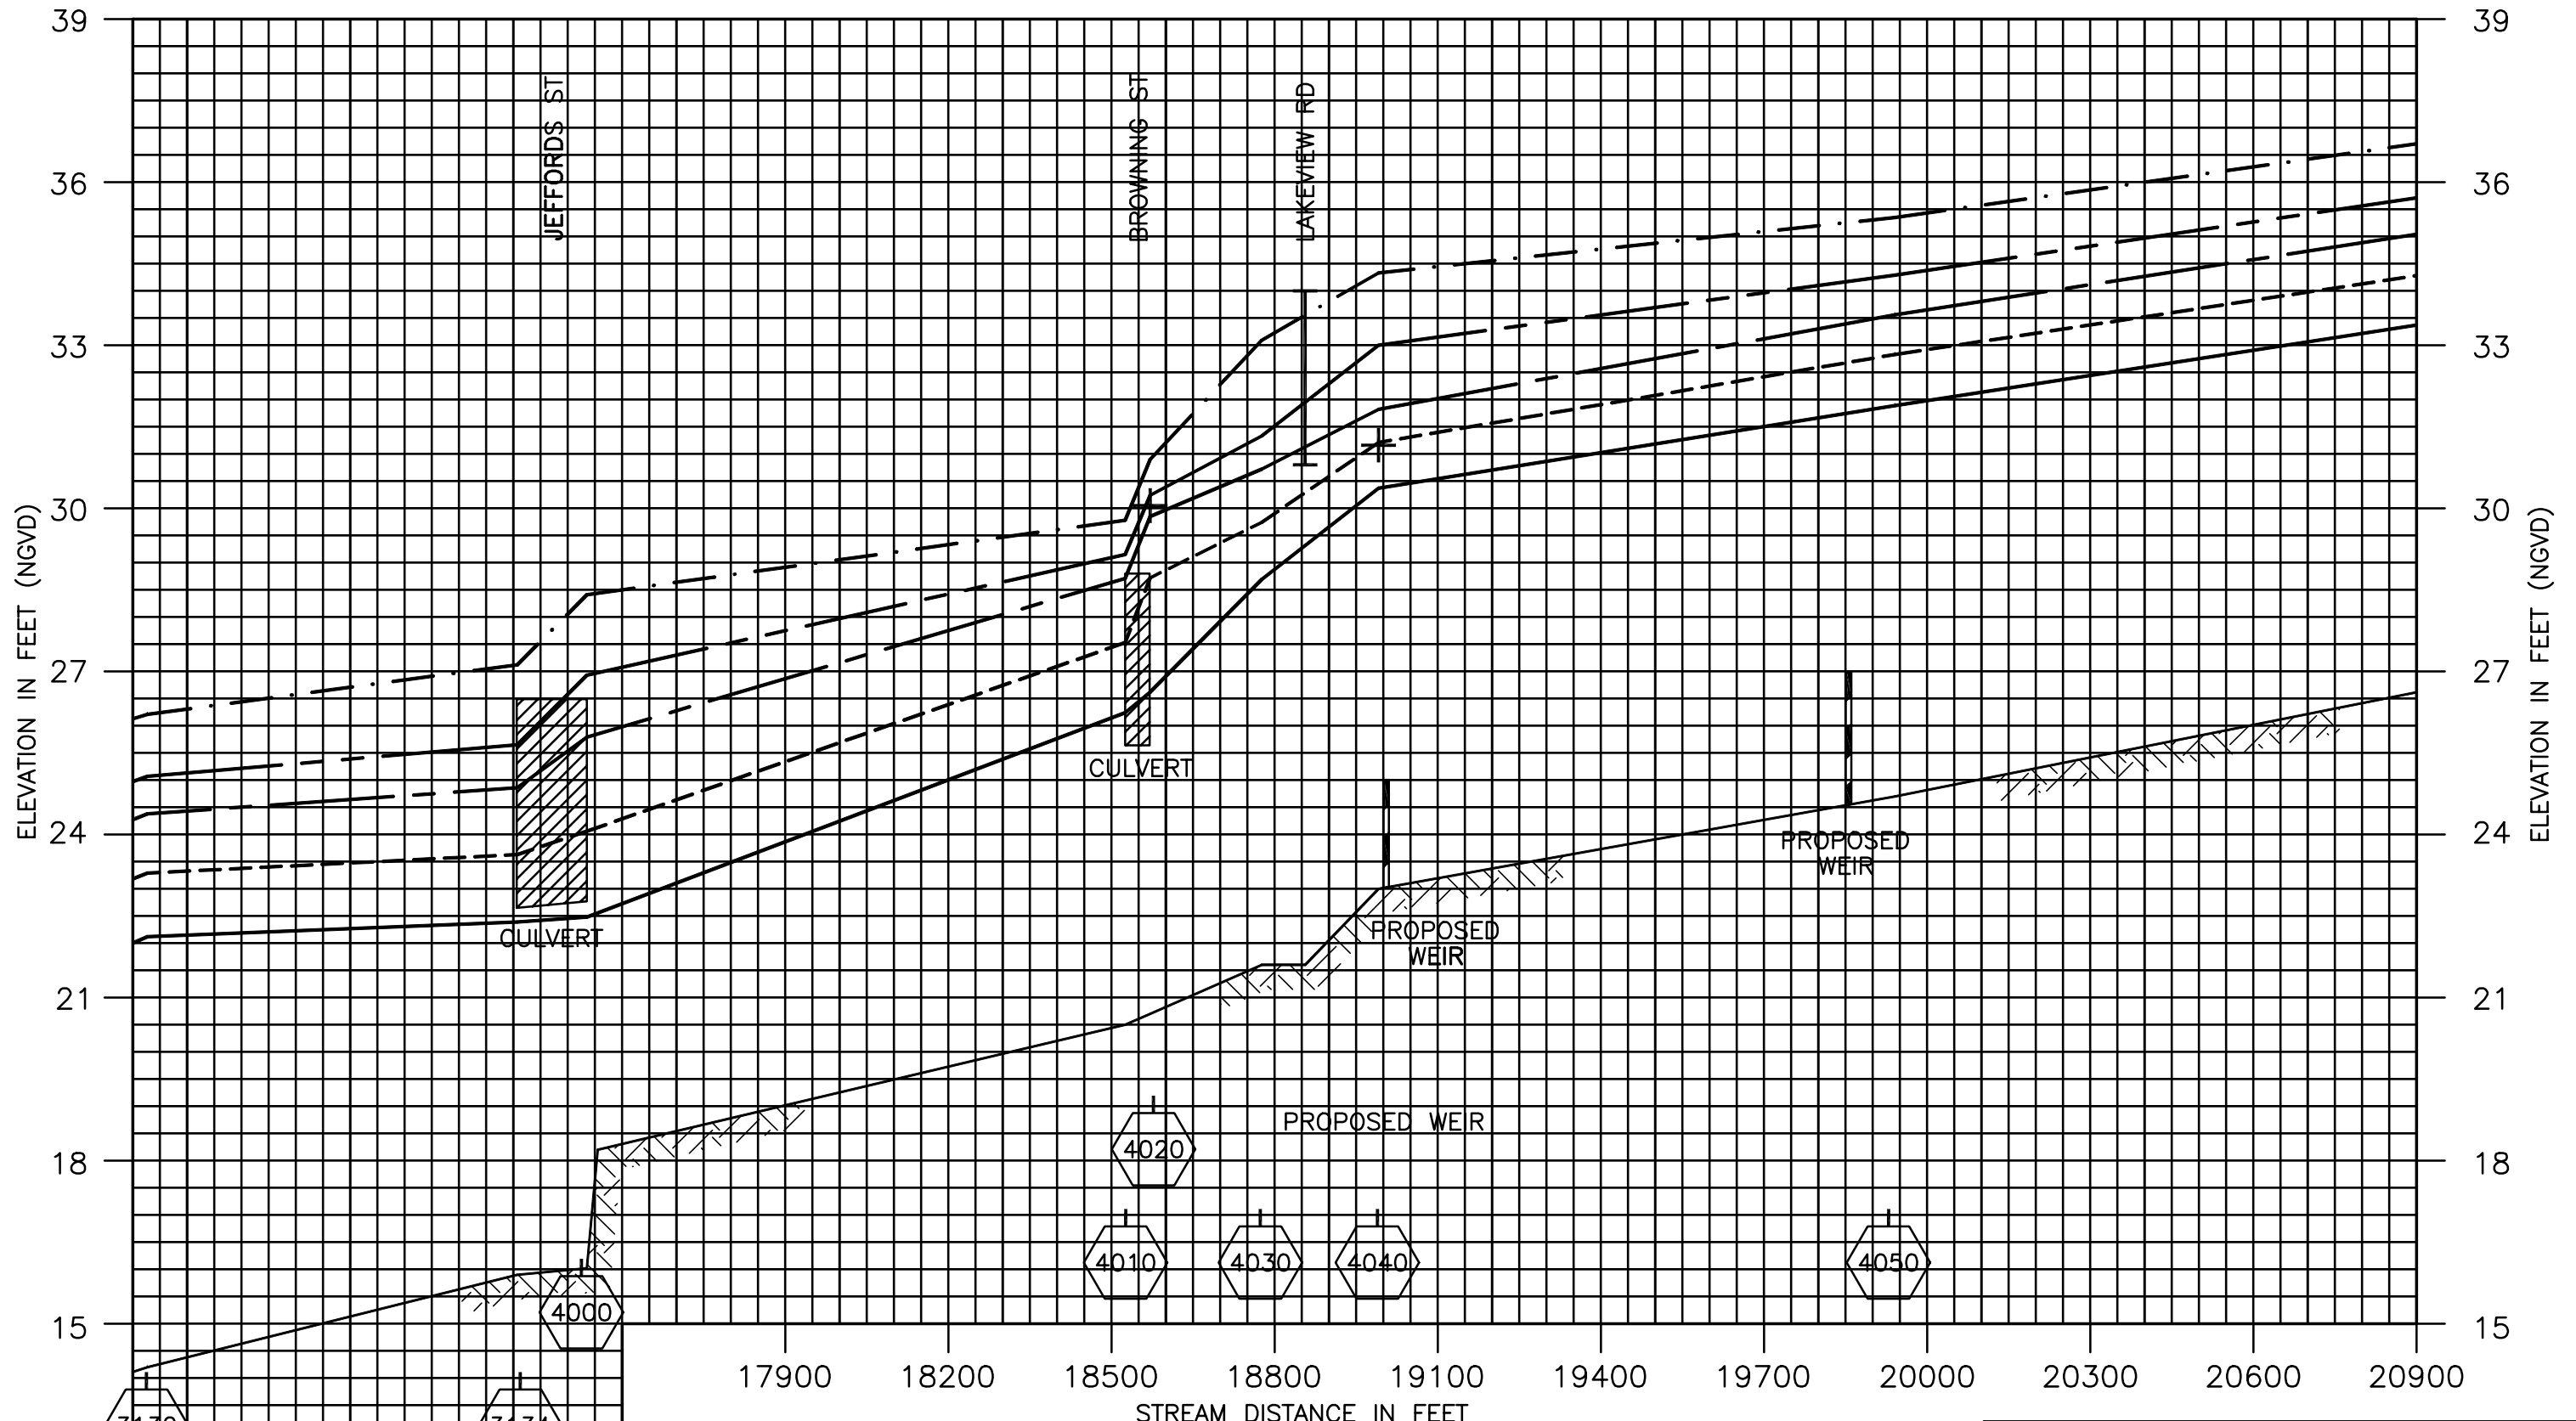
FIGURE 3.1-41
FLOOD PROFILE
PROJECT CONDITIONS
STEVENSON CREEK
CITY OF CLEARWATER, FL
PARSONS ENGINEERING SCIENCE, INC.

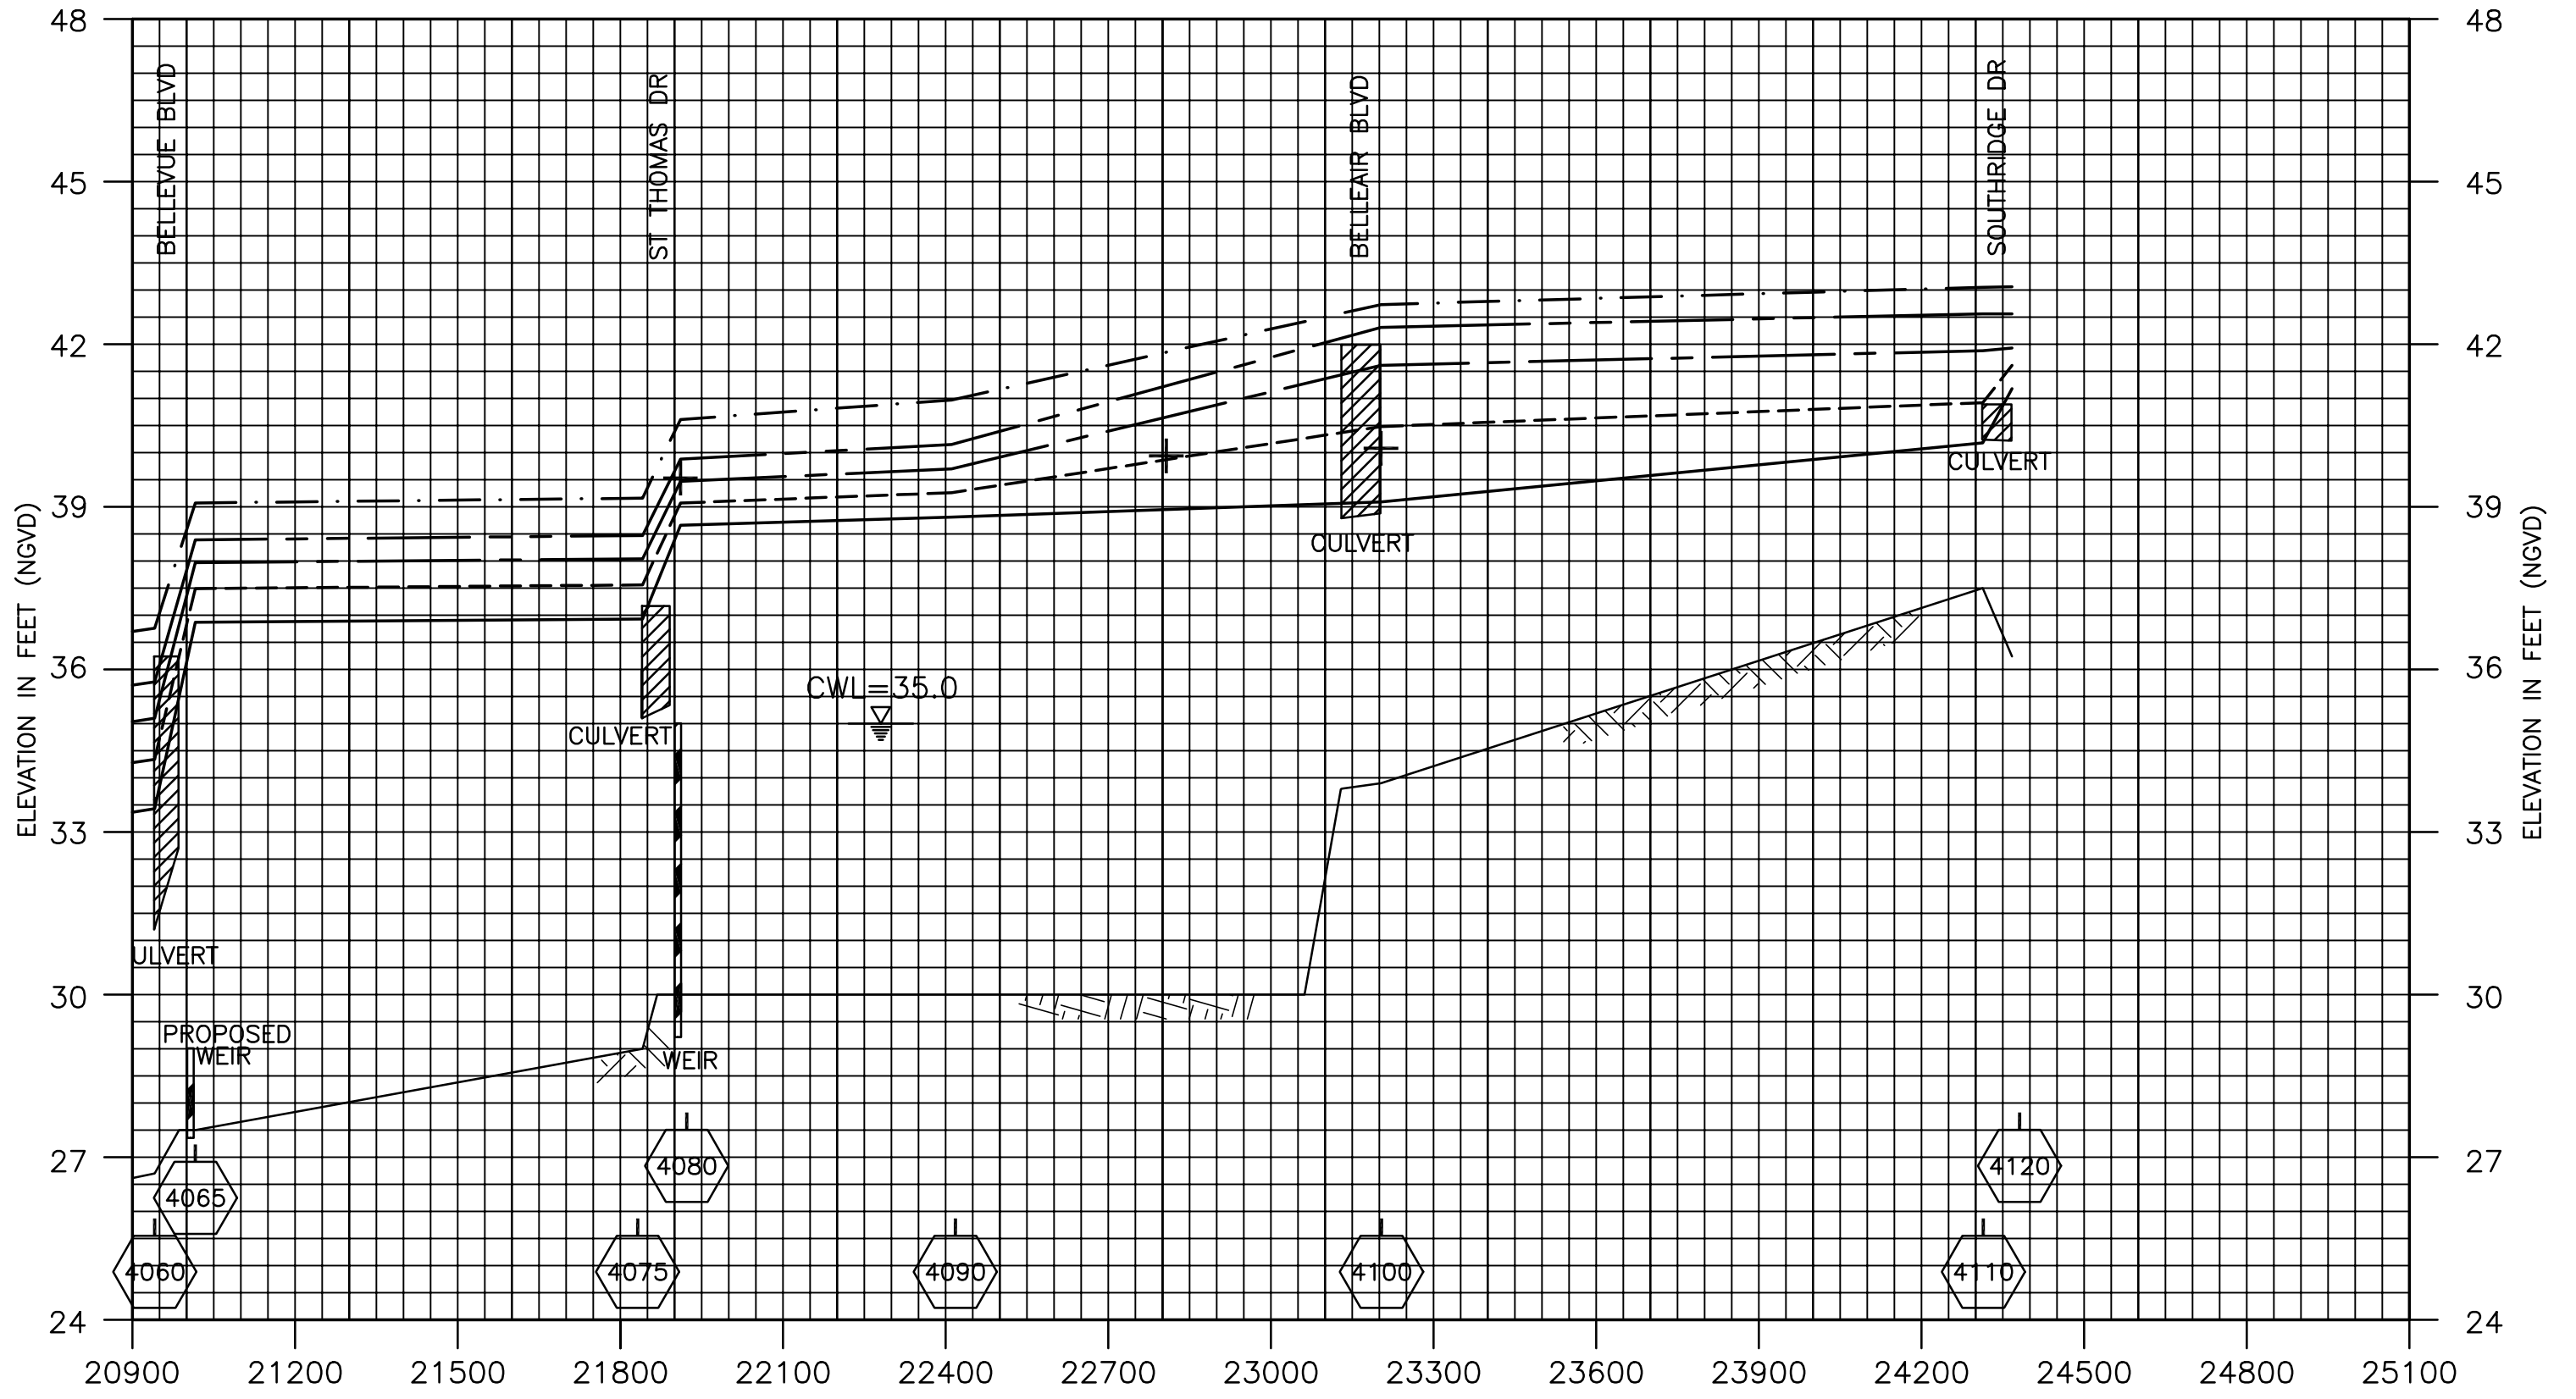
FIGURE 3.1-42
FLOOD PROFILE
PROJECT CONDITIONS
STEVENSON CREEK
CITY OF CLEARWATER, FL
PARSONS ENGINEERING SCIENCE, INC.

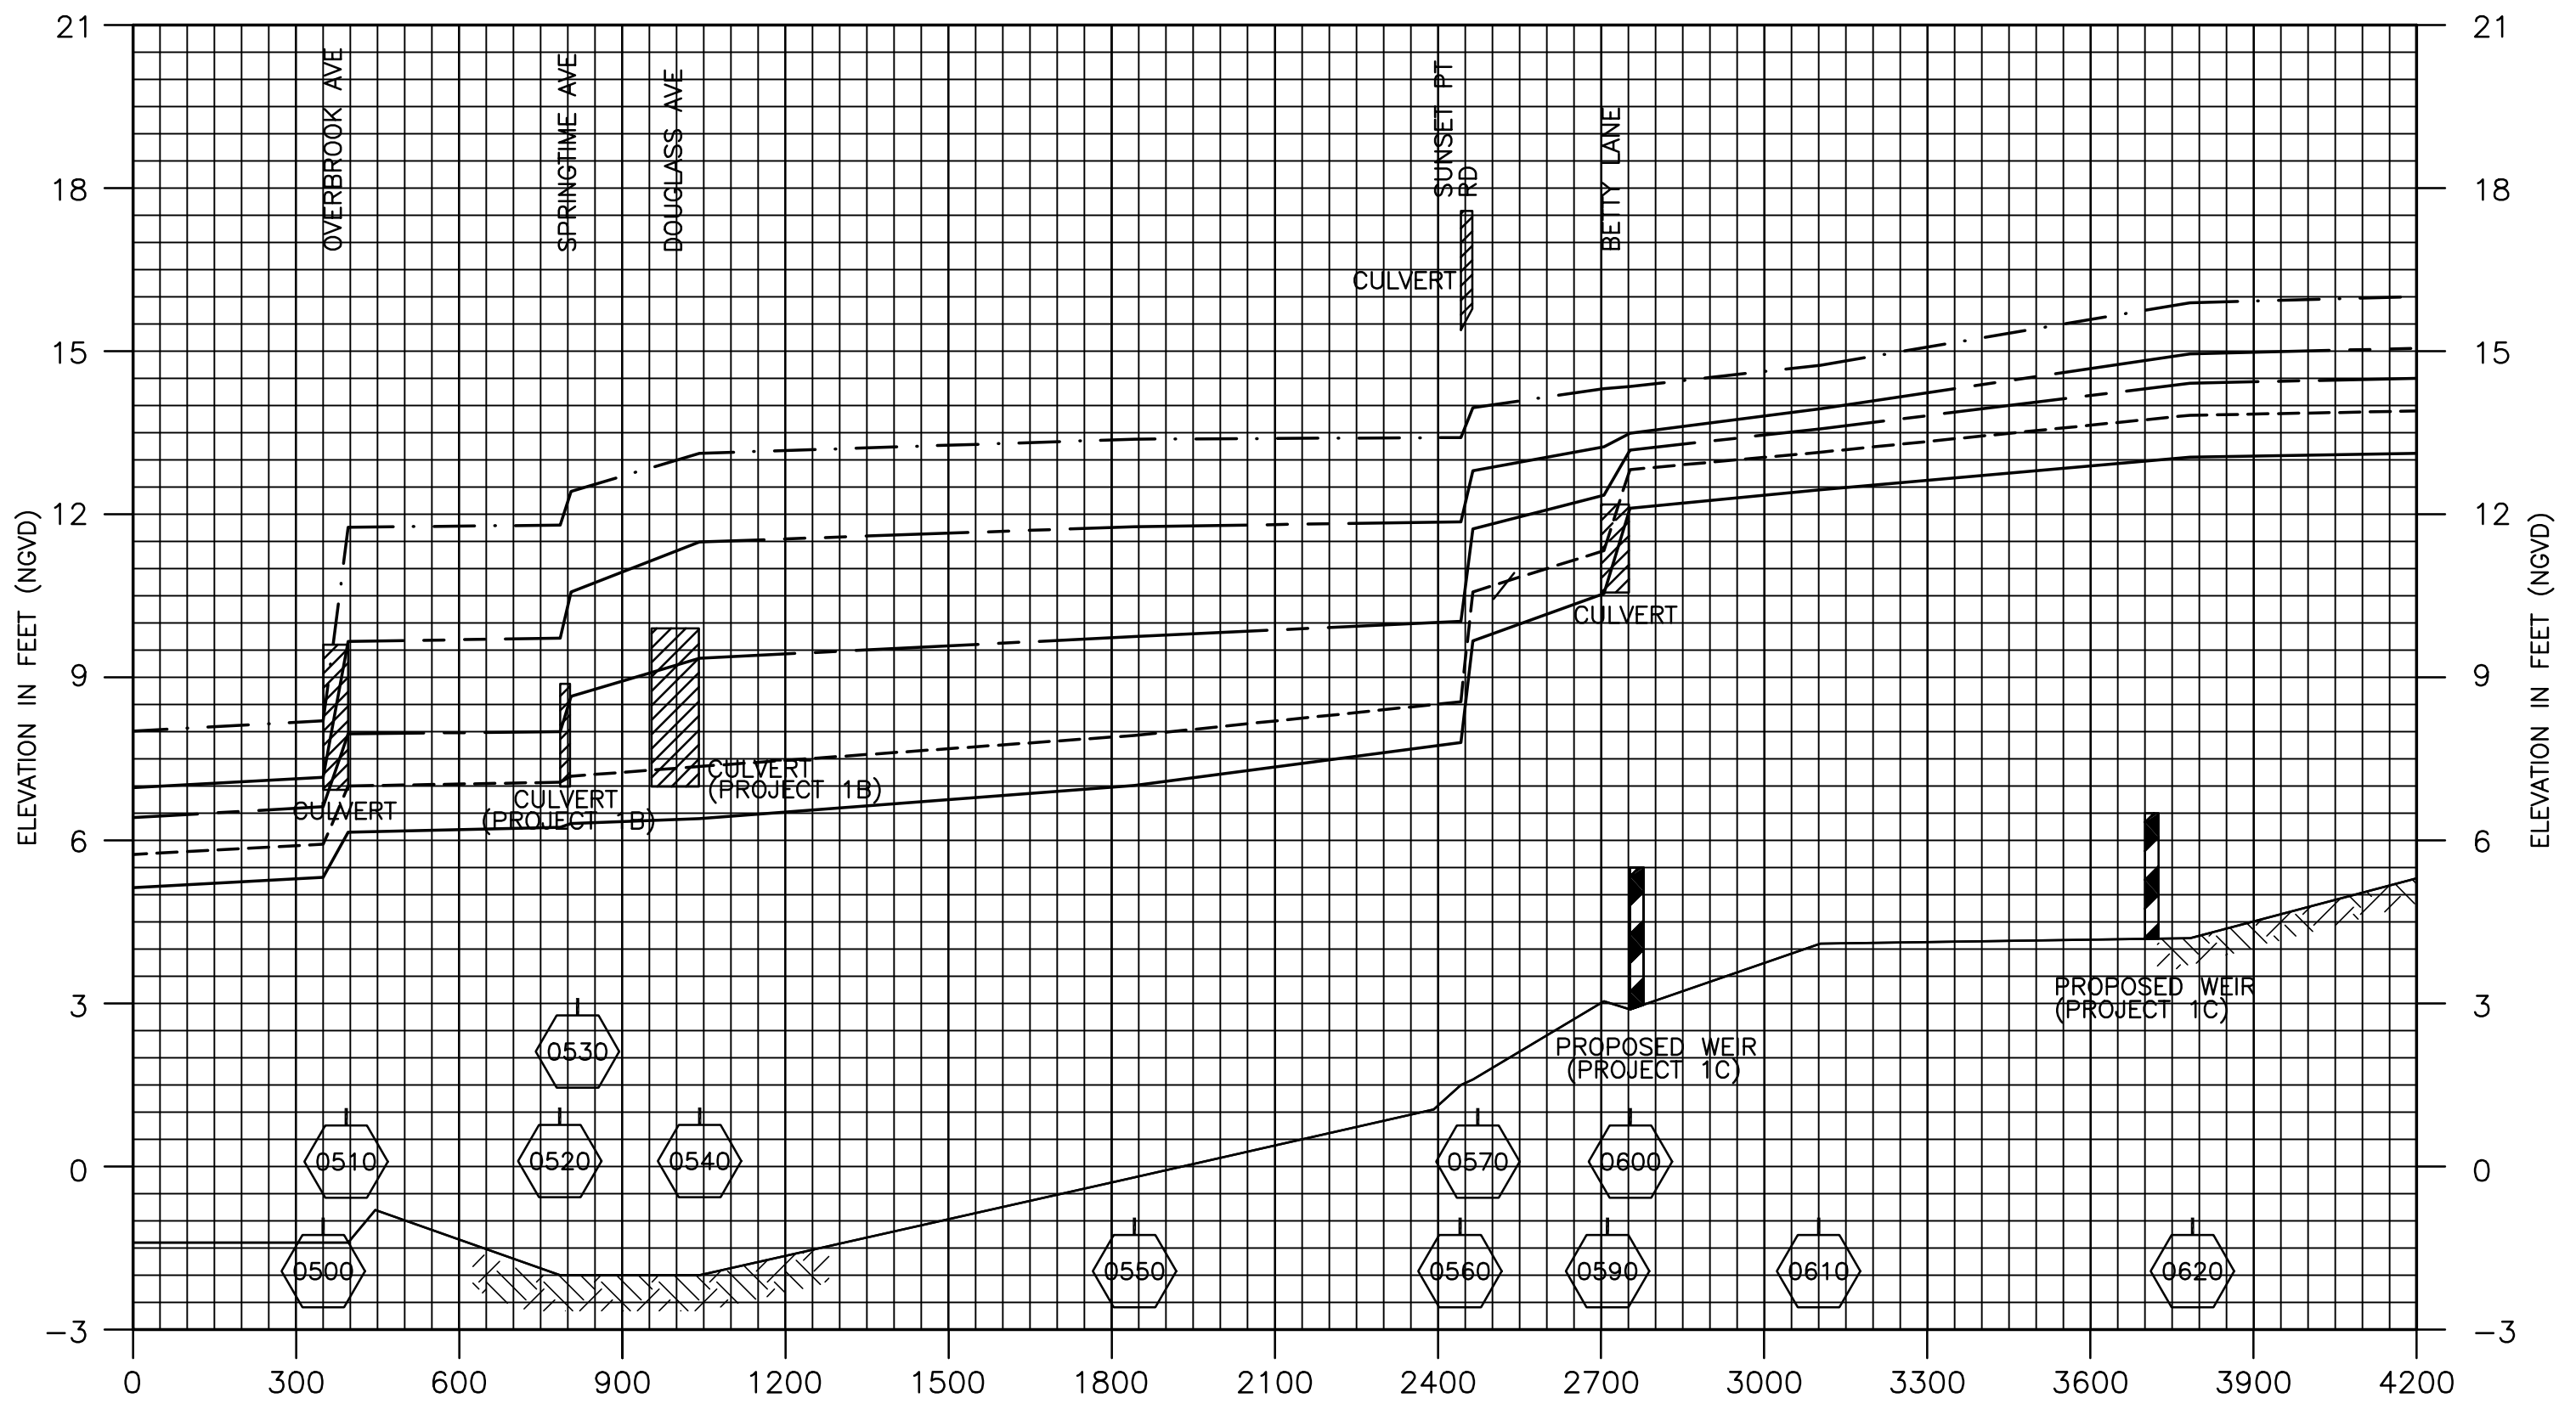
FIGURE 3.1-43
FLOOD PROFILE
PROJECT CONDITIONS
SPRING BRANCH
CITY OF CLEARWATER, FL
PARSONS ENGINEERING SCIENCE, INC.

- STREAM BED
- NODE LOCATION
- HIGH WATER MARK (JULY, 2000 FLOOD)

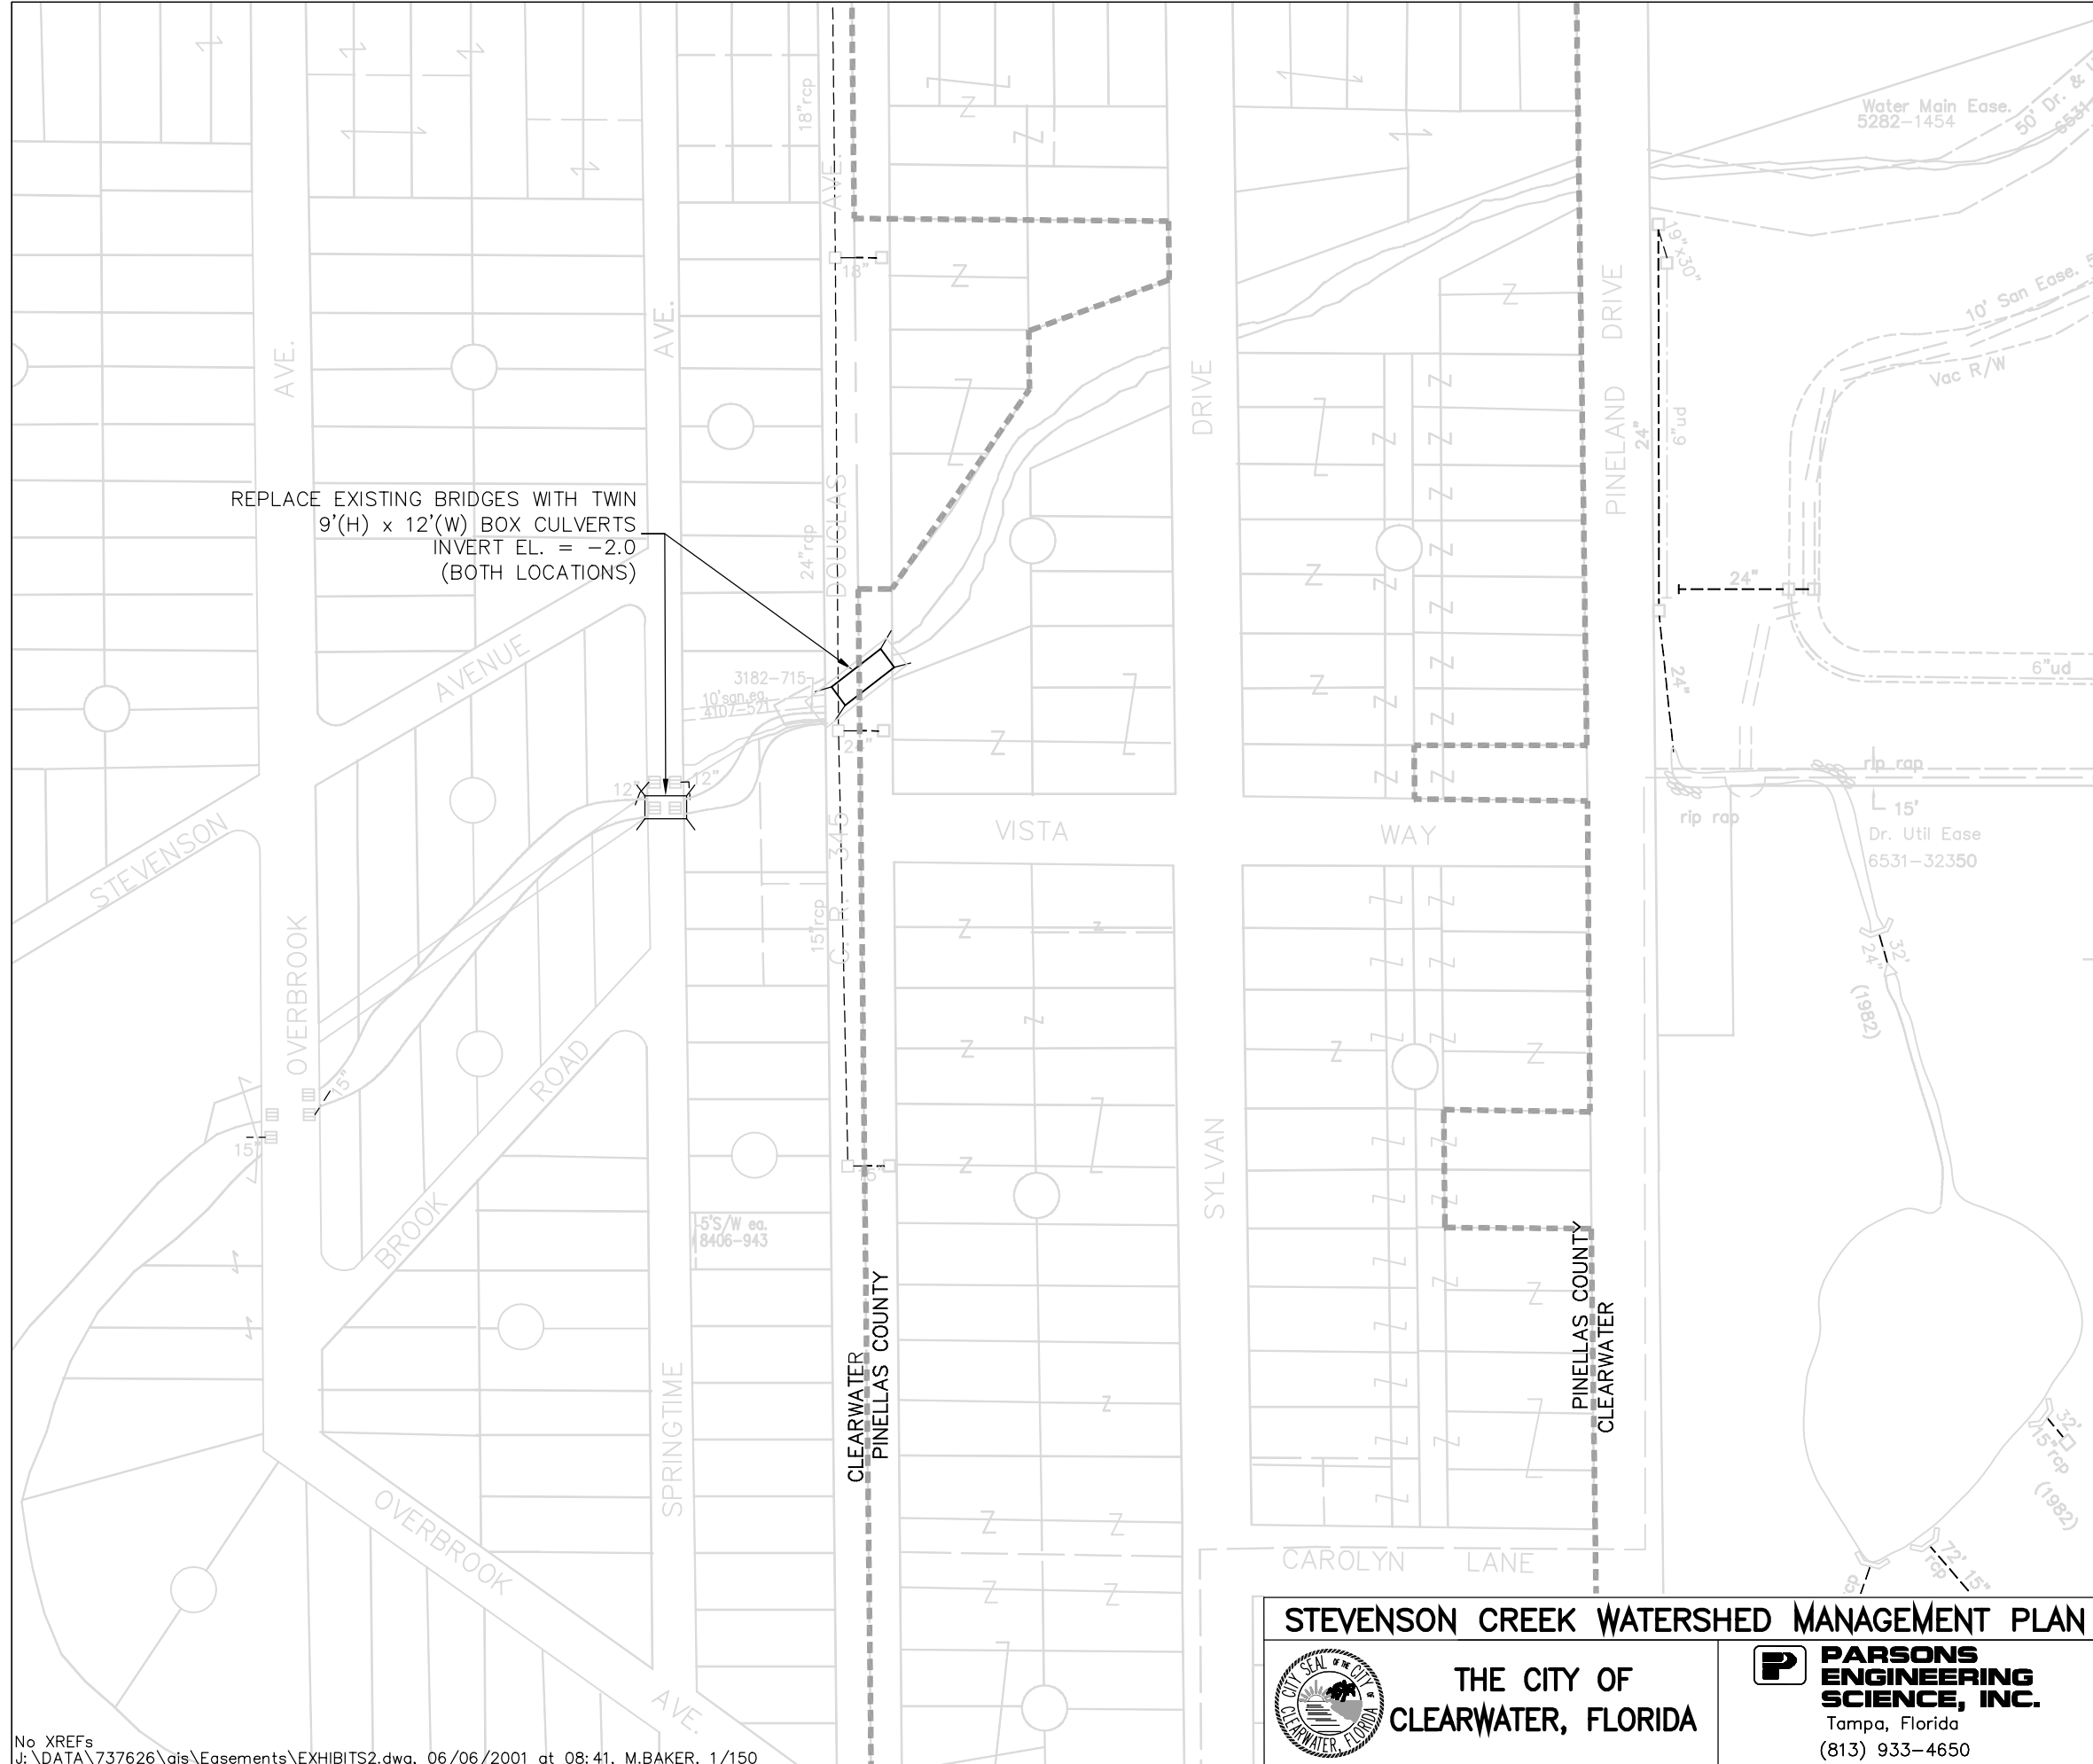
PROJECT 1B REPLACEMENT OF BRIDGES AT SPRINGTIME AVE & DOUGLAS AVE OVER SPRING BRANCH

REPLACE EXISTING BRIDGES WITH TWIN 9'(H) x 12'(W) BOX CULVERTS INVERT EL. = -2.0 (BOTH LOCATIONS)
