STEVENSON CREEK WATERSHED MANAGEMENT PLAN

FINAL REPORT

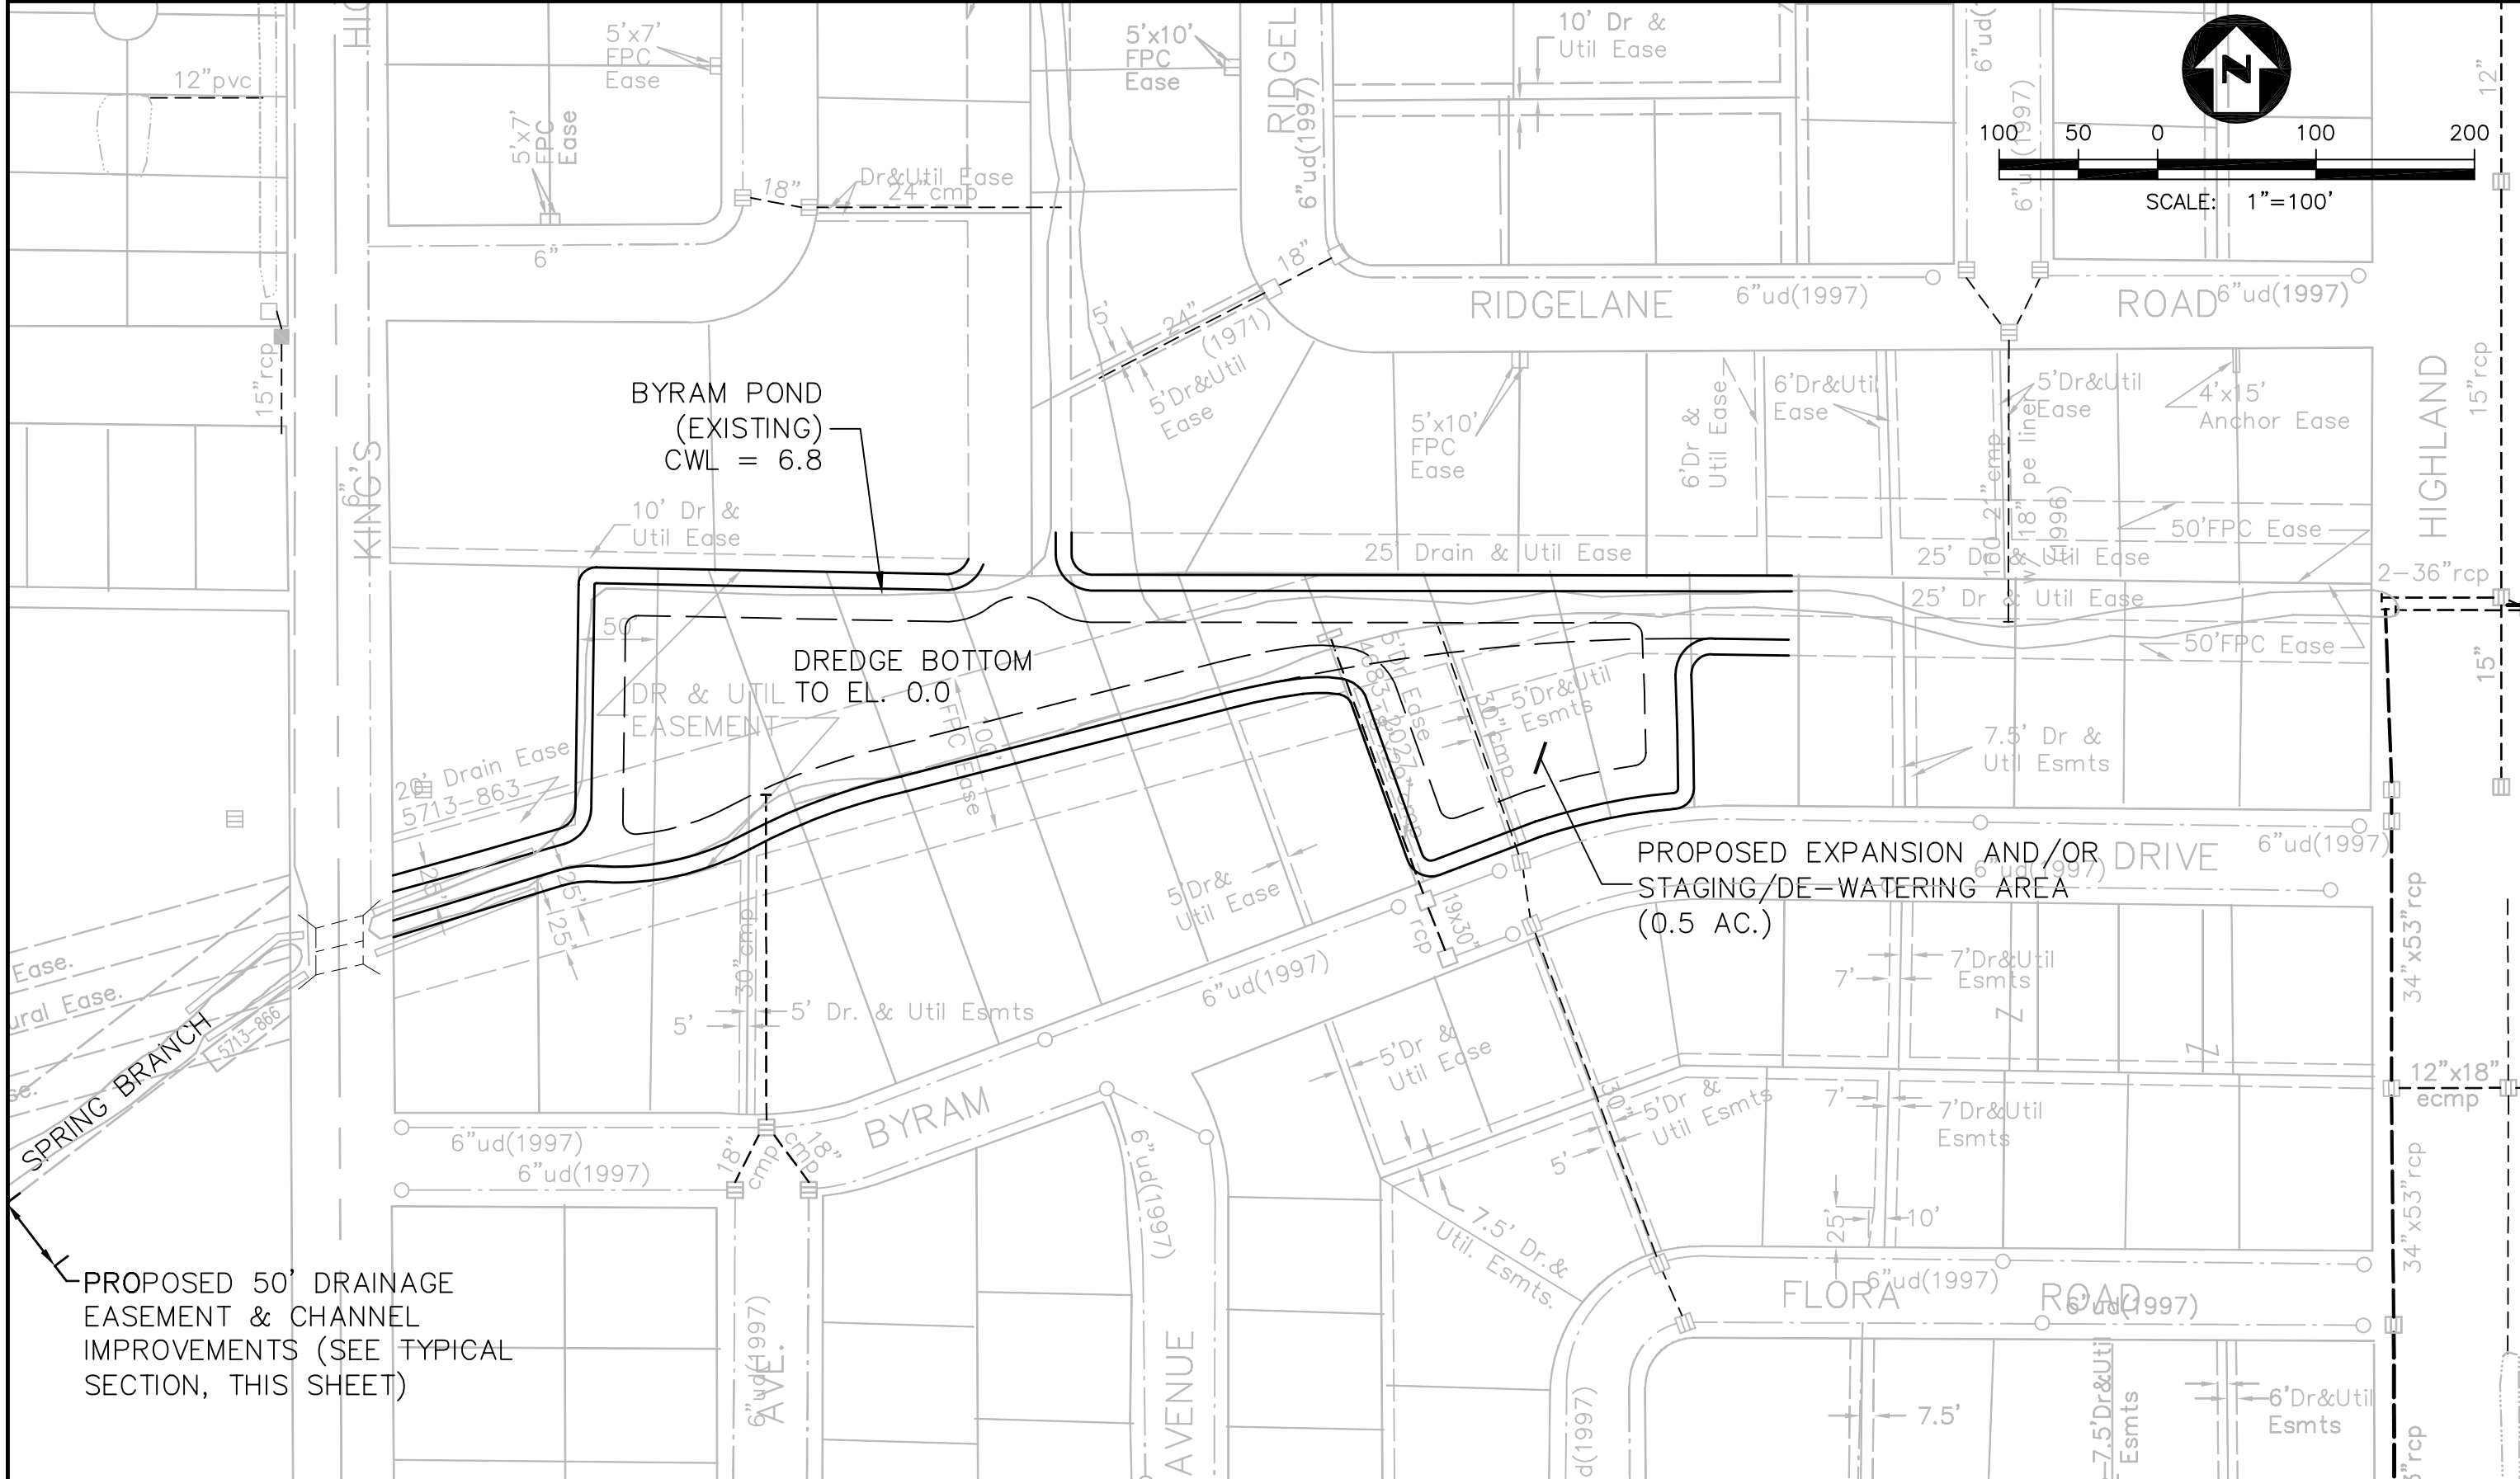
| <p>THE CITY OF CLEARWATER, FLORIDA</p> | <p>PARSONS ENGINEERING SCIENCE, INC. Tampa, Florida (813) 933-4650</p> | <p>PROJECT 1E BYRAM POND DREDGING & EXPANSION</p> |

PROPOSED 50' DRAINAGE EASEMENT & CHANNEL IMPROVEMENTS (SEE TYPICAL SECTION, THIS SHEET)

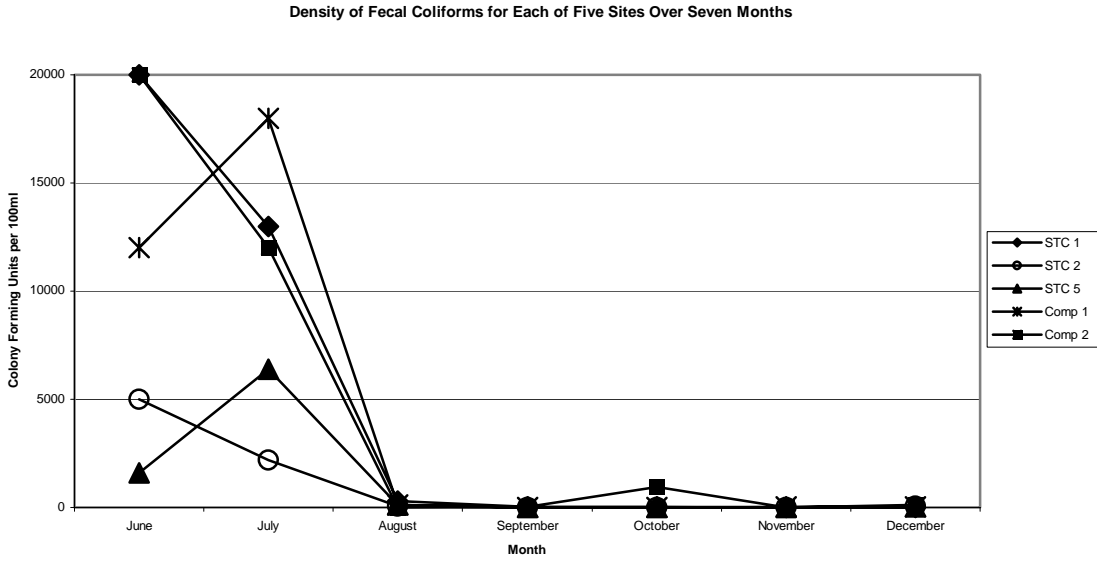
Figure 1. CFU/100ml from the five sites over seven months.

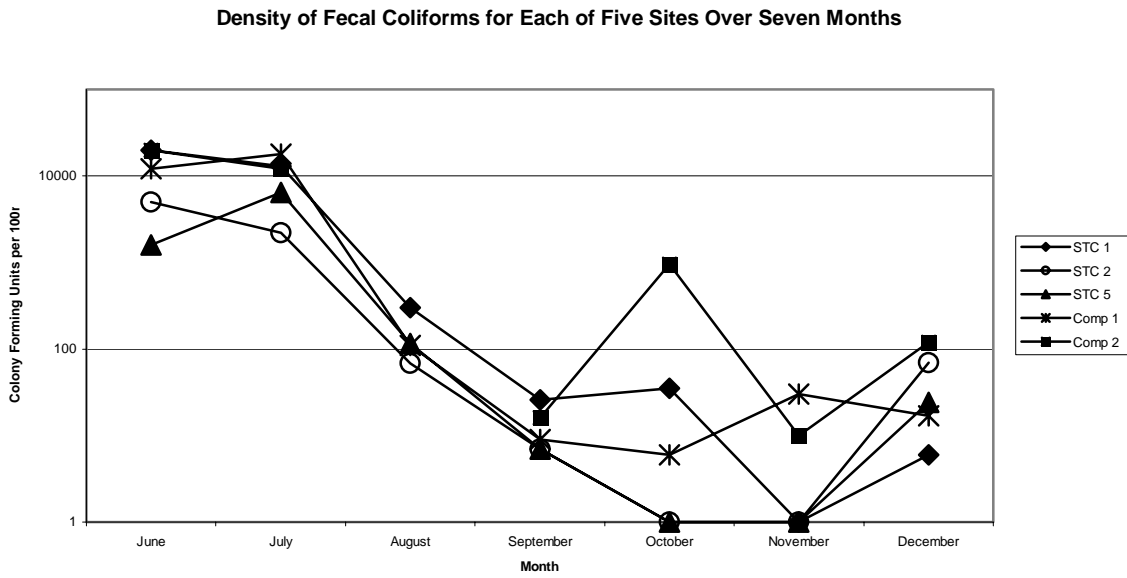
Figure 2. CFU/100ml from the five sites over seven months, graphed on a log scale.

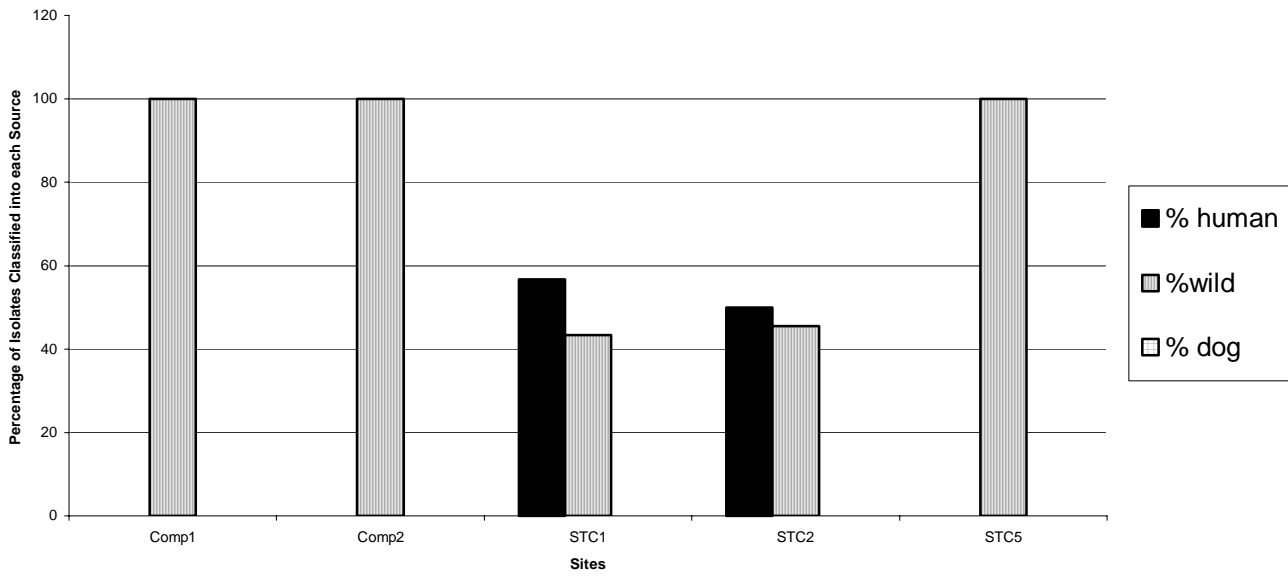
Figure 3

Categorization of Isolates from Each of Five Sites on 6/27/00

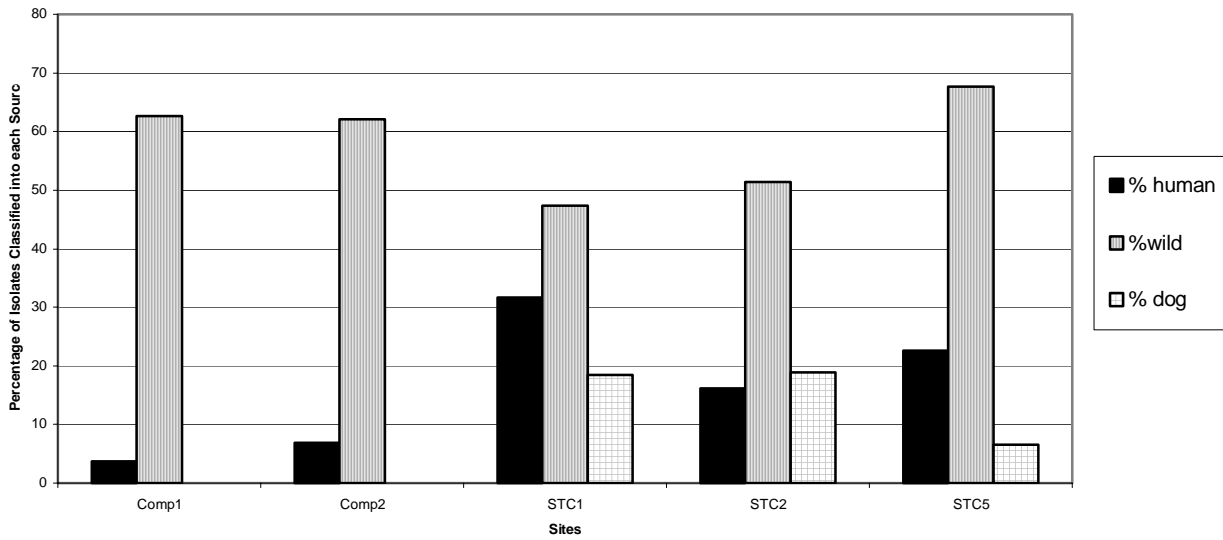
Figure 4.

Categorization of Isolates from Each of Five Sites on 7/25/00

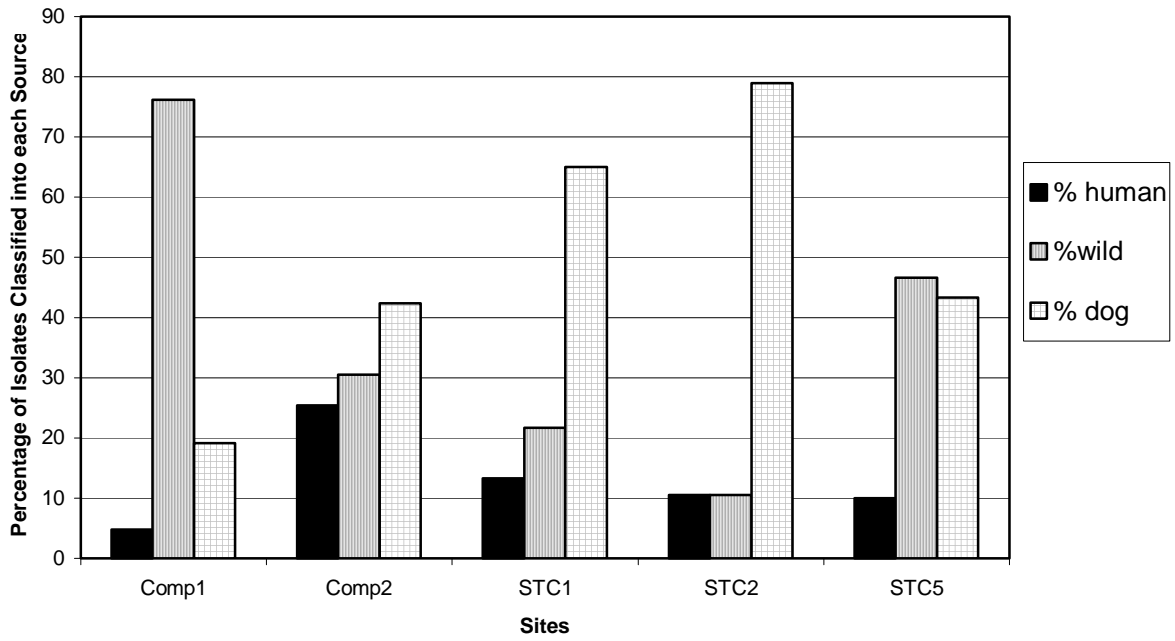
Figure 5.

Categorization of Isolates from Each of Five Sites on 8/22/00

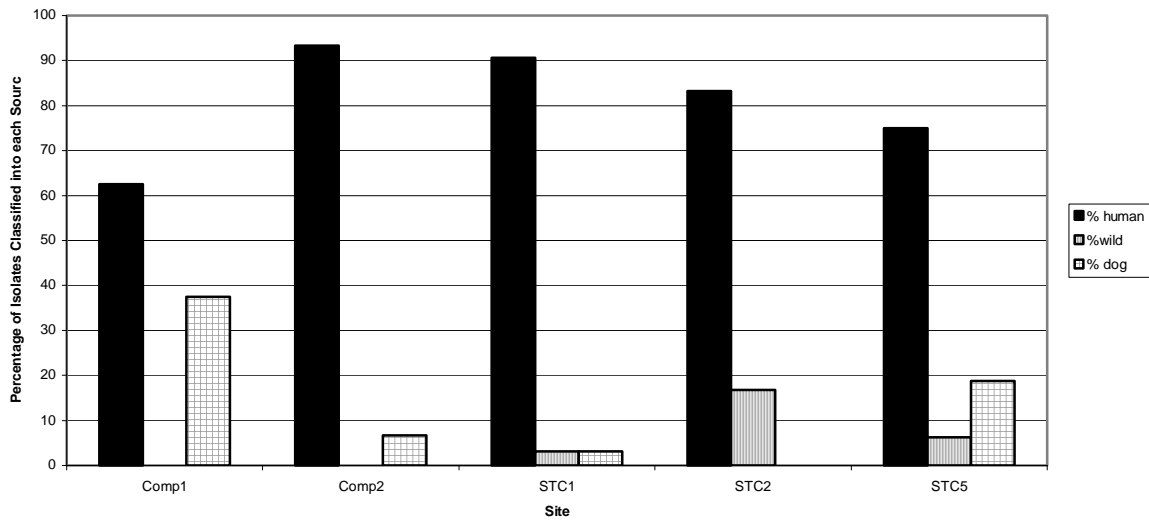
Figure 6.

Categorization of Isolates from each of Five Sites on 9/19/00

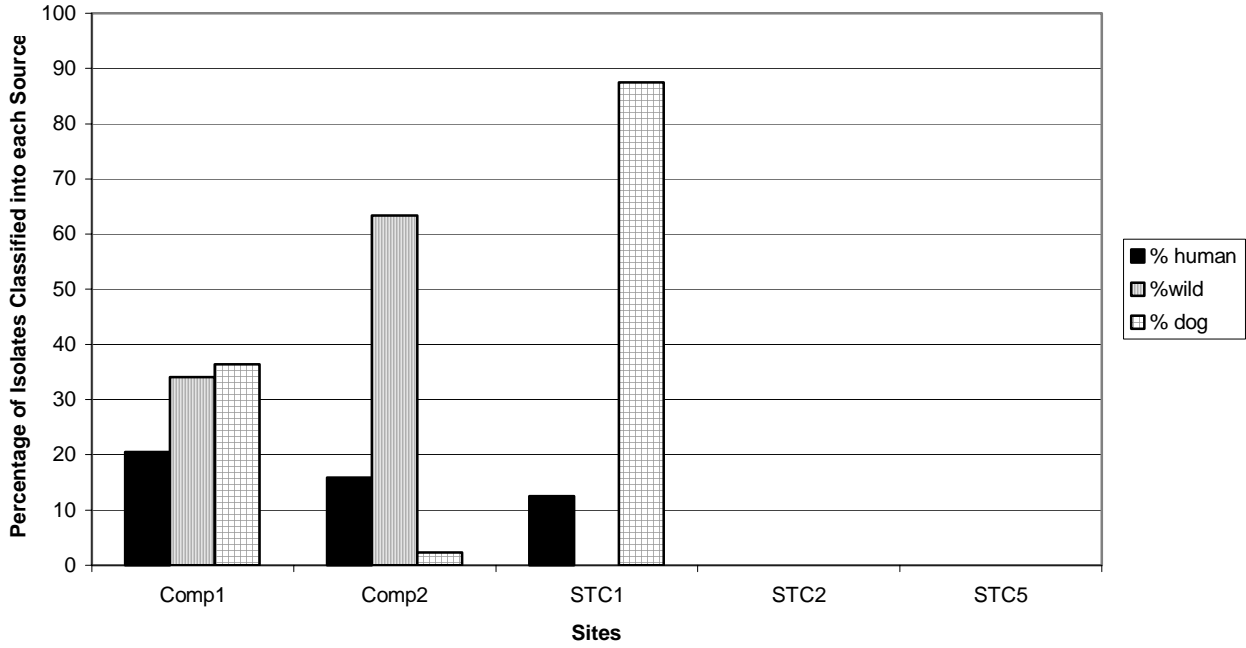
Figure 7.

Categorization of Isolates from the Three Sites from Which Fecal Coliforms were Obtained on 10/23/00

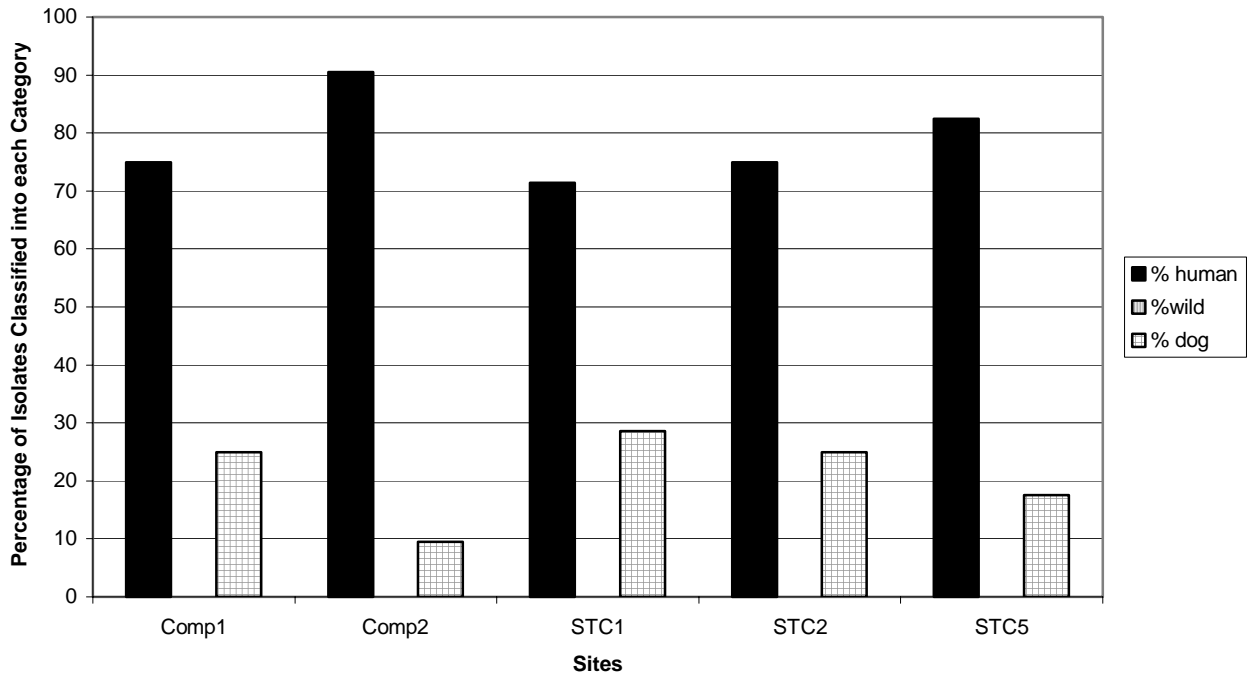
Figure 8.

Categorization of Isolates from Each of Five Sites on 12/27/00
